Analysis of accidents due to slope failure in Indian opencast coal mines

A. K. Dash*

Department of Mining Engineering, National Institute of Technology,
Raipur 492 010, India

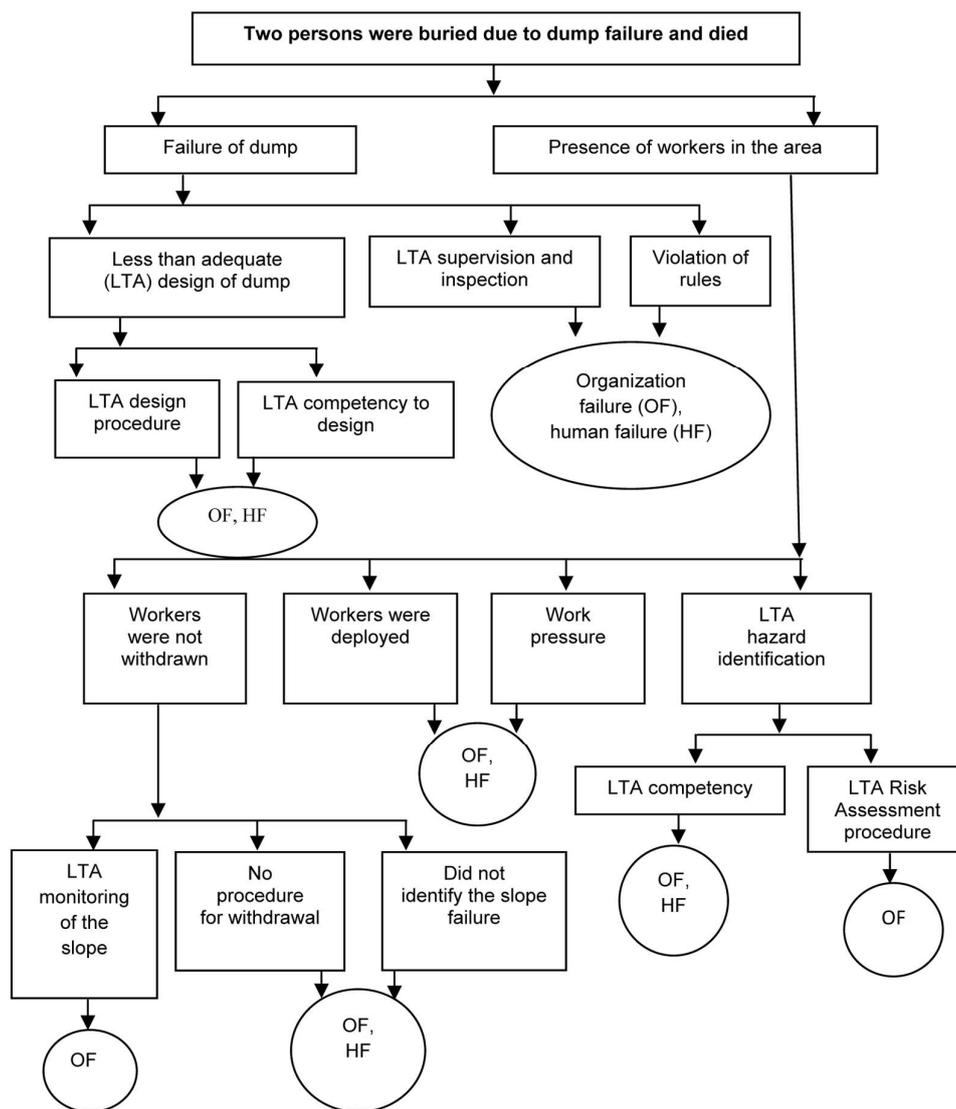
Figure 1. Accident causation tree of the case study.

During analysis of the above accident case study, an accident causation tree was developed, not only to identify all the probable causes along with the root causes but also to give a clear picture about the sequence of events prior to the accident (Figure 1).

According to the statutory inquiry, the accident took place due to (i) violation of rules and permission condition, (ii) the height of the dragline dump was more than 30 m, (iii) the dump was not formed on rough floor and made on slushy materials, (iv) an un-extracted berm of 10 m of coal was not left below loose dragline dump between two cuts to protect the dump base as required, (v) dangerous workplace conditions, i.e. toe of the dragline dump was not examined by competent persons even though it was reported by supervisors.

Mine safety management system failed: (i) To establish standard operating procedure (SOP) for the construction of waste dump based on risk assessment; (ii) To provide effective supervision at the time of work; (iii) To provide adequate resources for slope monitoring; (iv) To establish

procedures to ensure that workers do not enter into areas where imminent danger could be present.

All the possible hazards related to working at the toe or slope failure were ignored without any justification or risk assessment. The mine workers and management were not competent to identify the hazards or conducting risk assessment. This lack of hazard perception led to a catastrophic decision of allowing workers to work near to the toe of an active dump.

The general observations from the study are: (i) In opencast workings, the bench configurations in high wall and spoil dumps must be finalized after proper slope-stability studies. Dumping profile with minimum average factor of safety of 1.40 should be adopted. (ii) The slope of a spoil bank should be determined by the natural angle of repose of the material being deposited but, in any case, it must not exceed 37.5° from the horizontal¹⁴. (iii) The movement of high-dump slopes in large opencast projects should be monitored by sophisticated dump slope-monitoring systems and surveyors should be trained in the use of such systems. (iv) Any spoil bank exceeding 30 m in

height should be benched so that no bench exceeds 30 m in height and the overall slope must not exceed 1 vertical to 1.5 horizontal¹⁴. (v) Suitable drainage system must be maintained to reduce the risk of increasing hydrostatic pressure, in turn reducing the risk of failure. (vi) No person should approach or be permitted to approach the toe of an active spoil bank where he may be endangered from material sliding or rolling down the face¹⁴. In the toe of the overburden dump which was in the active stage had been declared as 'danger area or no-go-zone', as required under 108(7) of the Coal Mine Regulation 2017 (ref. 14), this accident could have been avoided.
