Damage to buildings in Latur earthquake

R. Sinha and A. Goyal

Civil Engineering Department, Indian Institute of Technology, Powai, Bombay 400 076, India

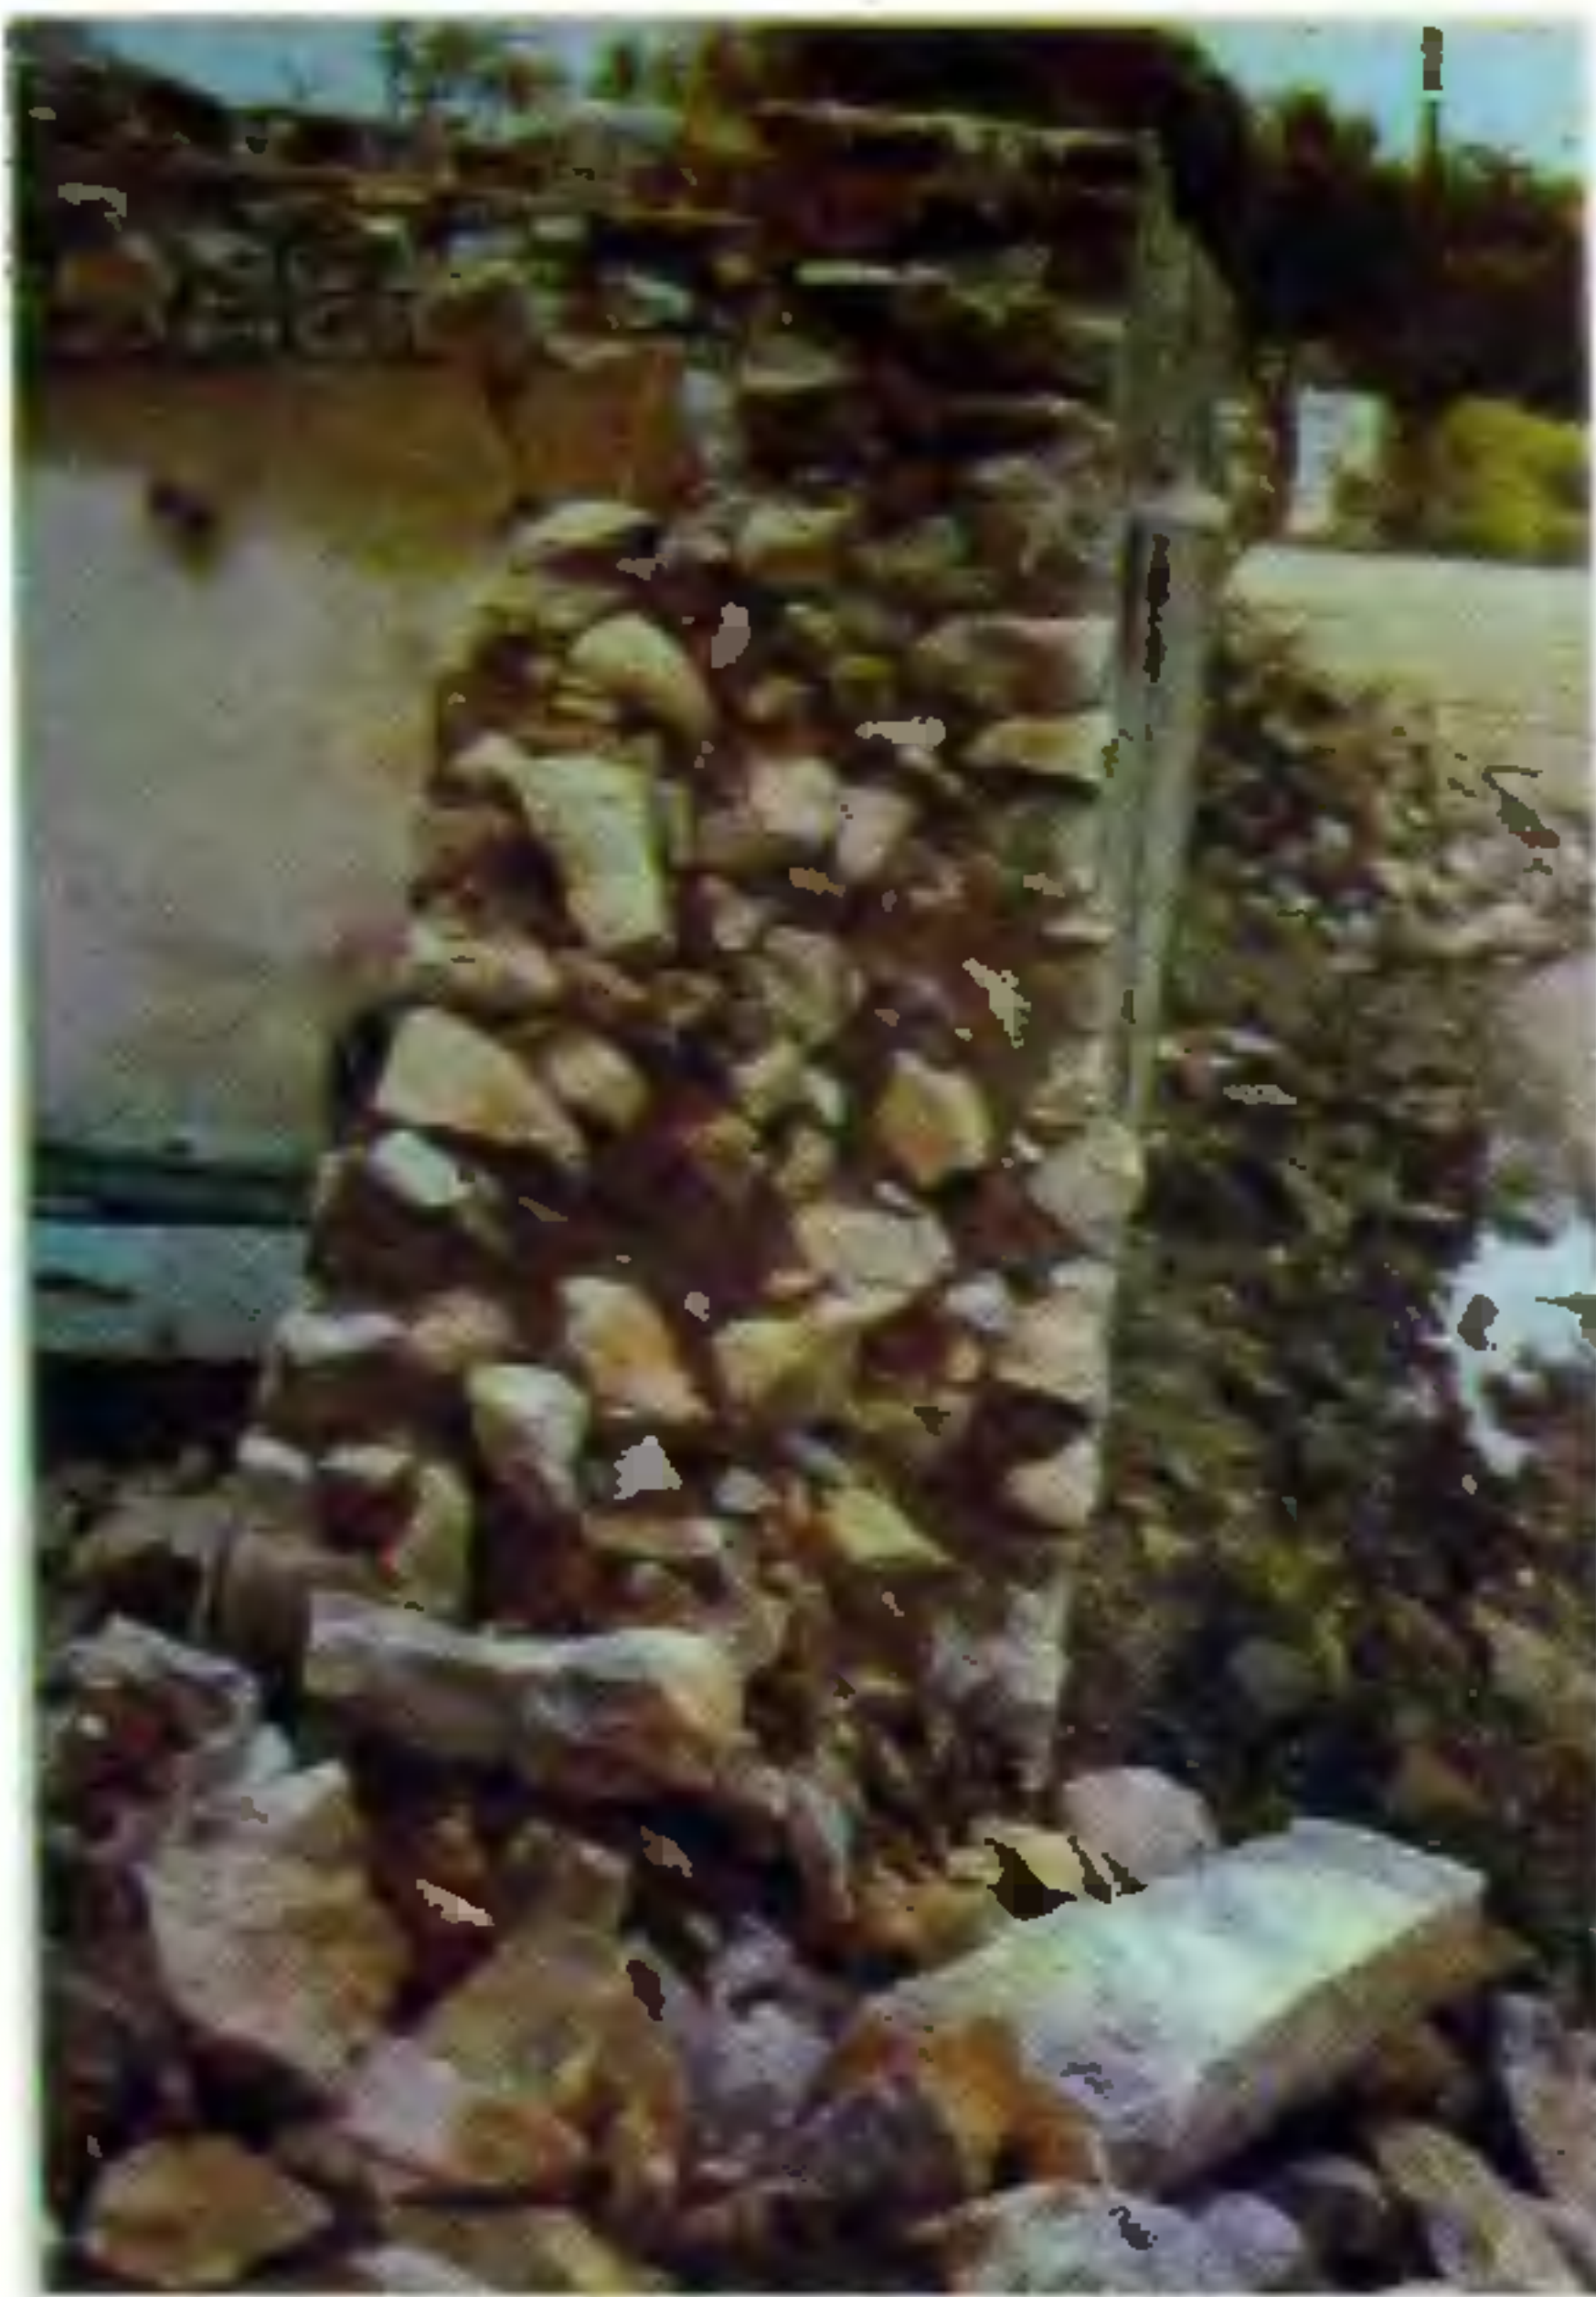
These are single-storied traditional buildings having stone masonry walls with mud mortar used as the binding material. The foundations in these buildings are provided by extending the walls downward to the hard rock level. At locations where the black-cotton soil is deeper than 4–5 m the walls are extended to a depth of about 4 m to act as a foundation. The stone masonry walls are typically about 600–1000 mm thick. The stone rubble blocks that are used in these constructions have rounded edges and are not usually shaped into rectangular blocks. The masonry pieces vary in size from 100 mm to even 600 mm along their longest axis. The inside wall surfaces in rooms are made smooth by interlocking the masonry blocks properly, whereas the outside surface is generally made smooth with small rubble pieces and mud filling (Figure 3).

Figure 3. Typical wall cross-section in mud mortar constructions.

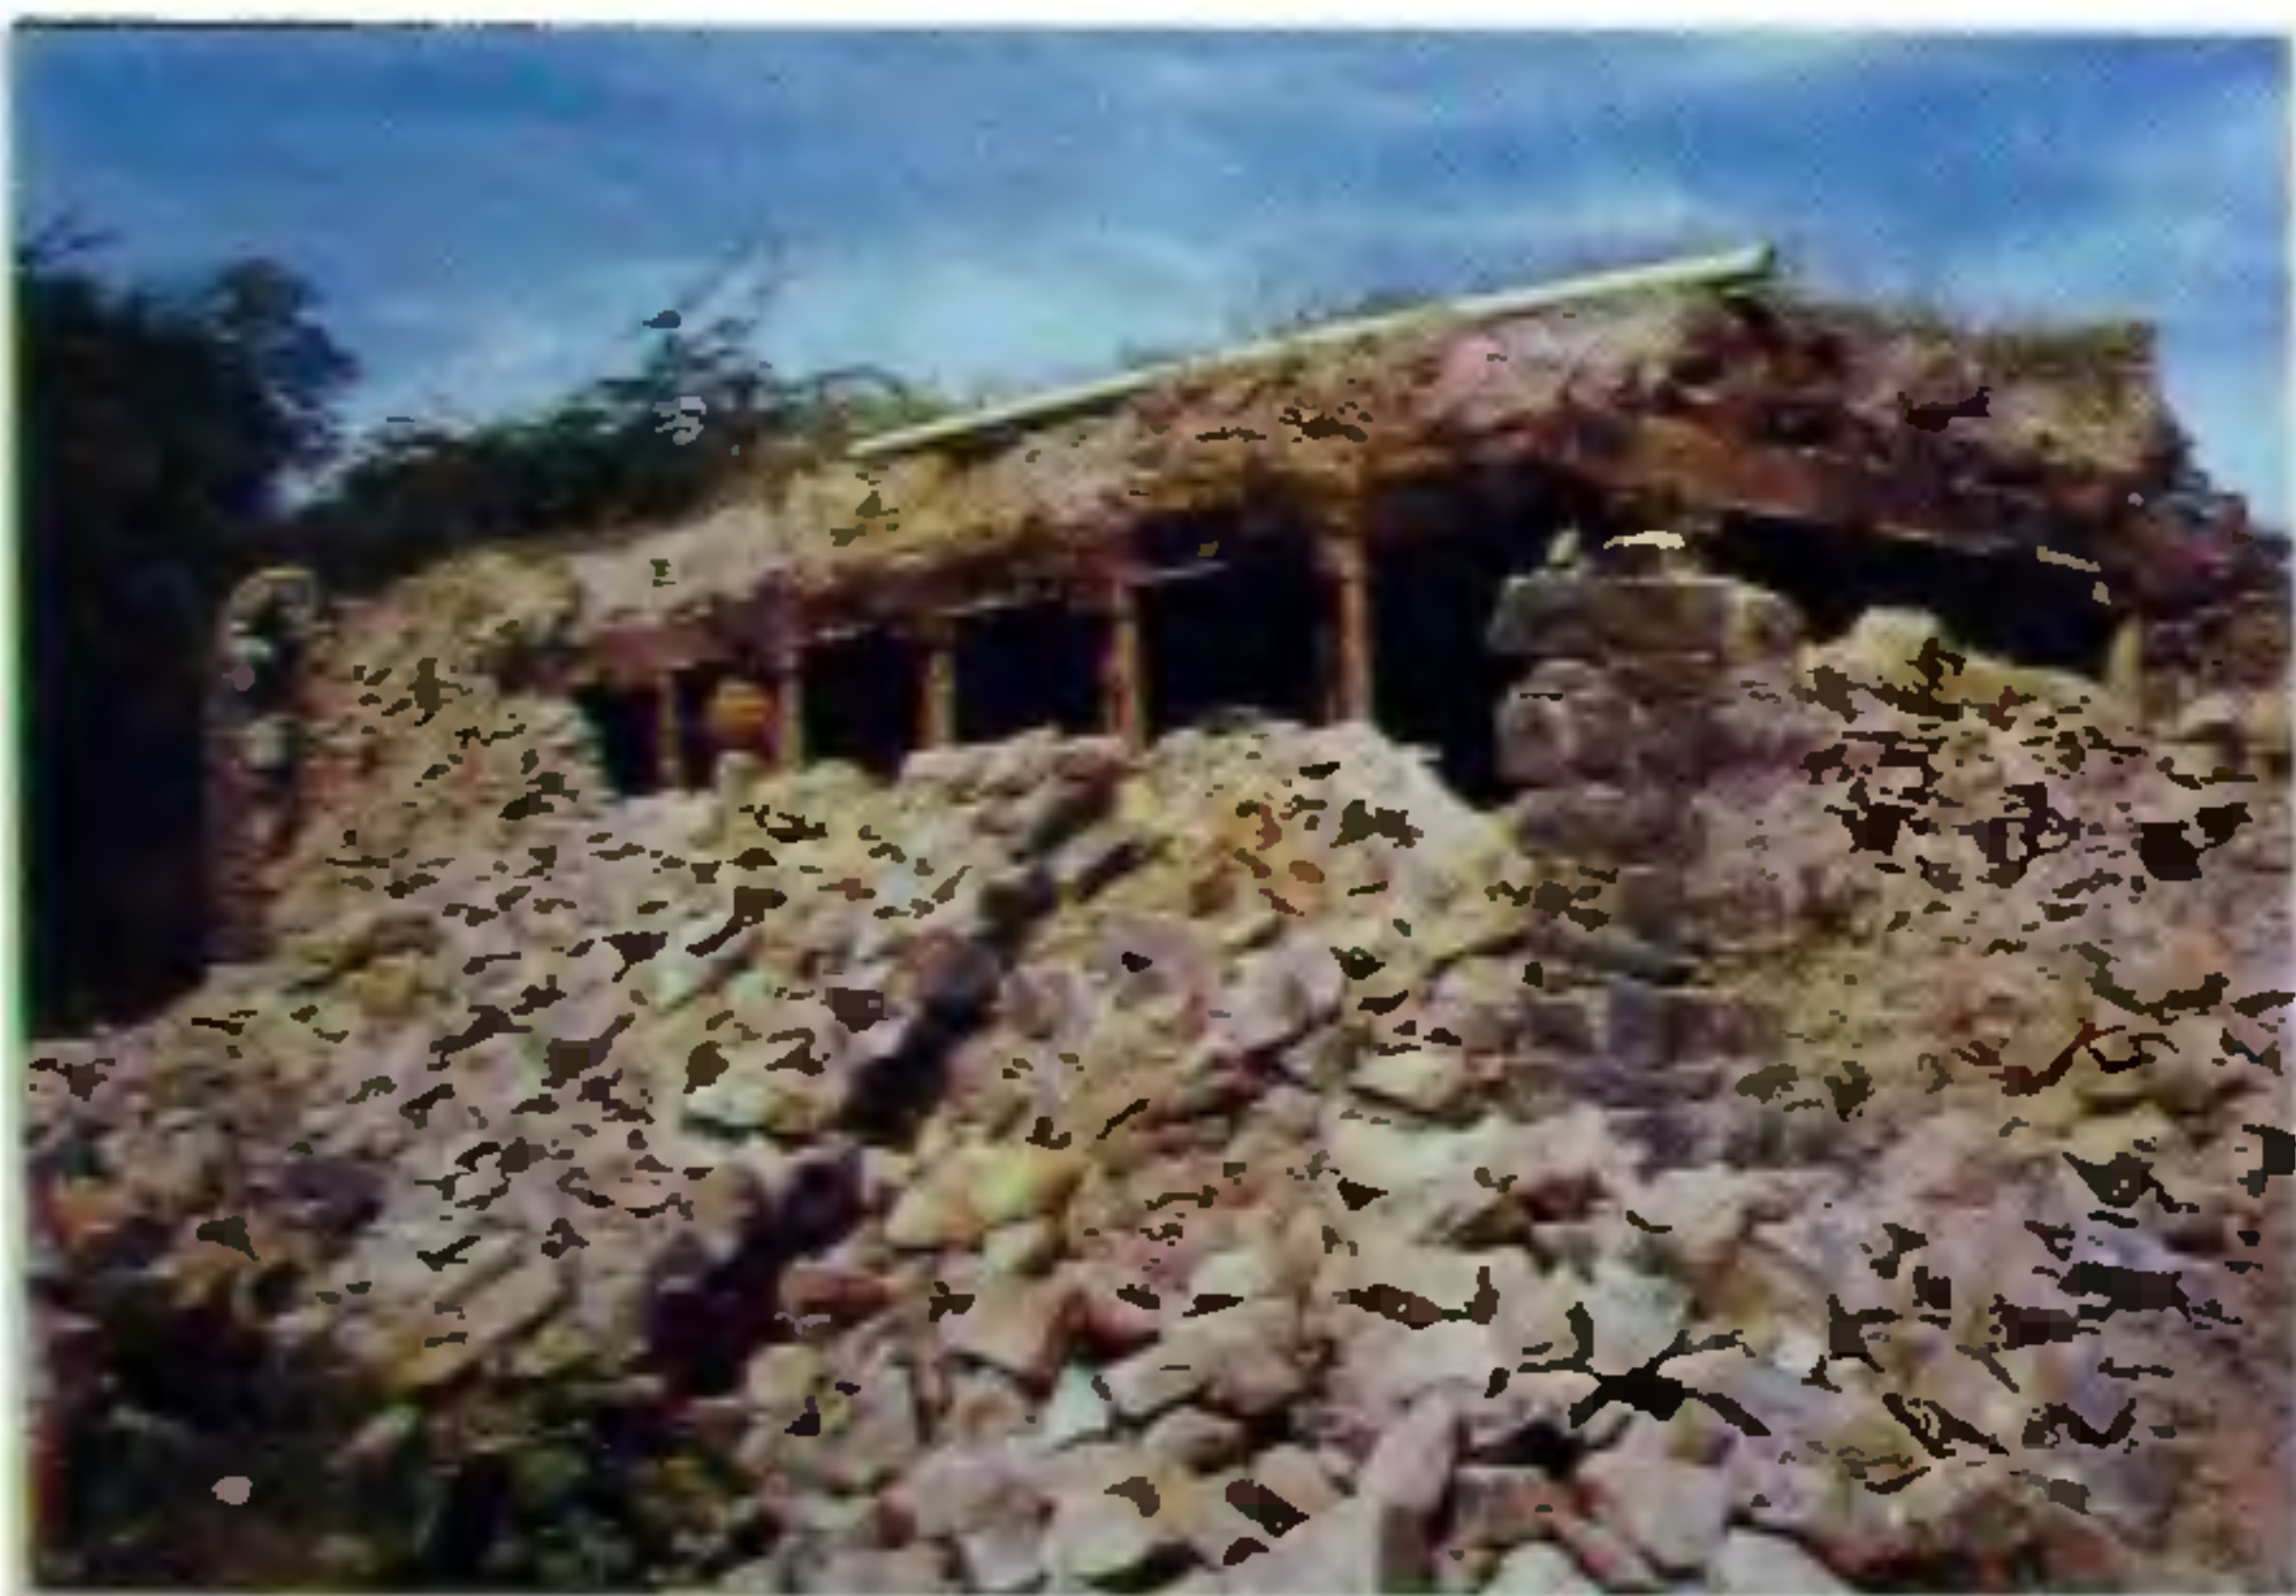
Mud mortar is known to have very poor shear and tensile strength. Consequently, the strength of walls to resist lateral forces that develop under earthquake excitation is very low. In addition, the mud layer on roofs of traditional buildings (Figure 4) has a significant mass and generates a very large inertia force. Consequently, the lateral strength to mass ratio for these buildings is very low. Therefore these constructions developed wall cracks or collapsed partially even at considerable distances from the most affected areas (up to 75 km from the epicentre). In regions close to the epicentre, almost all buildings constructed with mud mortar showed very severe distress or collapse of walls.

Figure 4. Typical vertical load-carrying system in traditional constructions.

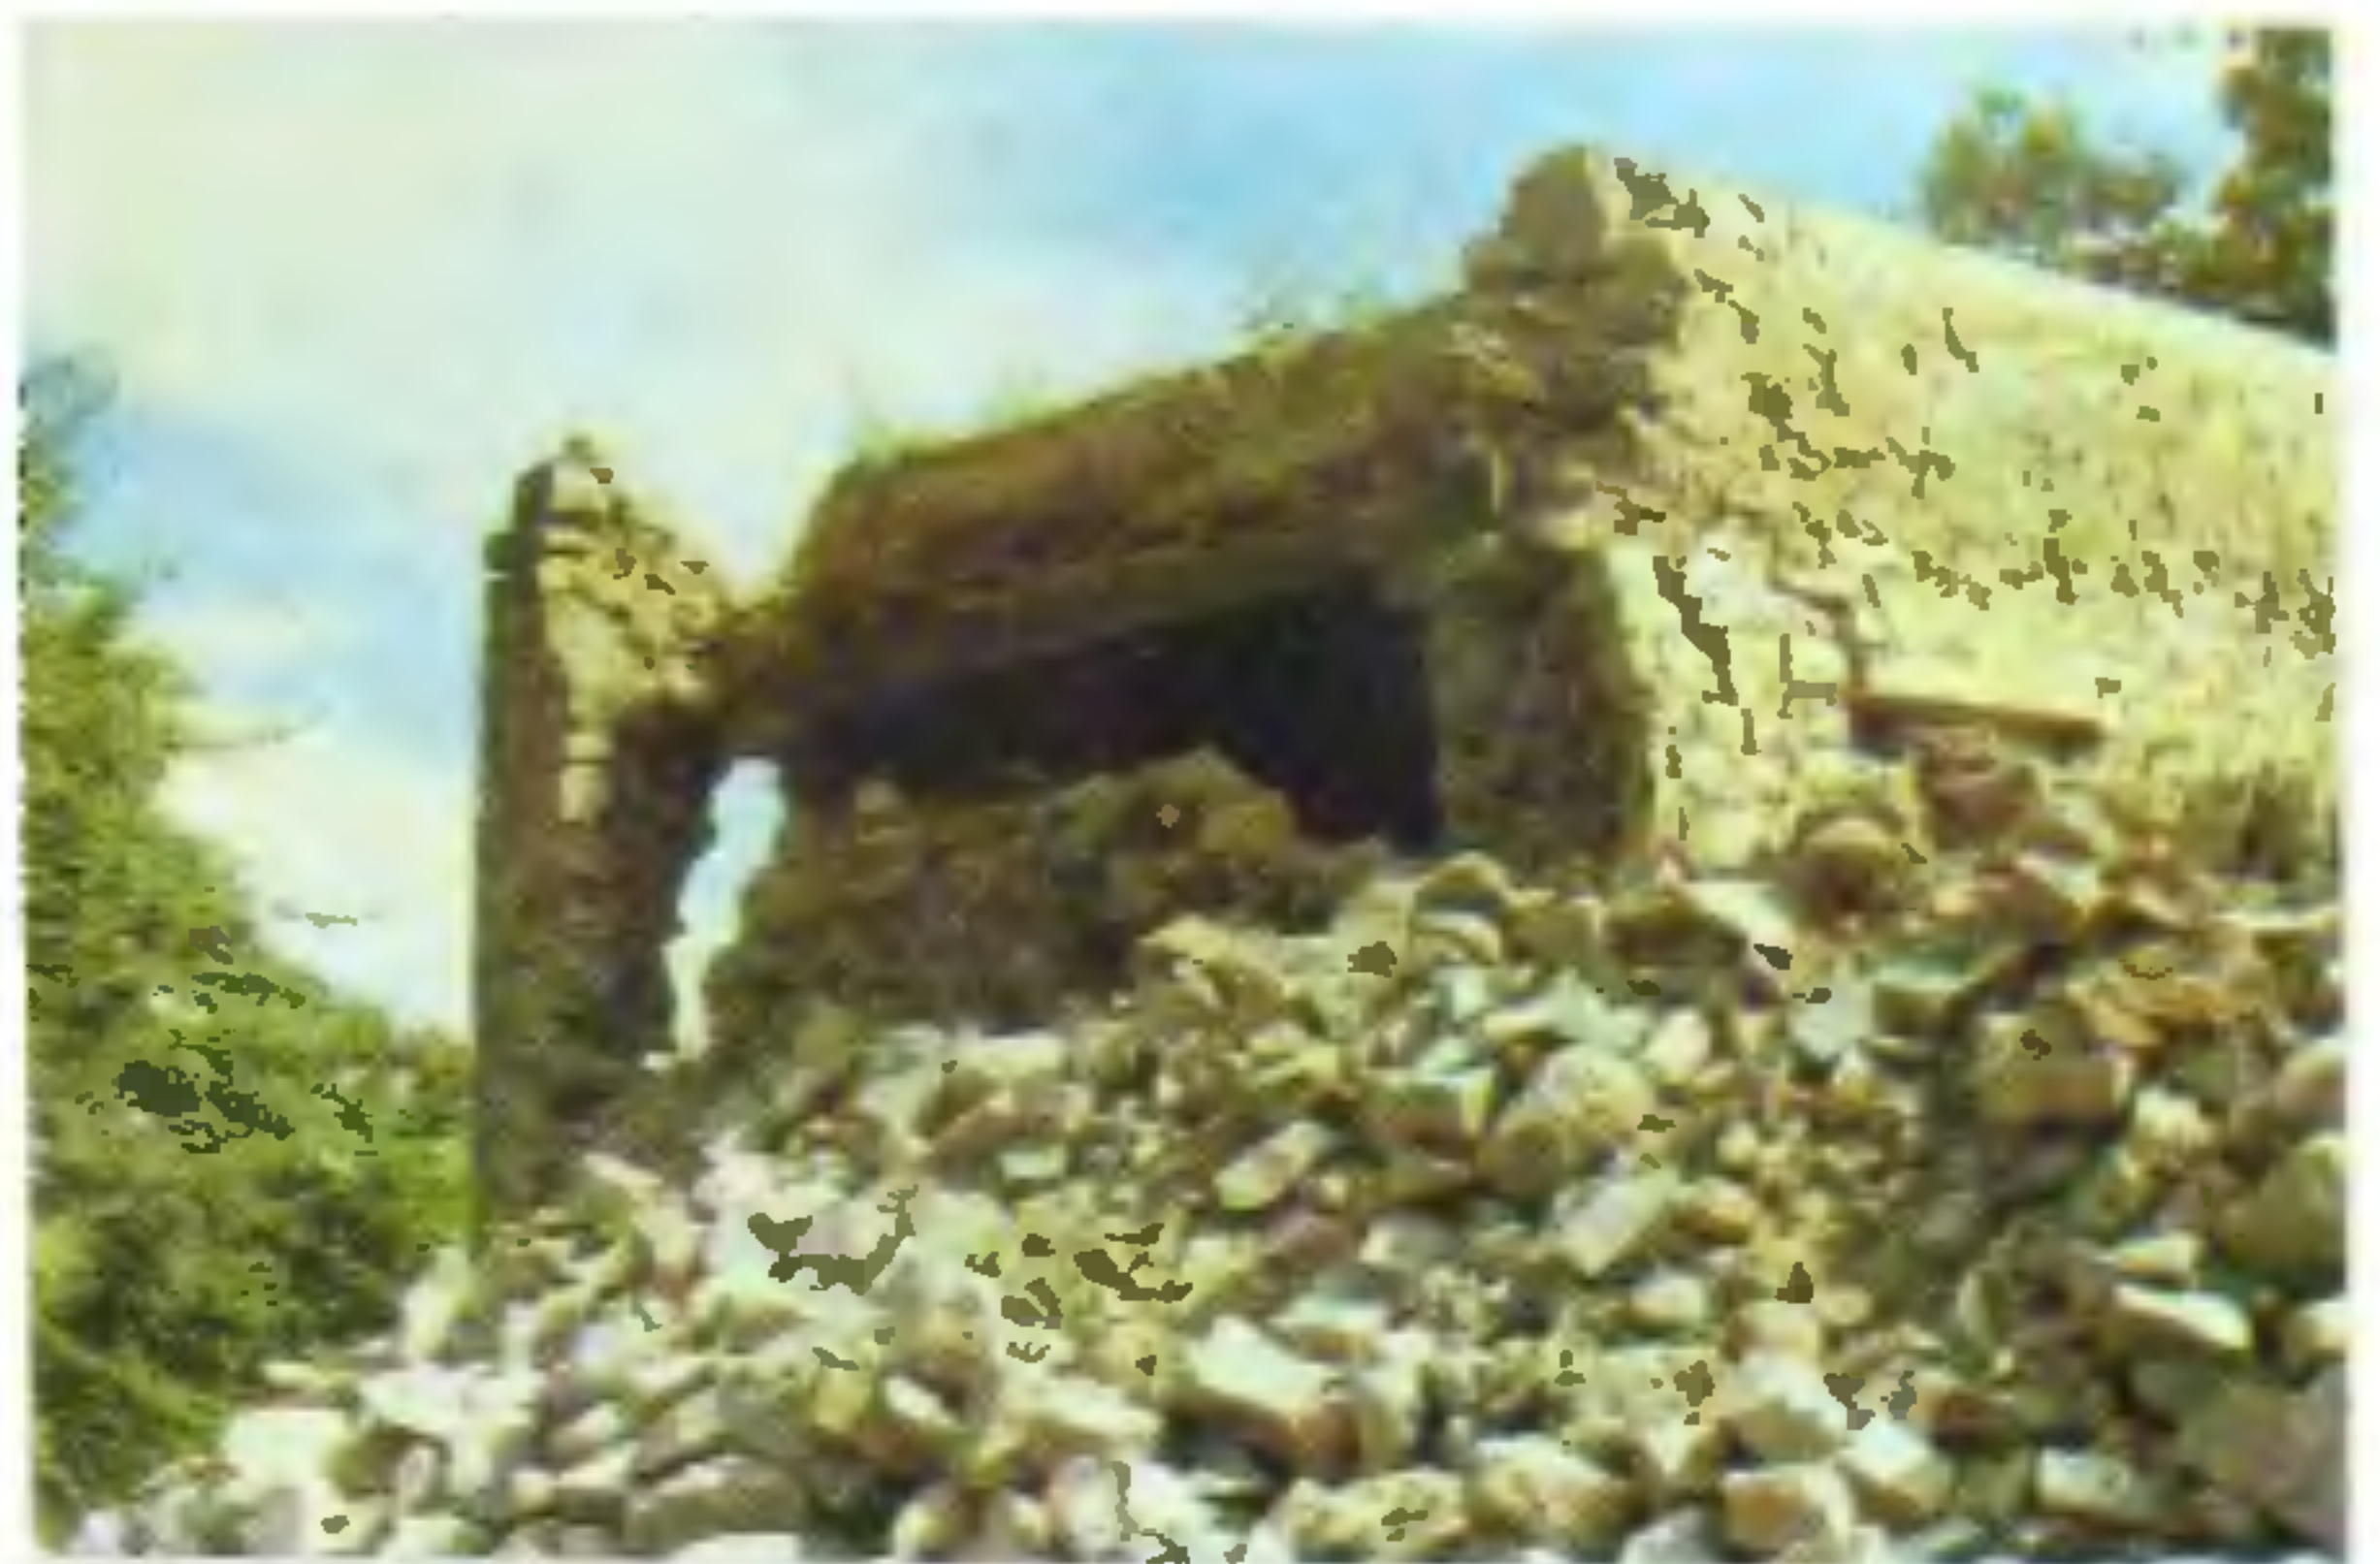
Wooden planks or galvanized iron sheets supported on wooden joists are most commonly used as roof. A thick layer of mud (up to 300 mm thick) is often placed on the roof to provide insulation. In older constructions, the joists are supported on wooden columns at regular intervals along the walls. The wooden frame and columns are tied together to act as an integral unit (Figure 4). In most new constructions, however, the joists rest directly on the walls. In these constructions, there is no continuity between the roof and the members that carry its weight (Figure 5), making the structure vulnerable to earthquake forces.

Figure 5. Typical roof-wall connection in traditional constructions with load-bearing walls.

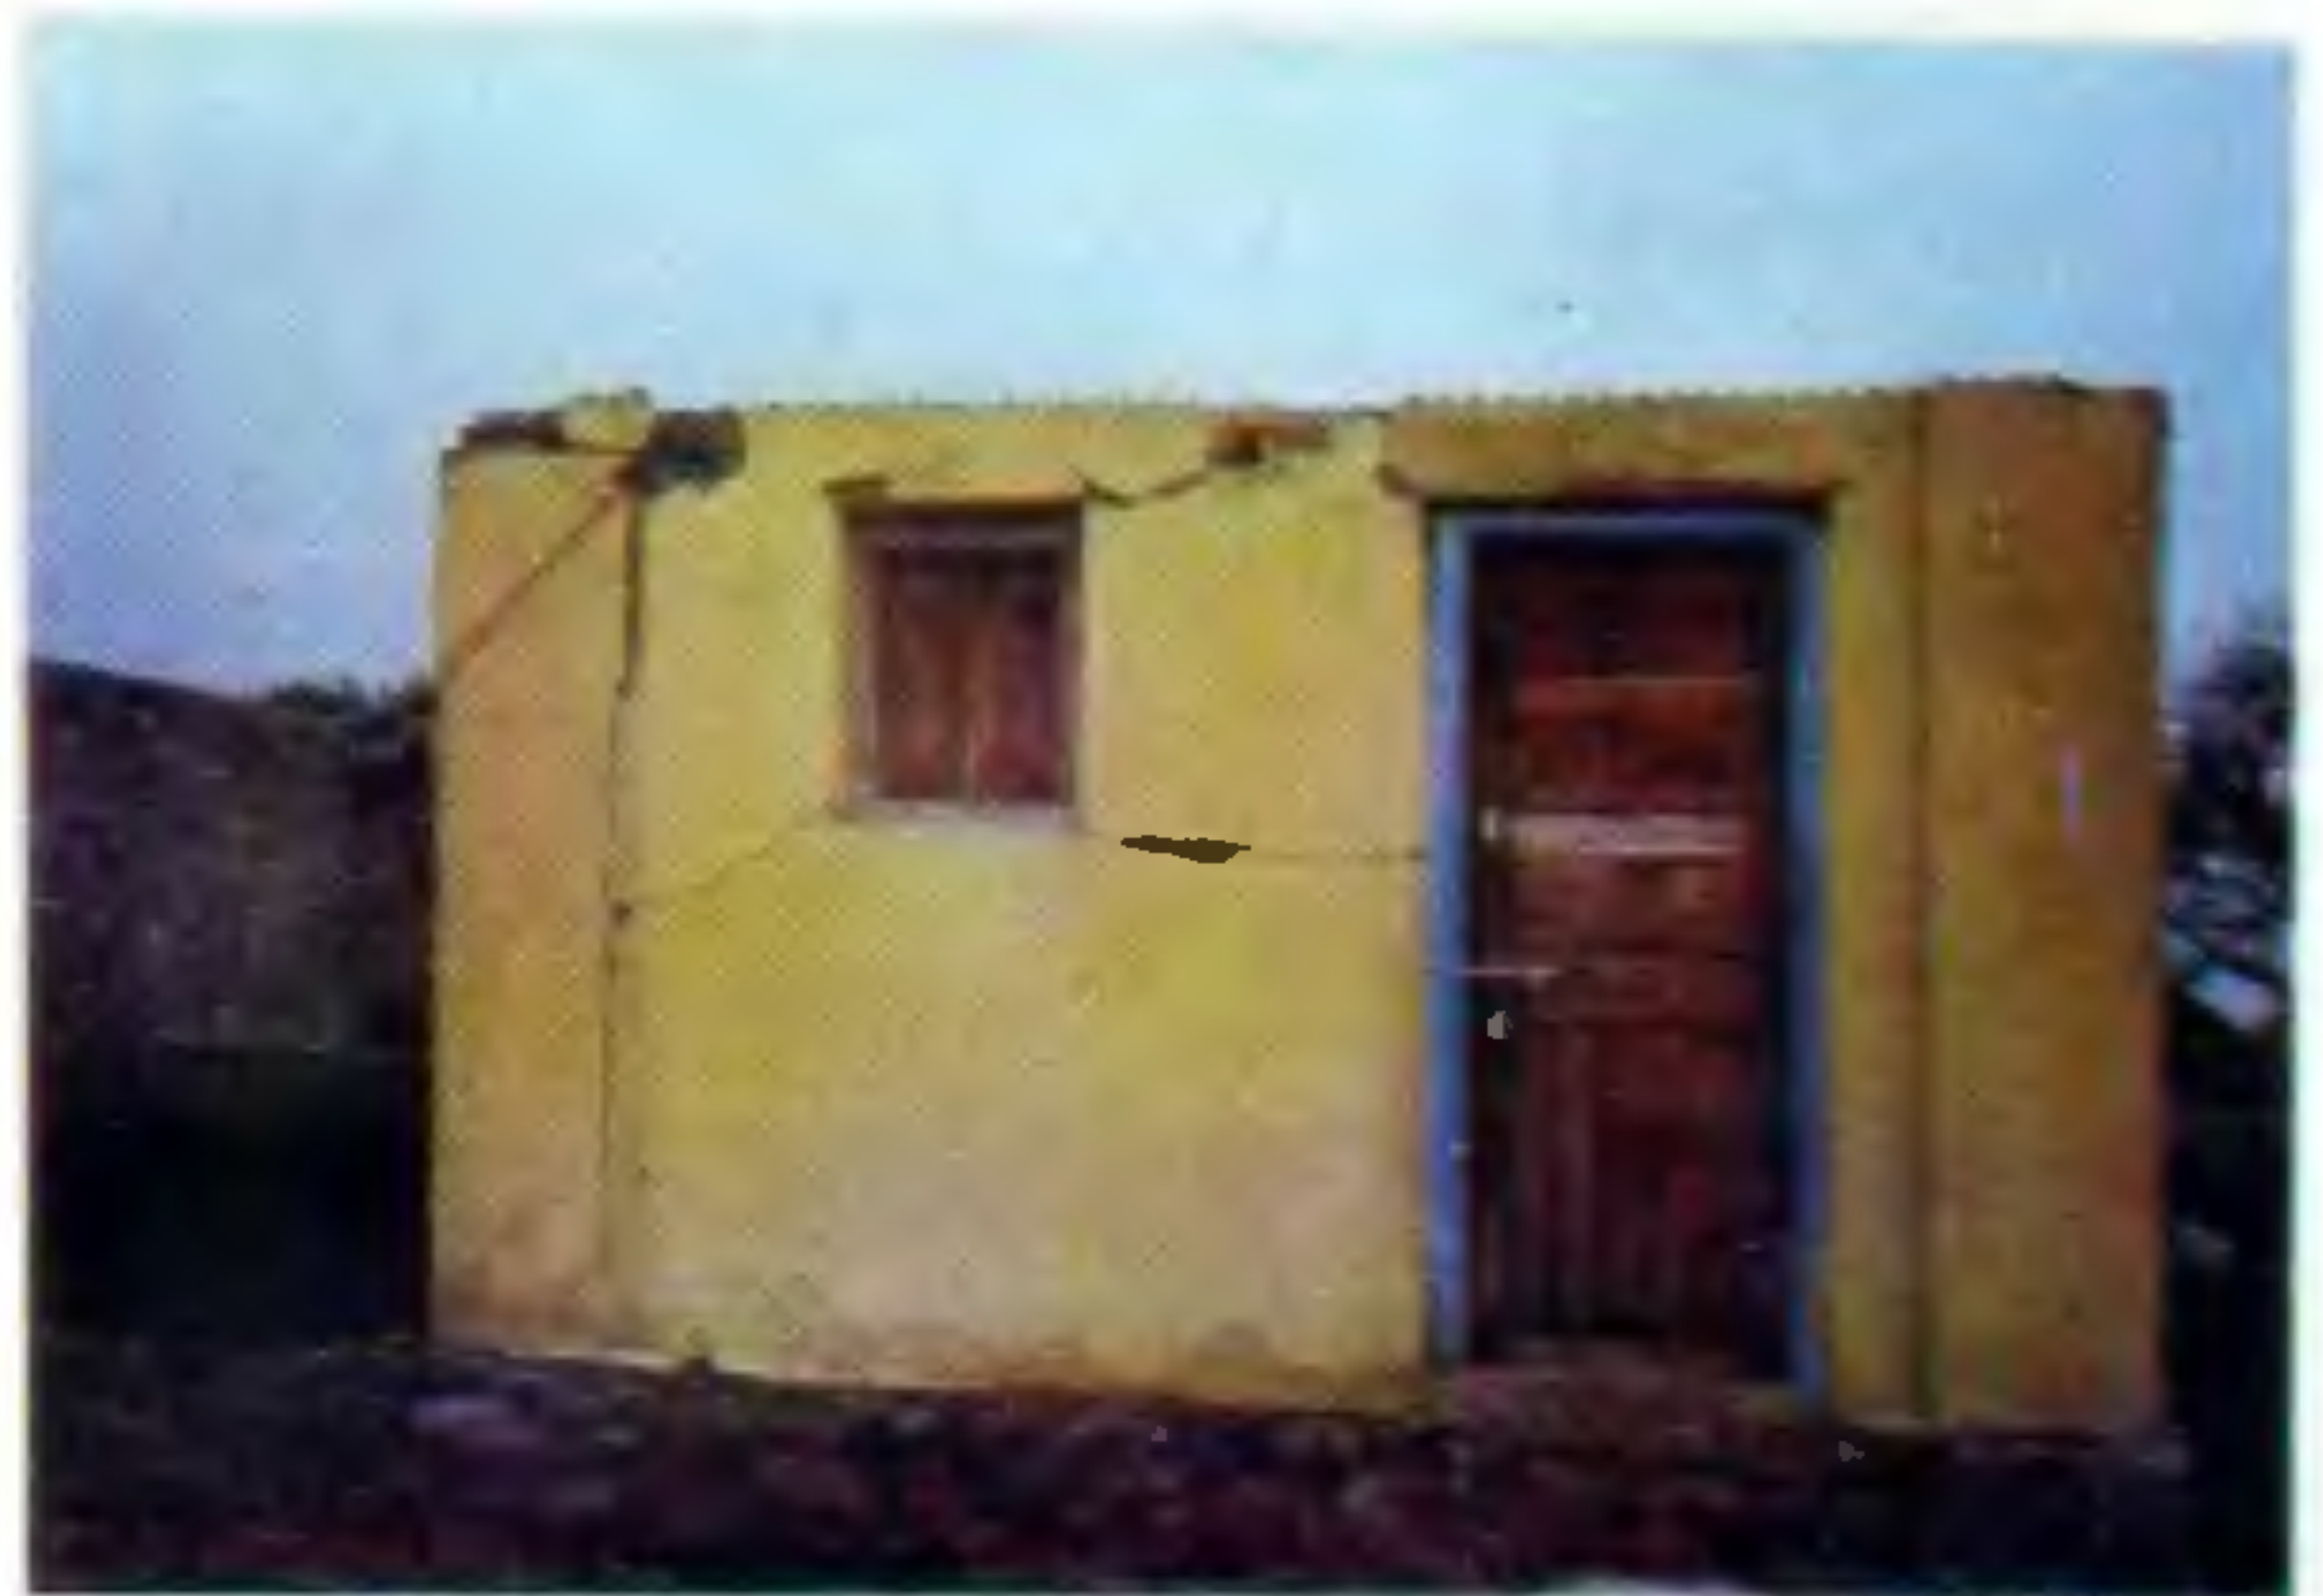
Both stone and brick masonry houses, mostly non-engineered, have been constructed in this region using cement mortar as the binding material. The building dimensions are similar to mud mortar buildings but the walls are 600–1000 mm thick even with brick masonry (Figure 6). The walls in stone masonry constructions have field stones of greatly varying sizes and shapes. Some brick masonry buildings have stone masonry between the lintel and roof level (Figure 7). The foundations of all these buildings are similar to those of the corresponding mud-mortar buildings, provided by extending the walls below the ground level.

Figure 6. Brick masonry building showing size of walls and orientation of cracks.

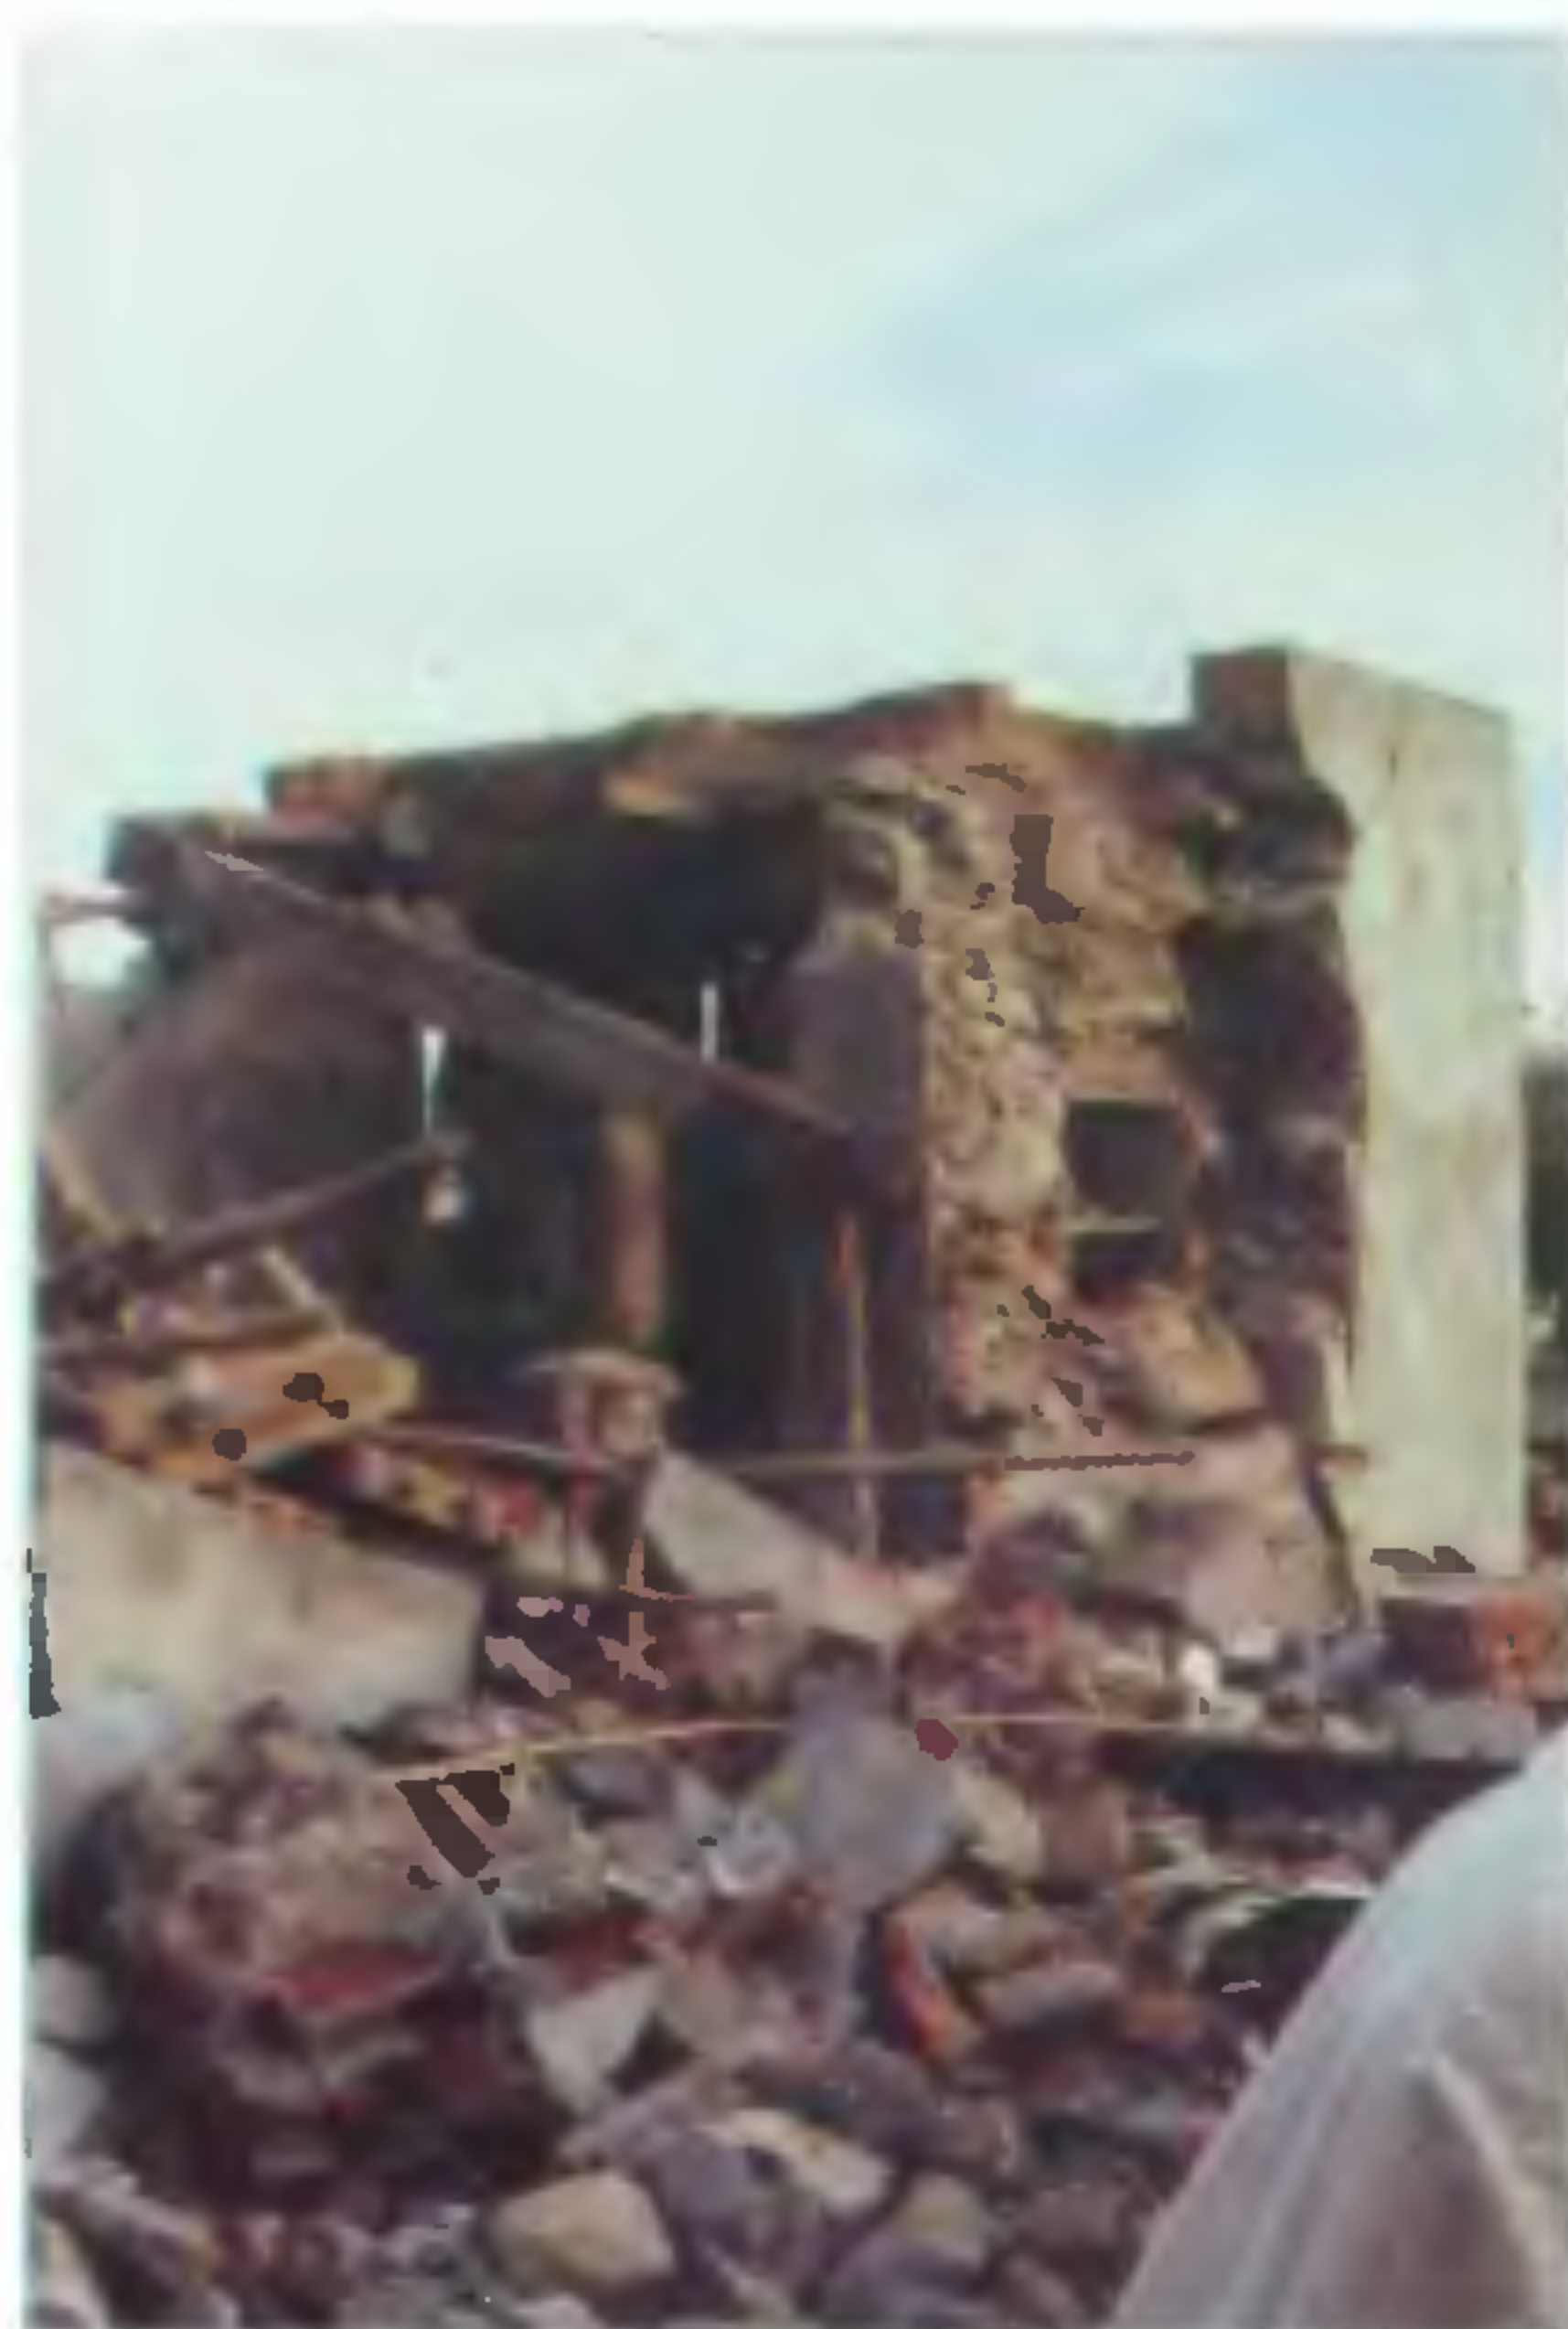
Stone masonry buildings showed much greater distress than brick masonry buildings for both types of structure systems discussed here. There are two main reasons for this difference in performance. Firstly, the stone masonry walls had much lower lateral strength to mass ratio. Secondly, the stone masonry blocks usually consisted of weathered random rubble. The weathered layer on

the surface disallowed a good bond from developing between the masonry blocks and mortar. Under earthquake excitation, the surface of these rubble blocks acted as weak planes and delaminated easily, leading to easy propagation path for cracks.

Figure 7. A building with both brick and stone masonry in the same wall
