Damage to buildings in Latur earthquake

R. Sinha and A. Goyal

Civil Engineering Department, Indian Institute of Technology, Powai, Bombay 400 076, India

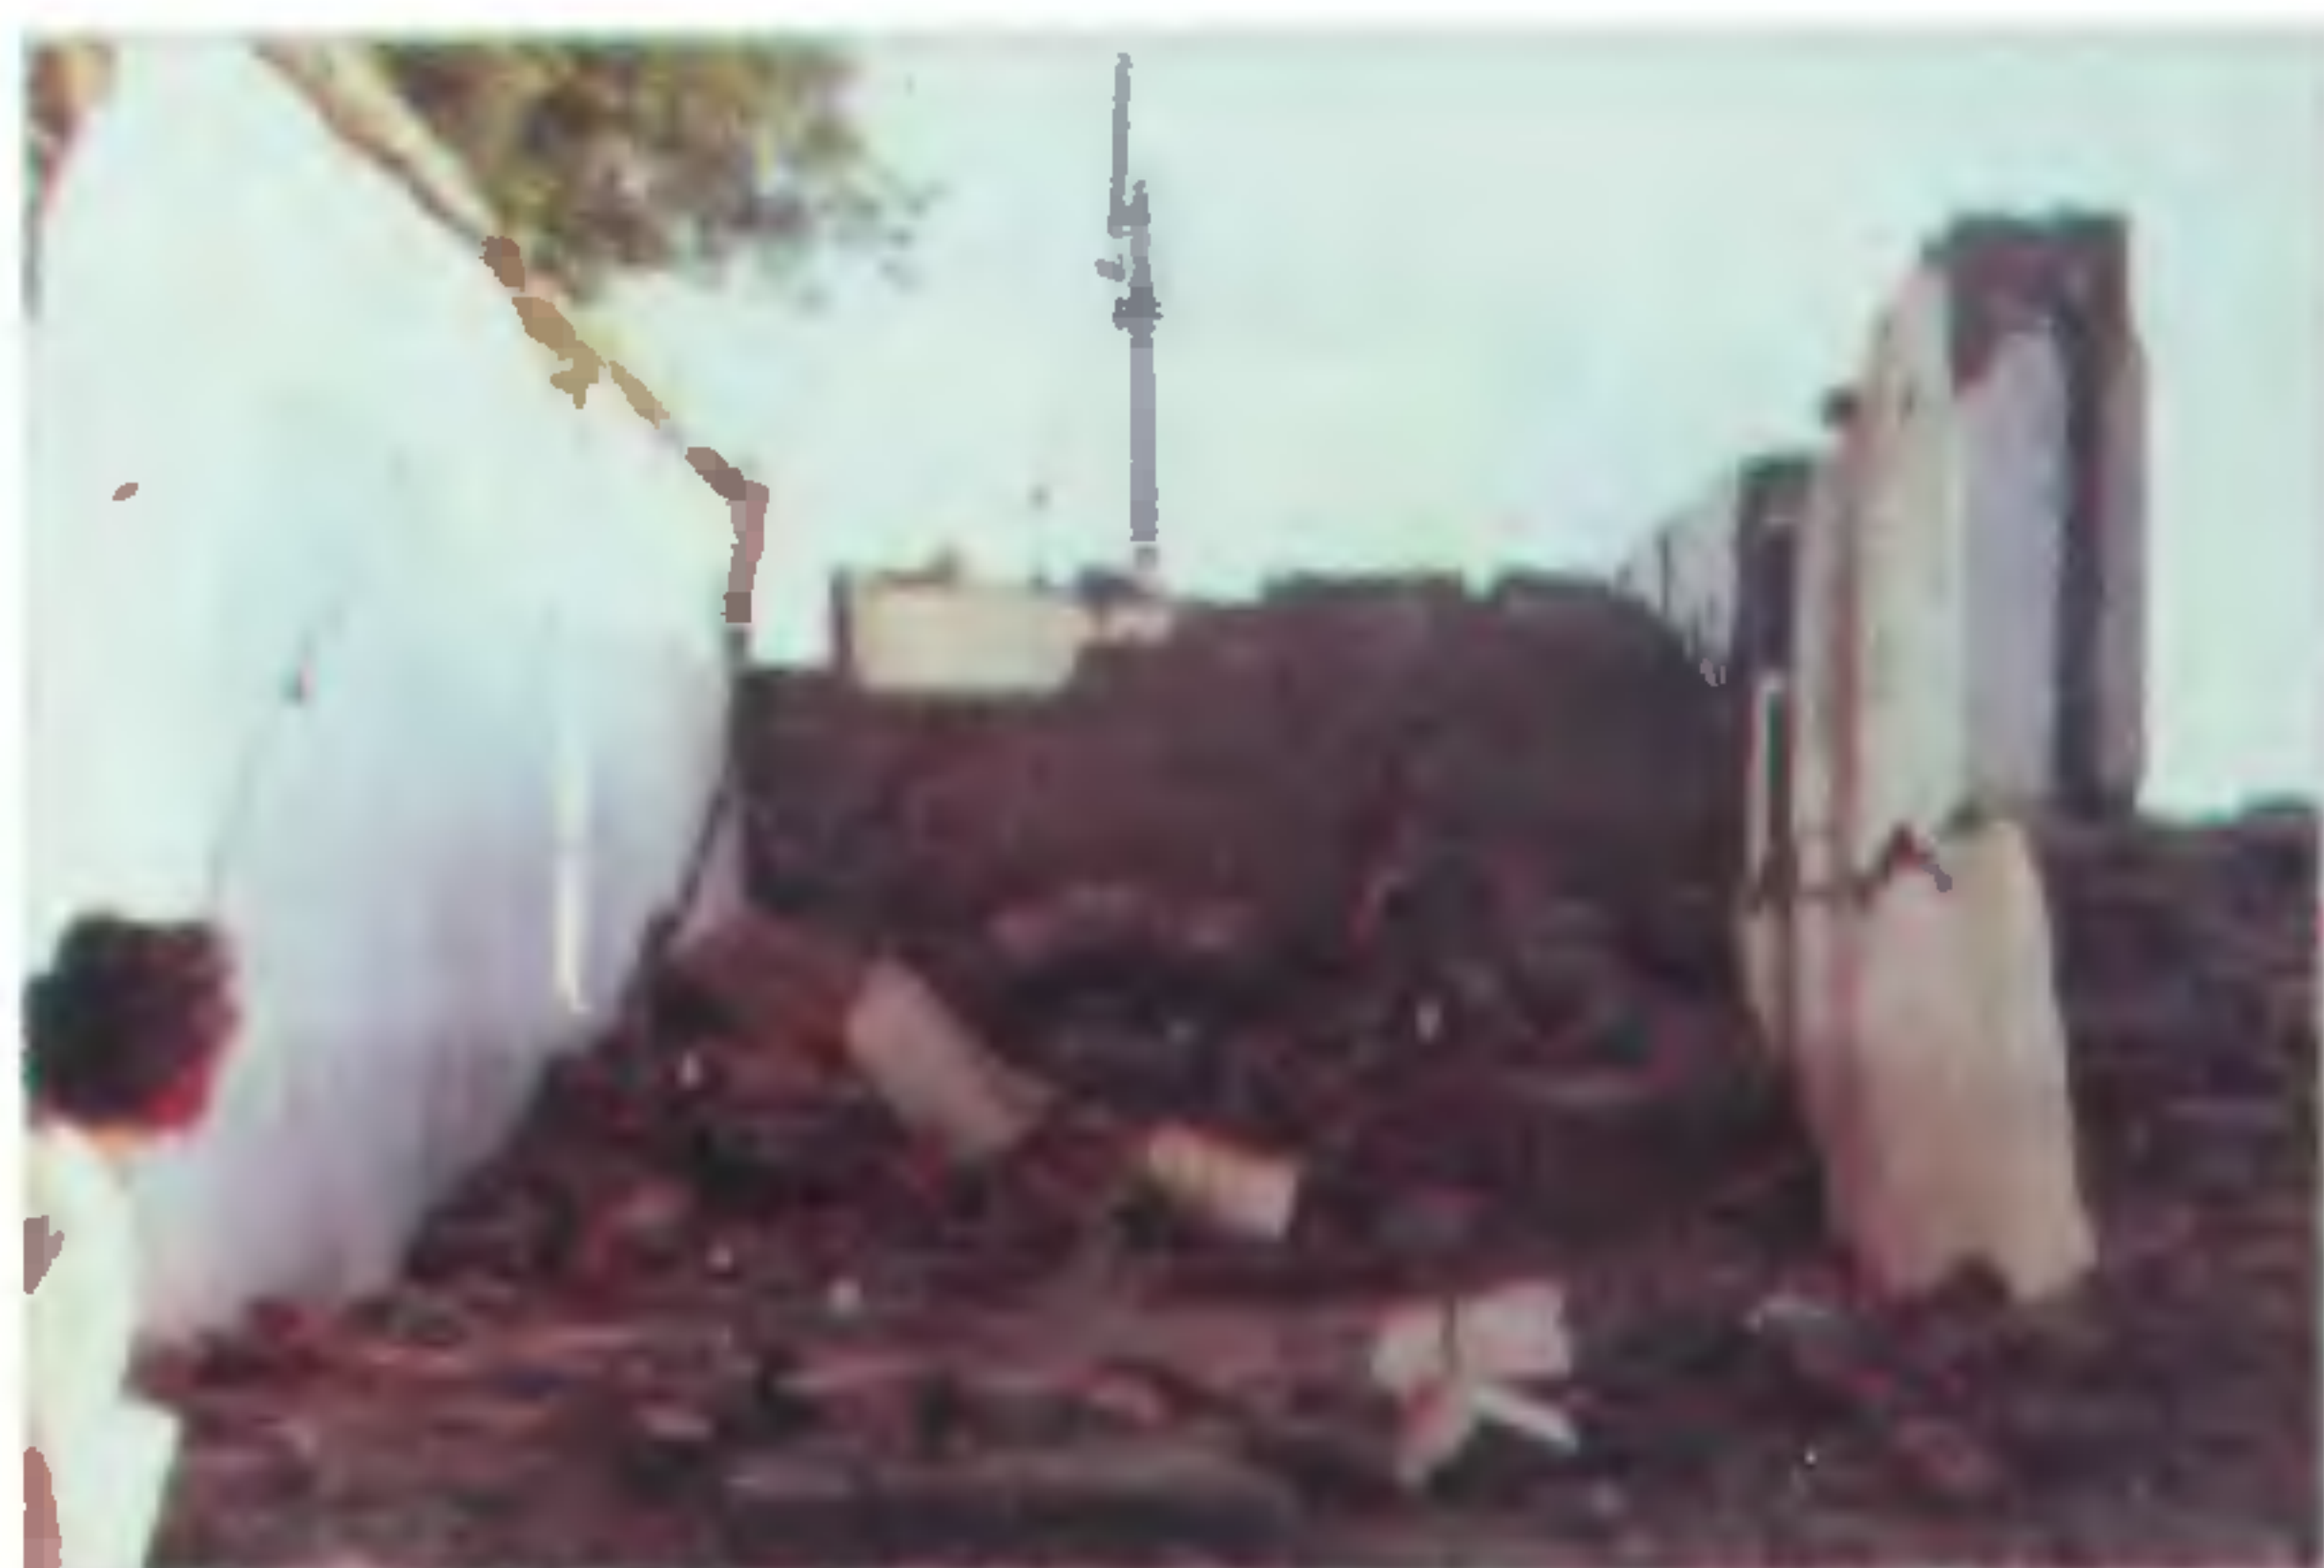
Most cement mortar buildings that were partially or fully destroyed had a traditional roof. The walls of these buildings had collapsed or developed large cracks at several locations (Figure 8). These cracks invariably included a corner of an opening, which was most likely the origin of crack. When the openings were very close to each other, these cracks had coalesced and resulted in partial collapse of the walls (Figure 9). It appears that the mortar strength controlled the performance against earthquake forces since no cracks were observed in masonry blocks.

Figure 8. Typical cracks in brick masonry walls.

against such cracks can be greatly increased by strengthening the walls at the level of openings, i.e. at lintel level and sill level of windows and lintel level of doors.

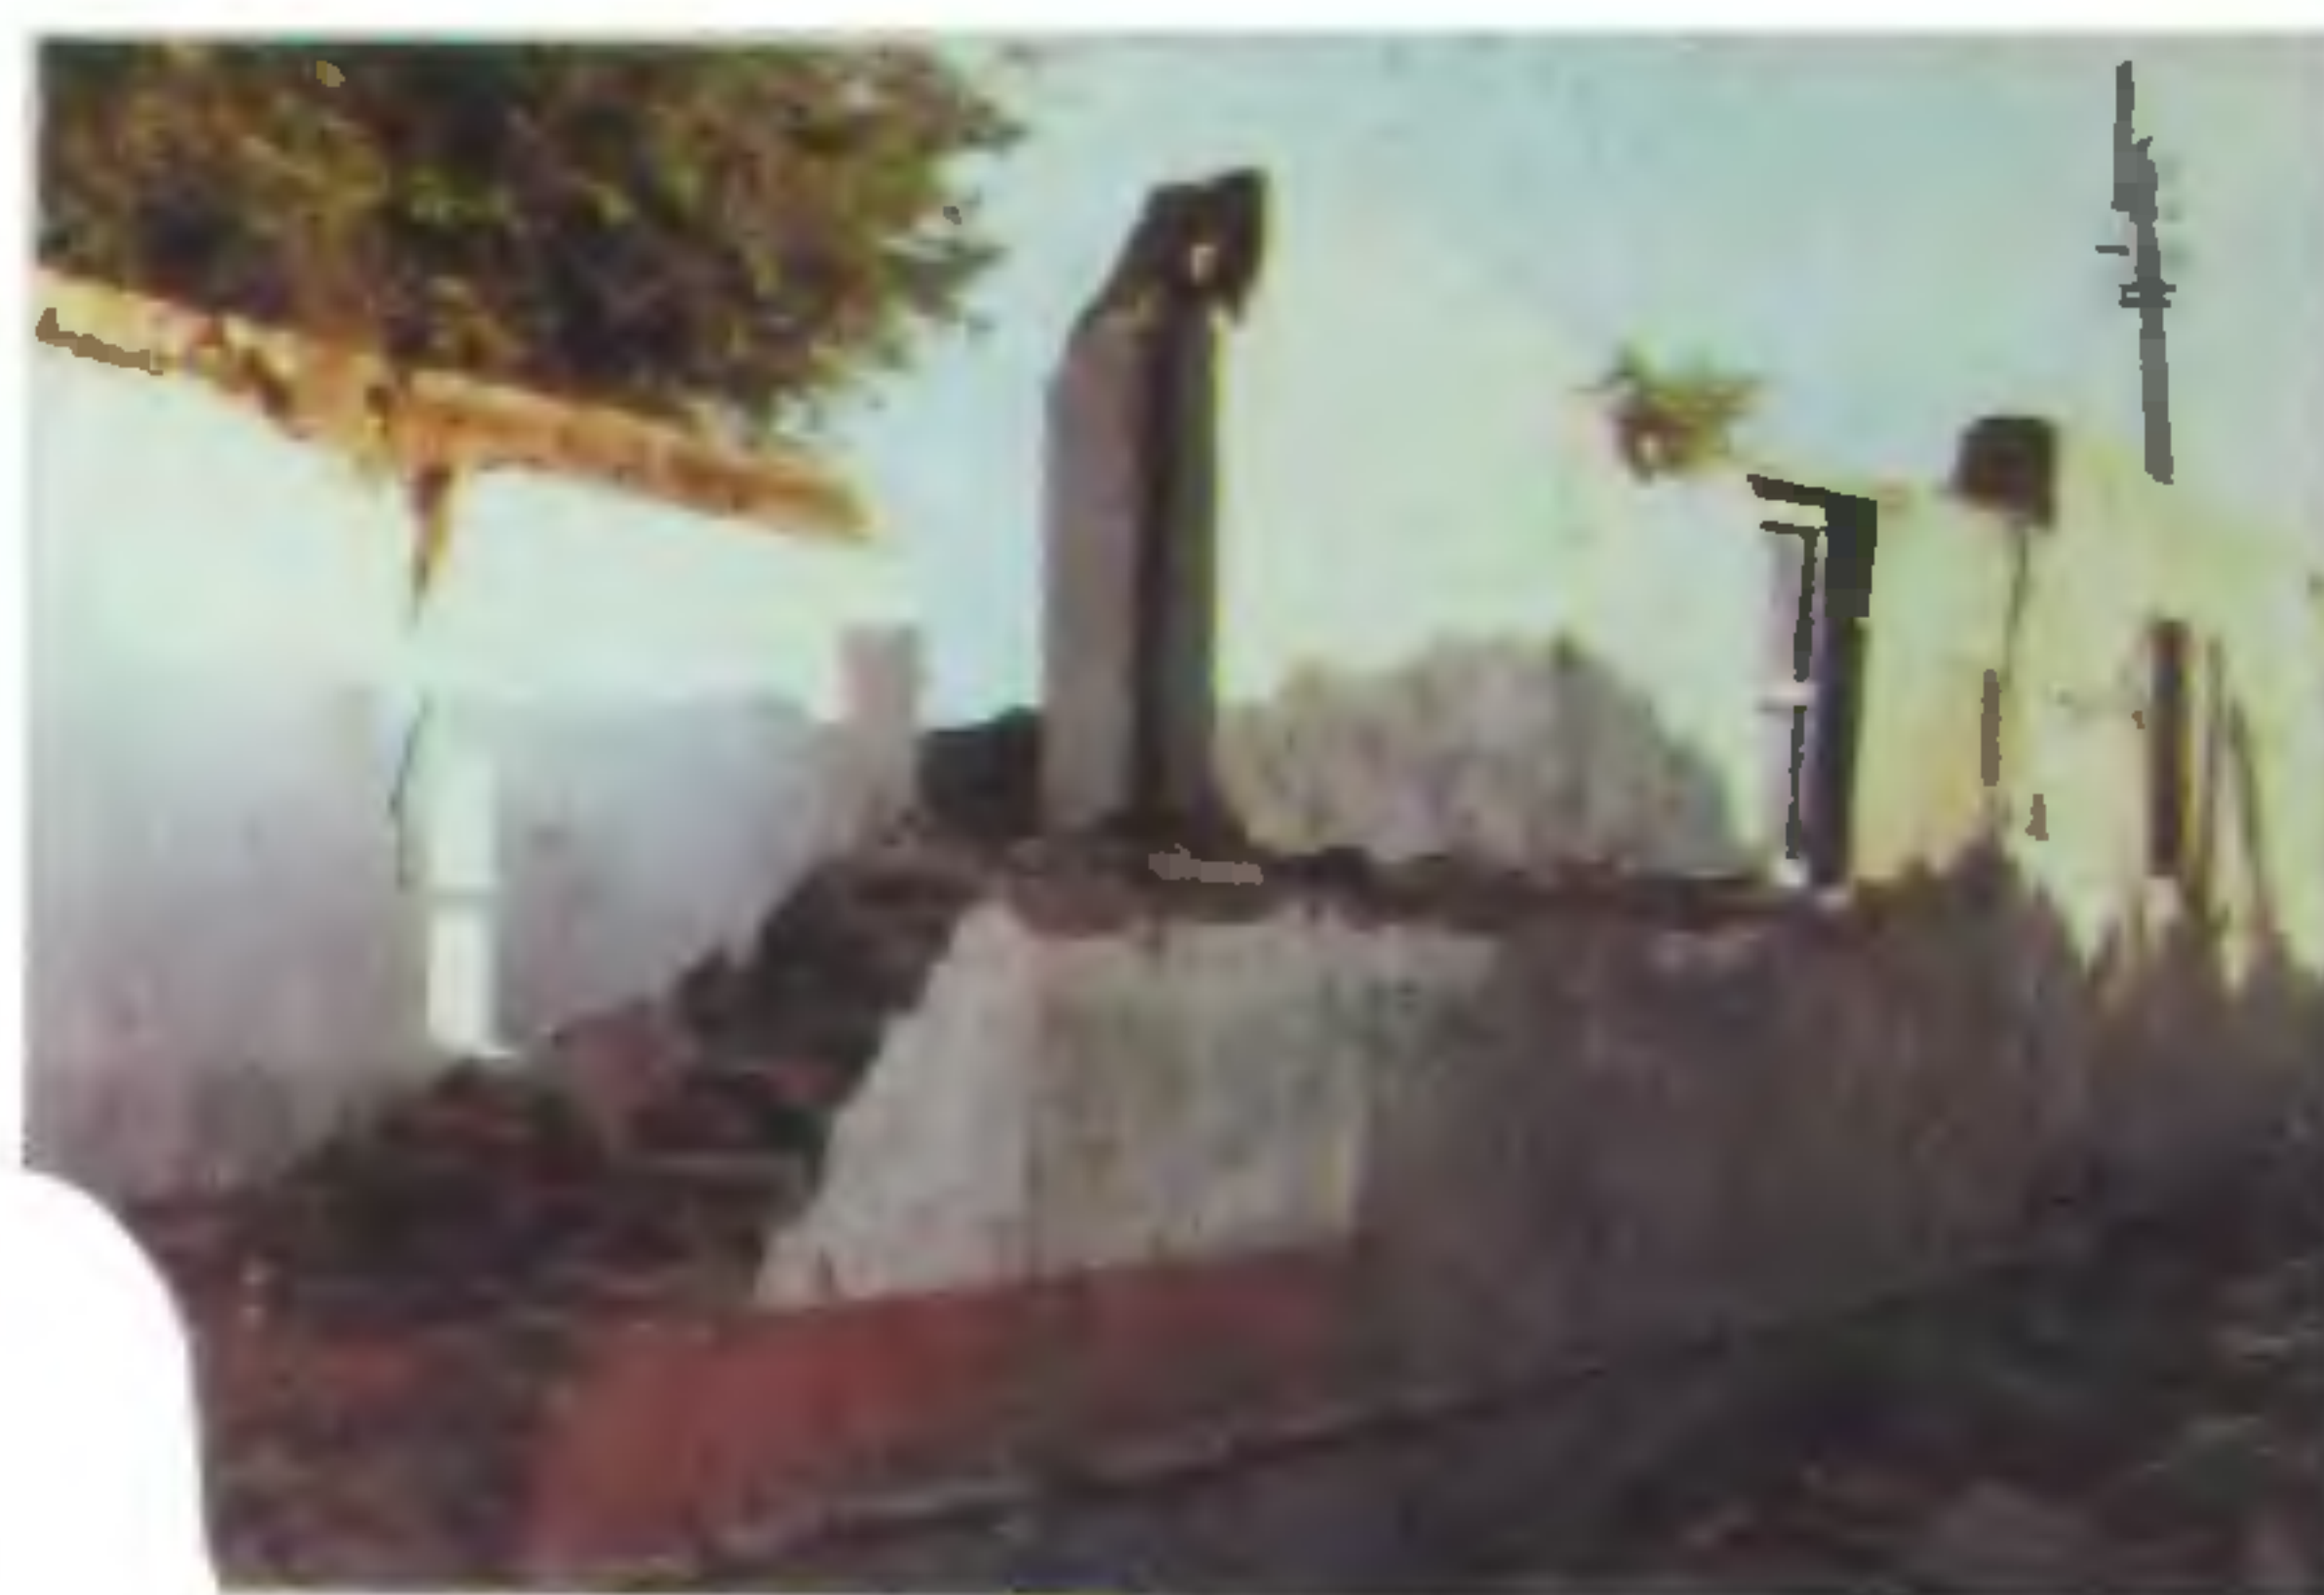
Figure 9. Partial collapse of brick masonry walls due to coalescence of cracks.

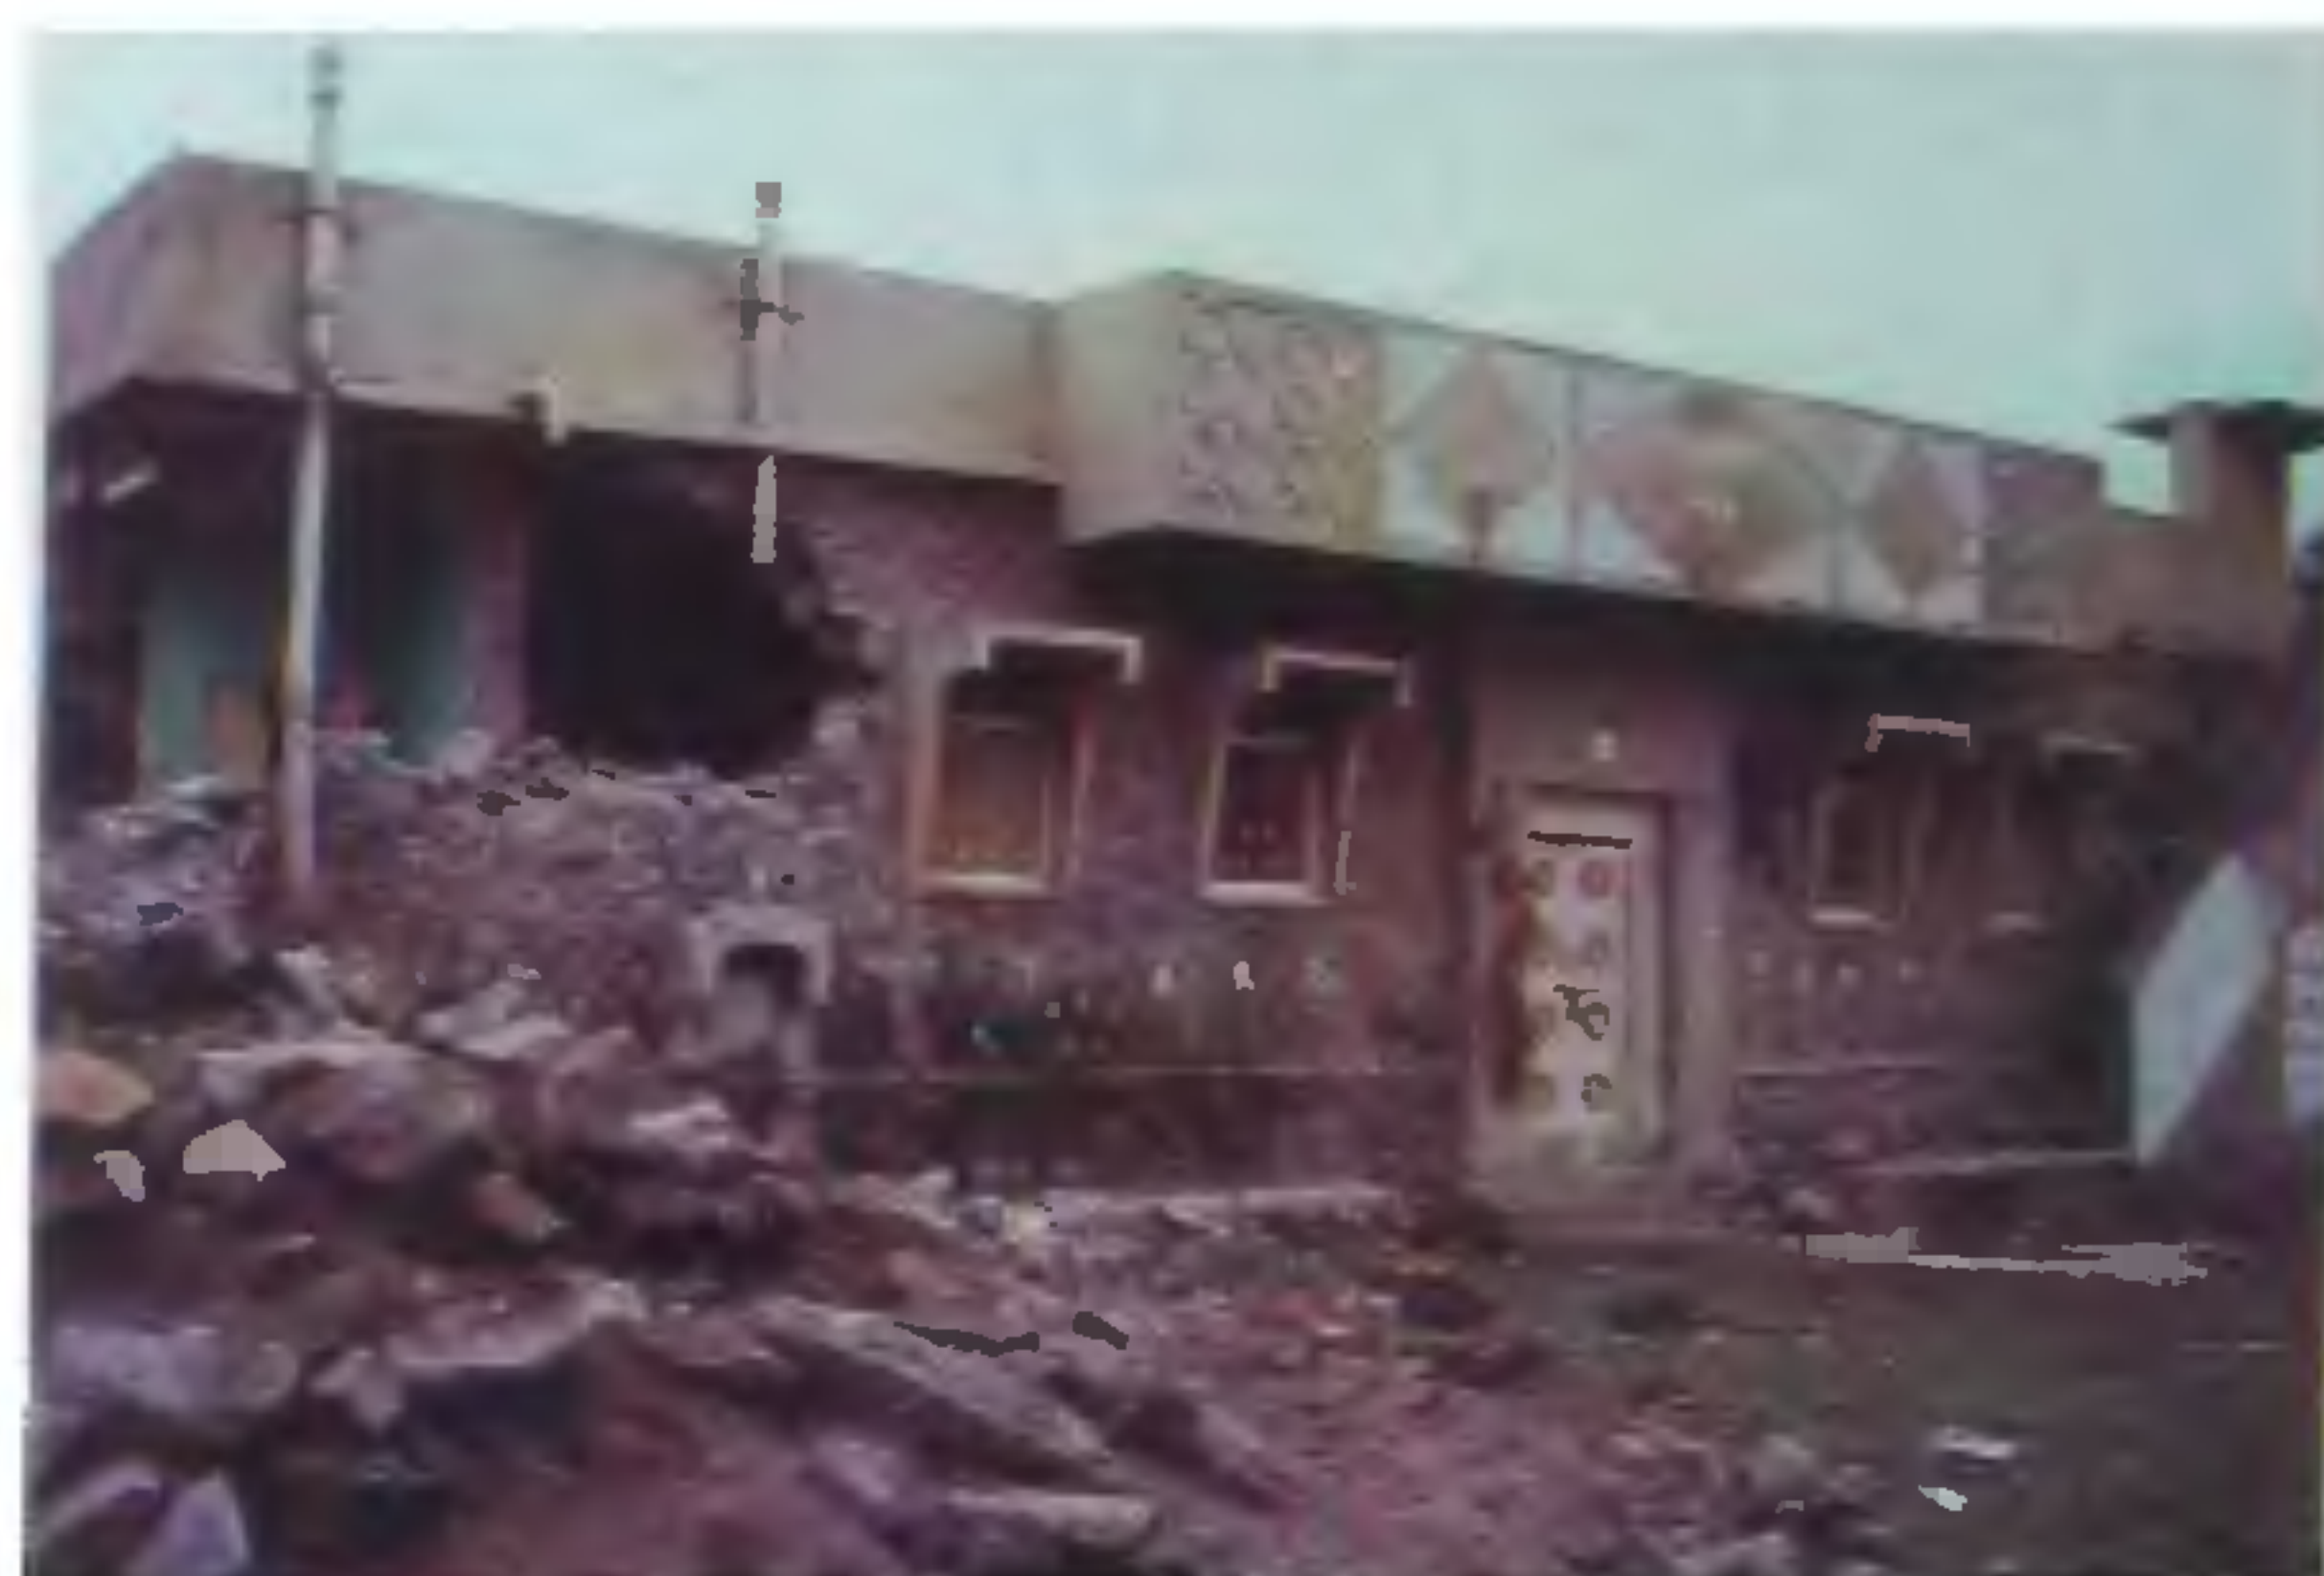
Figure 10. Stone masonry building with partial collapse of walls at corner.

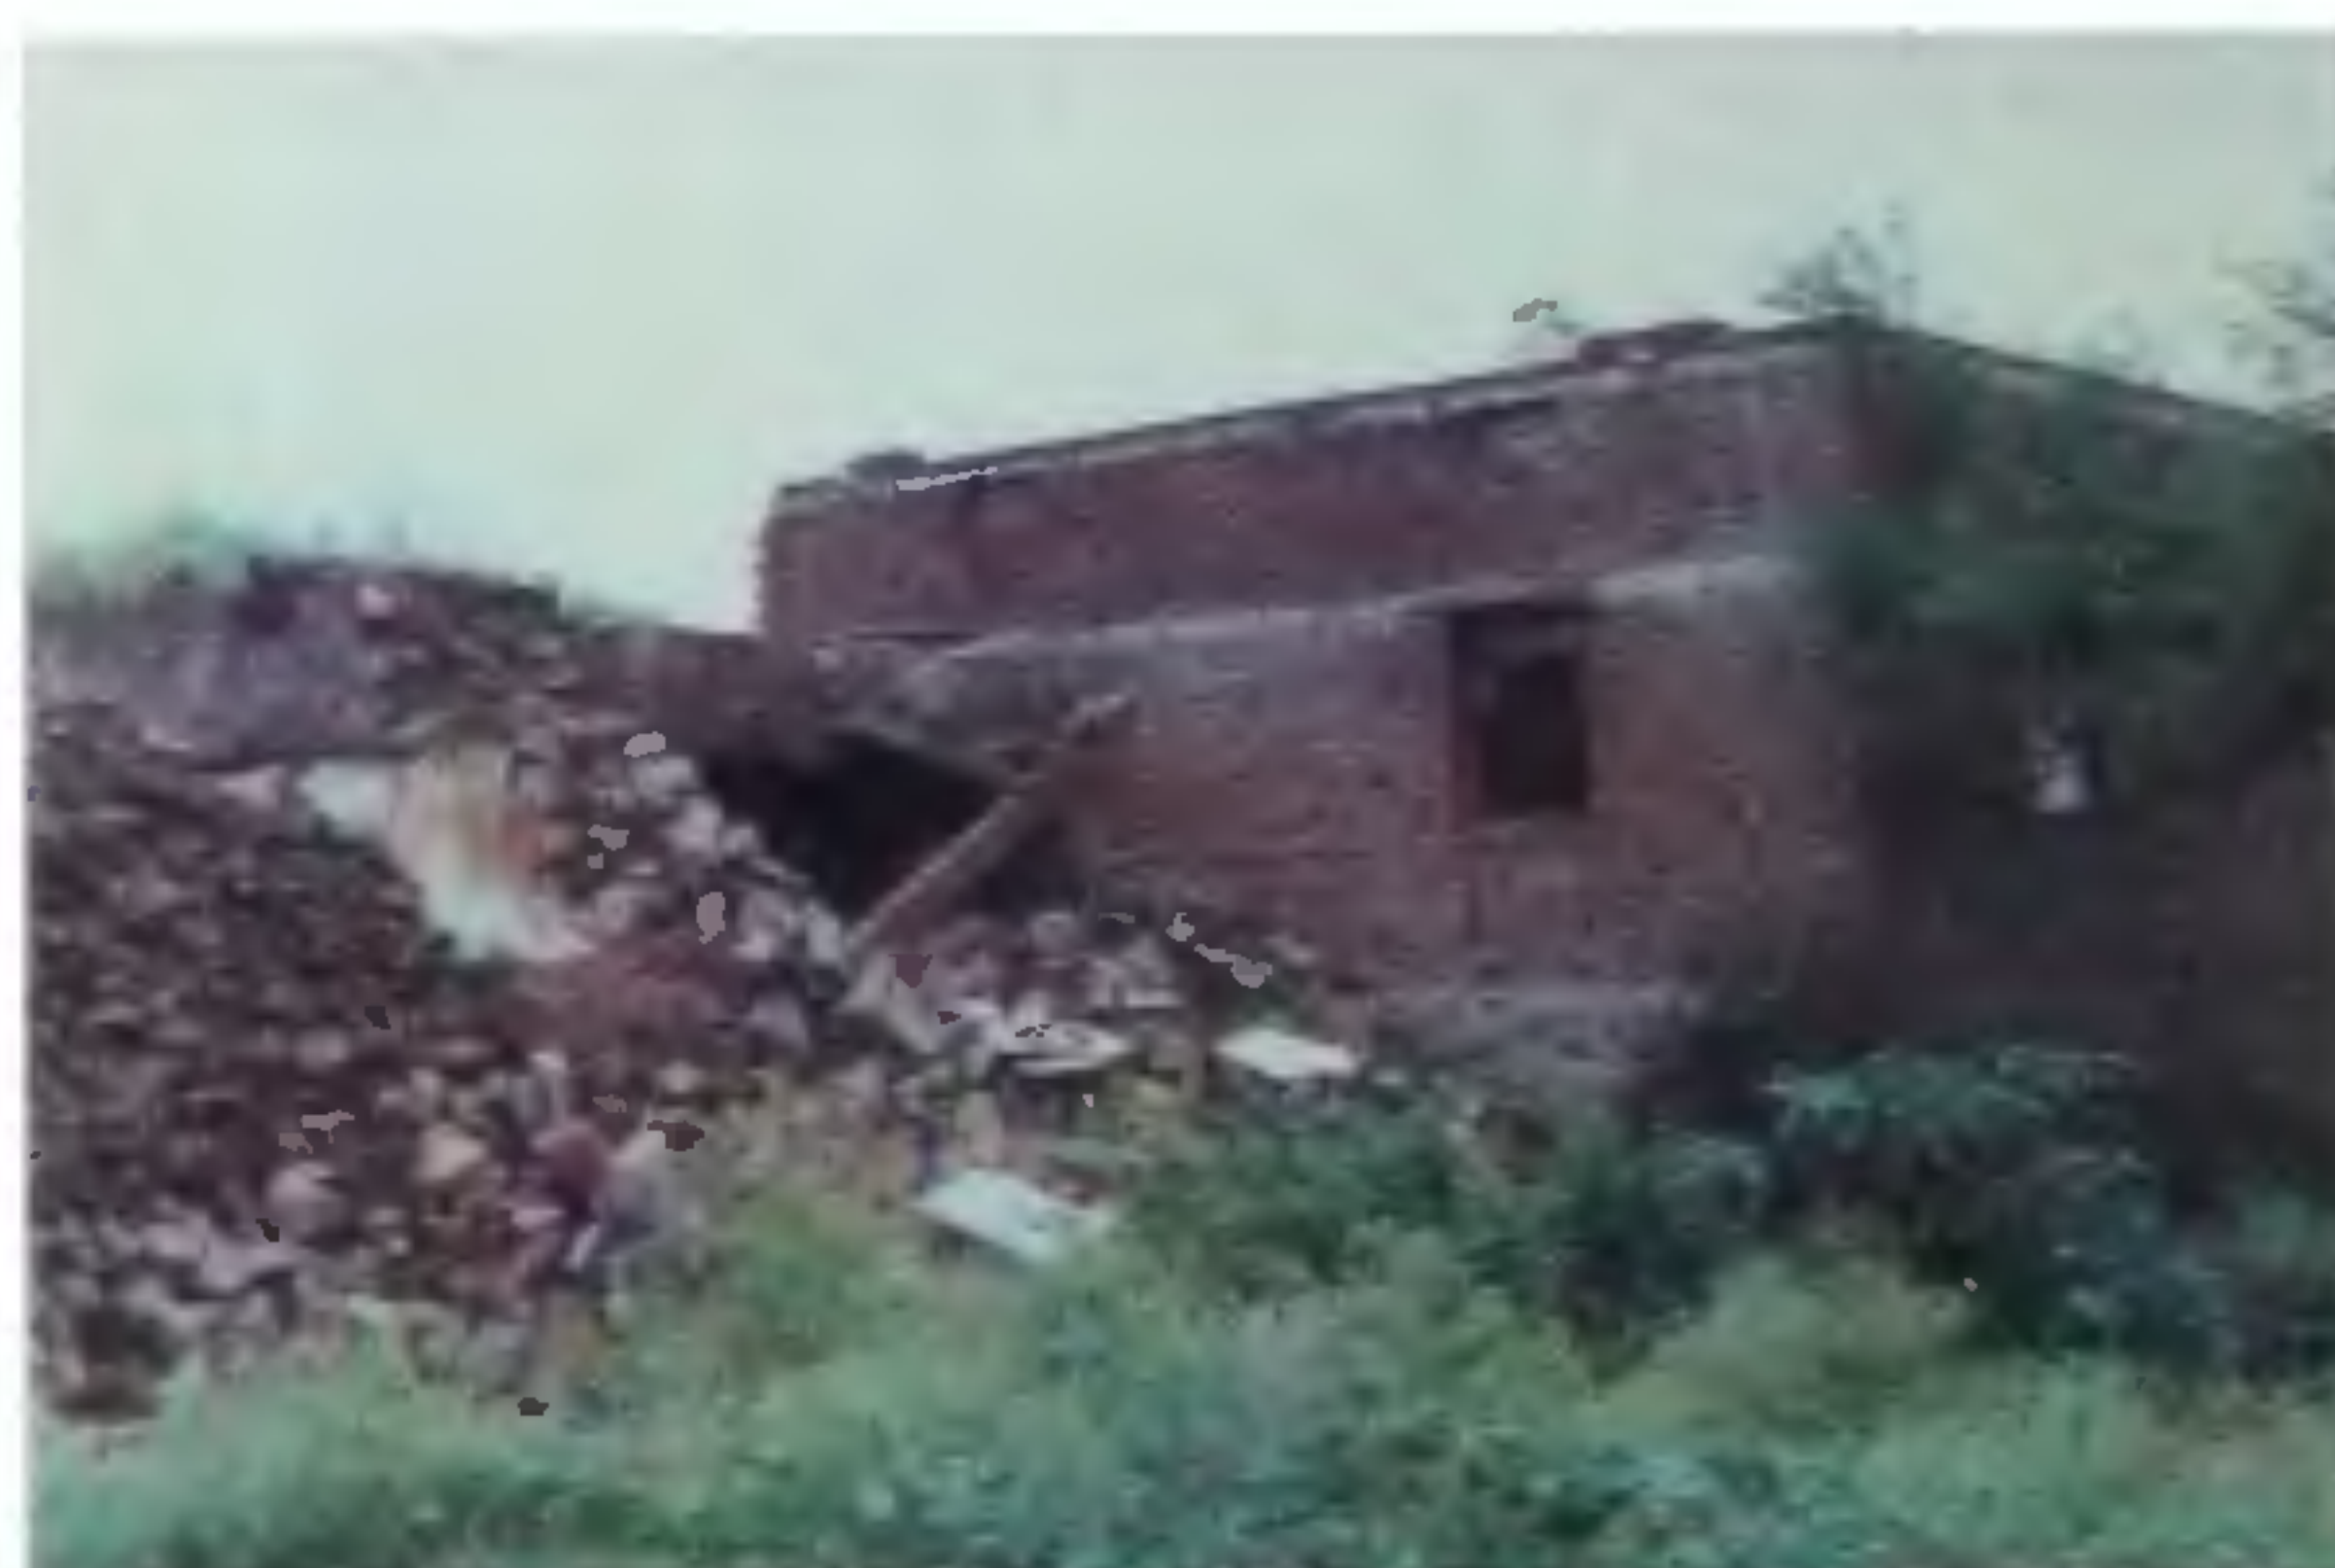
Figure 11. An undamaged building with lintel band surrounded by collapsed non-engineered constructions.

A recently retrofitted building at Killari with lintel band performed quite satisfactory during the earthquake. A few superficial cracks were observed (about 2 mm wide and only plaster deep) at sill level of walls. Since in a building without any earthquake-resistant features, cracks are always formed at lintel level before sill level, the performance of this building clearly demonstrates the effectiveness of a lintel band. It is noteworthy that all other constructions surrounding this building were totally destroyed in this earthquake (Figure 11).

5. The performance of a building with lintel band, which is economical to construct, was at par with the performance of a RC frame building which is much more expensive. Furthermore, the local builders and masons can easily be trained to use this simple earthquake-resistant feature. Consequently, the use of lintel band must be encouraged to enhance the earthquake resistance of new constructions.
