Malpa rockfall disaster, Kali valley, Kumaun Himalaya

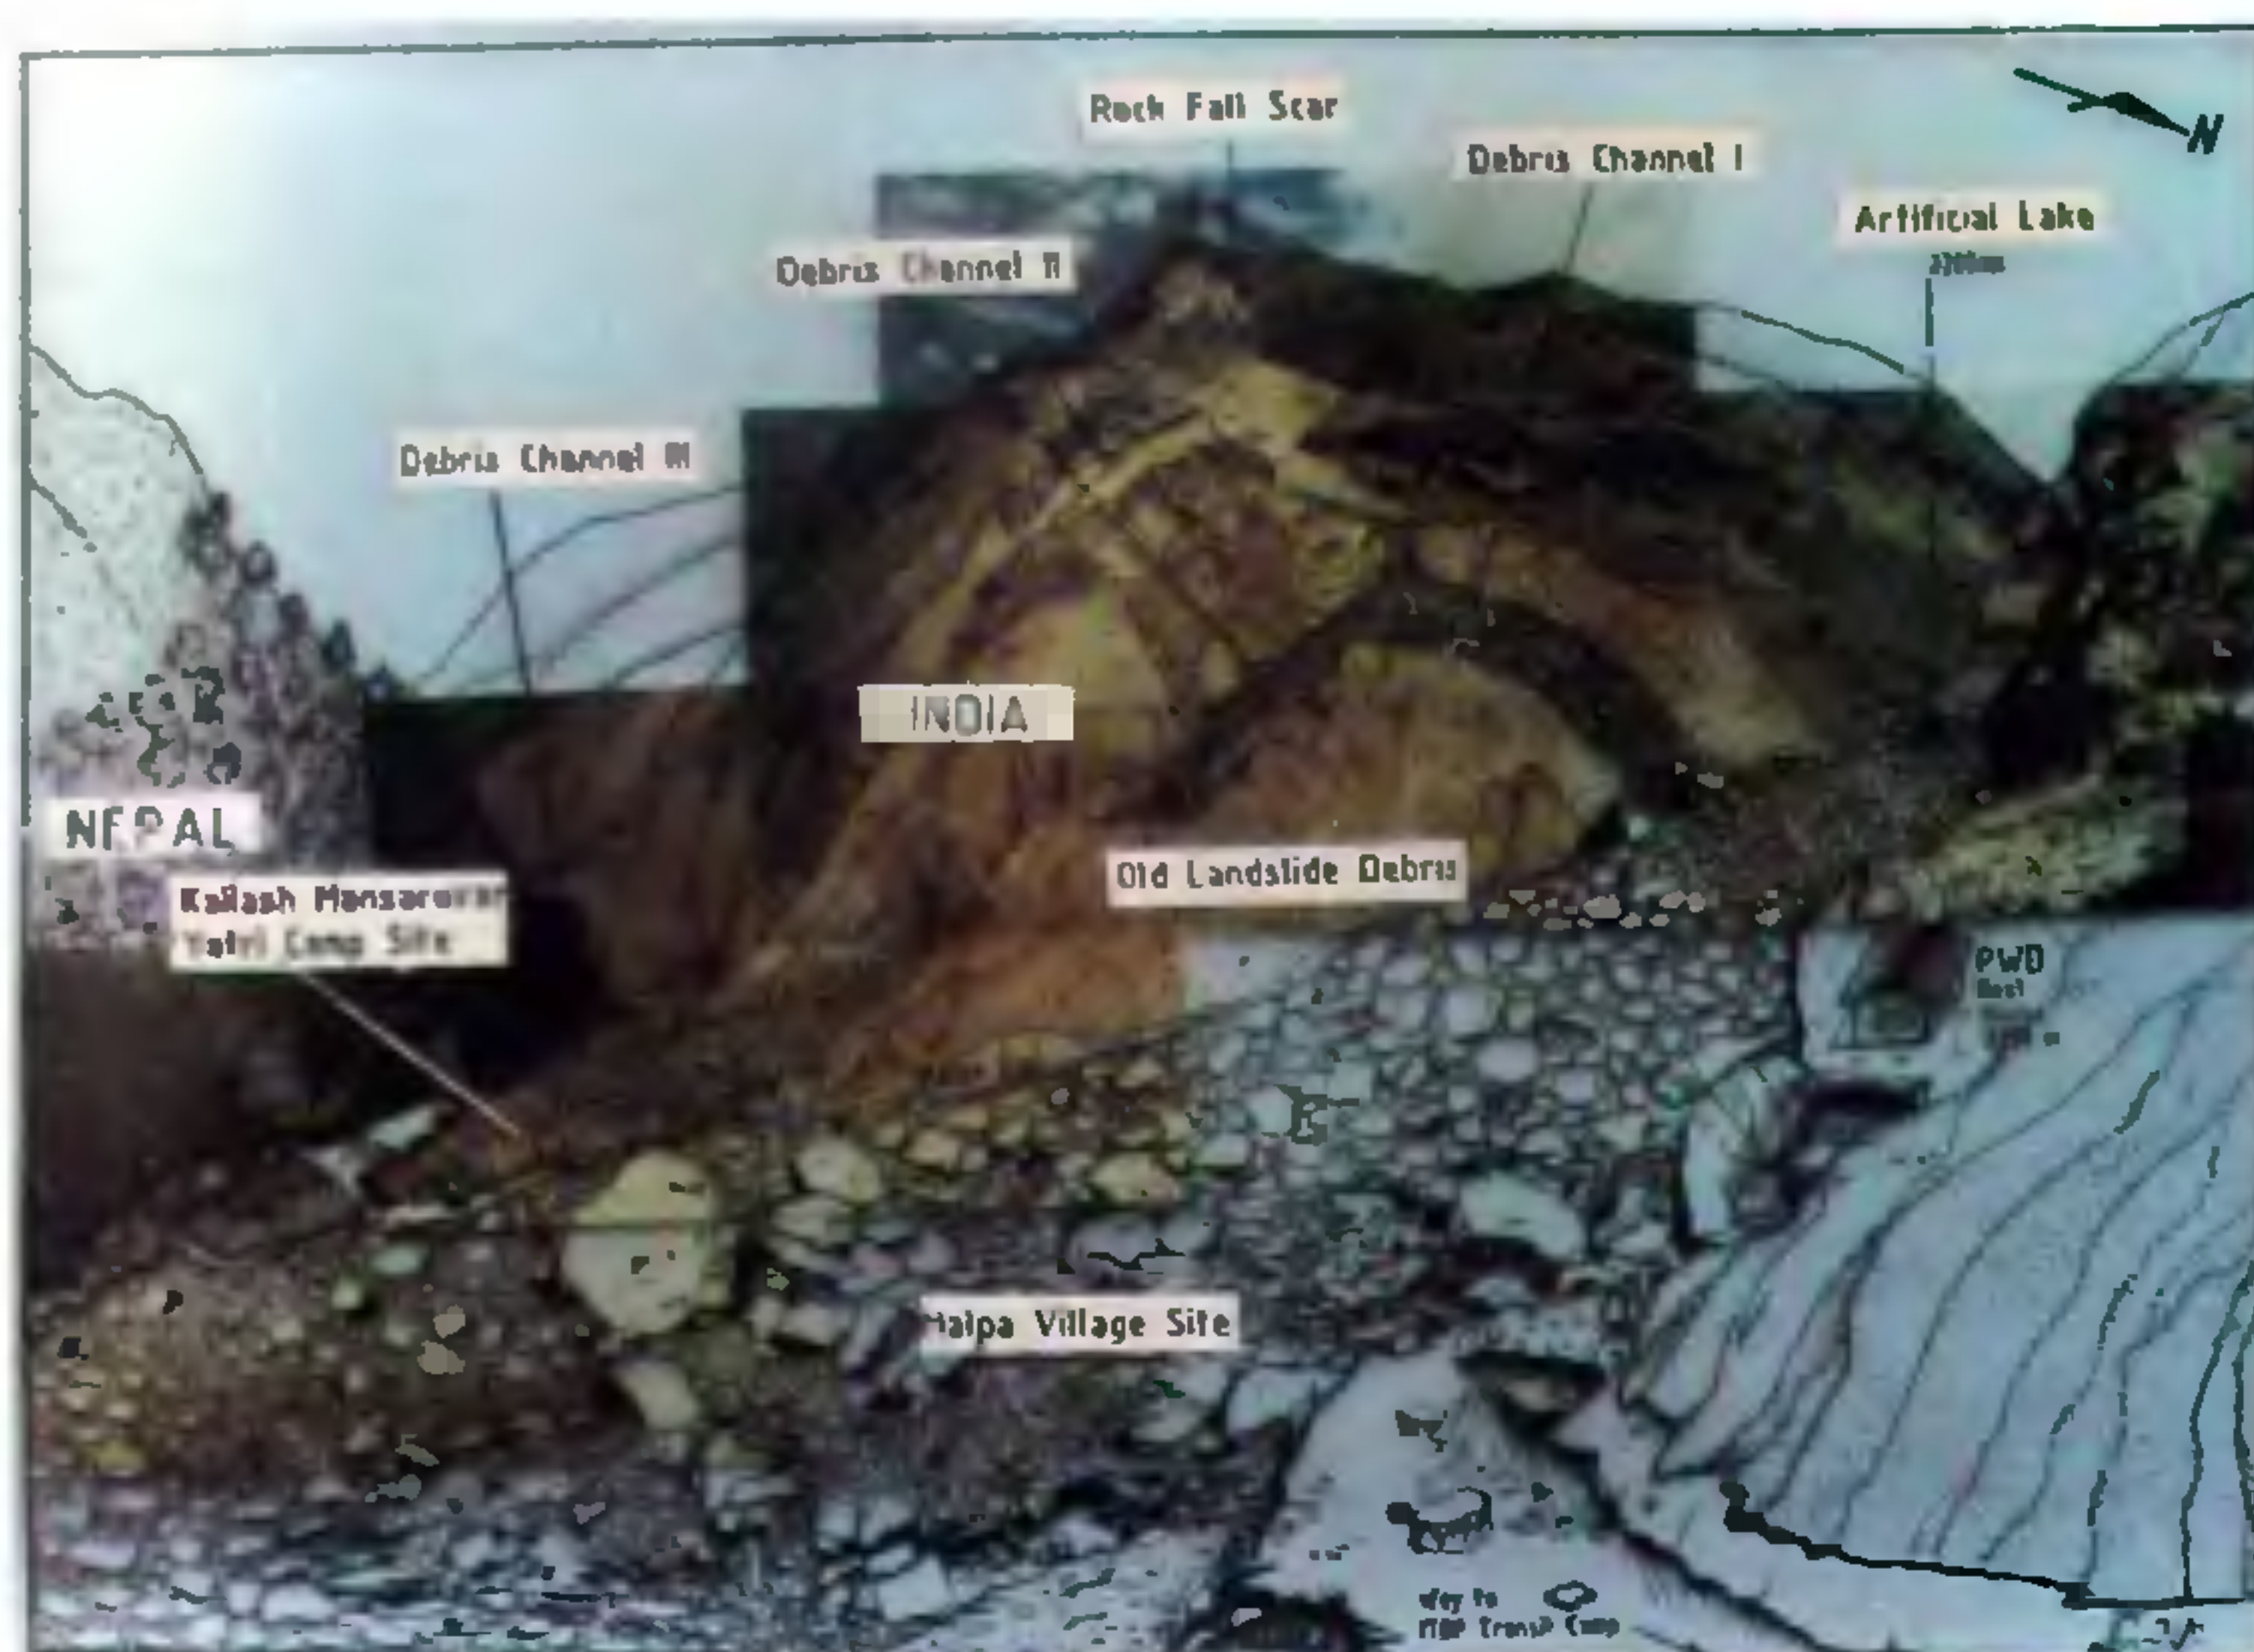
Figure 2. Diagrammatic sketch and photo view of the site of tragedy looking southward from the ITBP camp site.

zone (Figure 2) is in the snow-bound terrain where regular freeze-and-thaw cycle has progressively weakened the rock-masses by increasing the fissure spacing to 0.3–0.5 m. Rainfall data show that there was high precipitation for a week preceding the time of disaster. This must have created pore-water pressure in the fractures perpendicular to the bedding planes, culminating in the failure. The shear zone is characterized by ramps-and-flat structure in the quartzite, indicating southward thrust movement in the brittle regime. This must have generated shear stress in the rock and caused the slide (Figure 2).

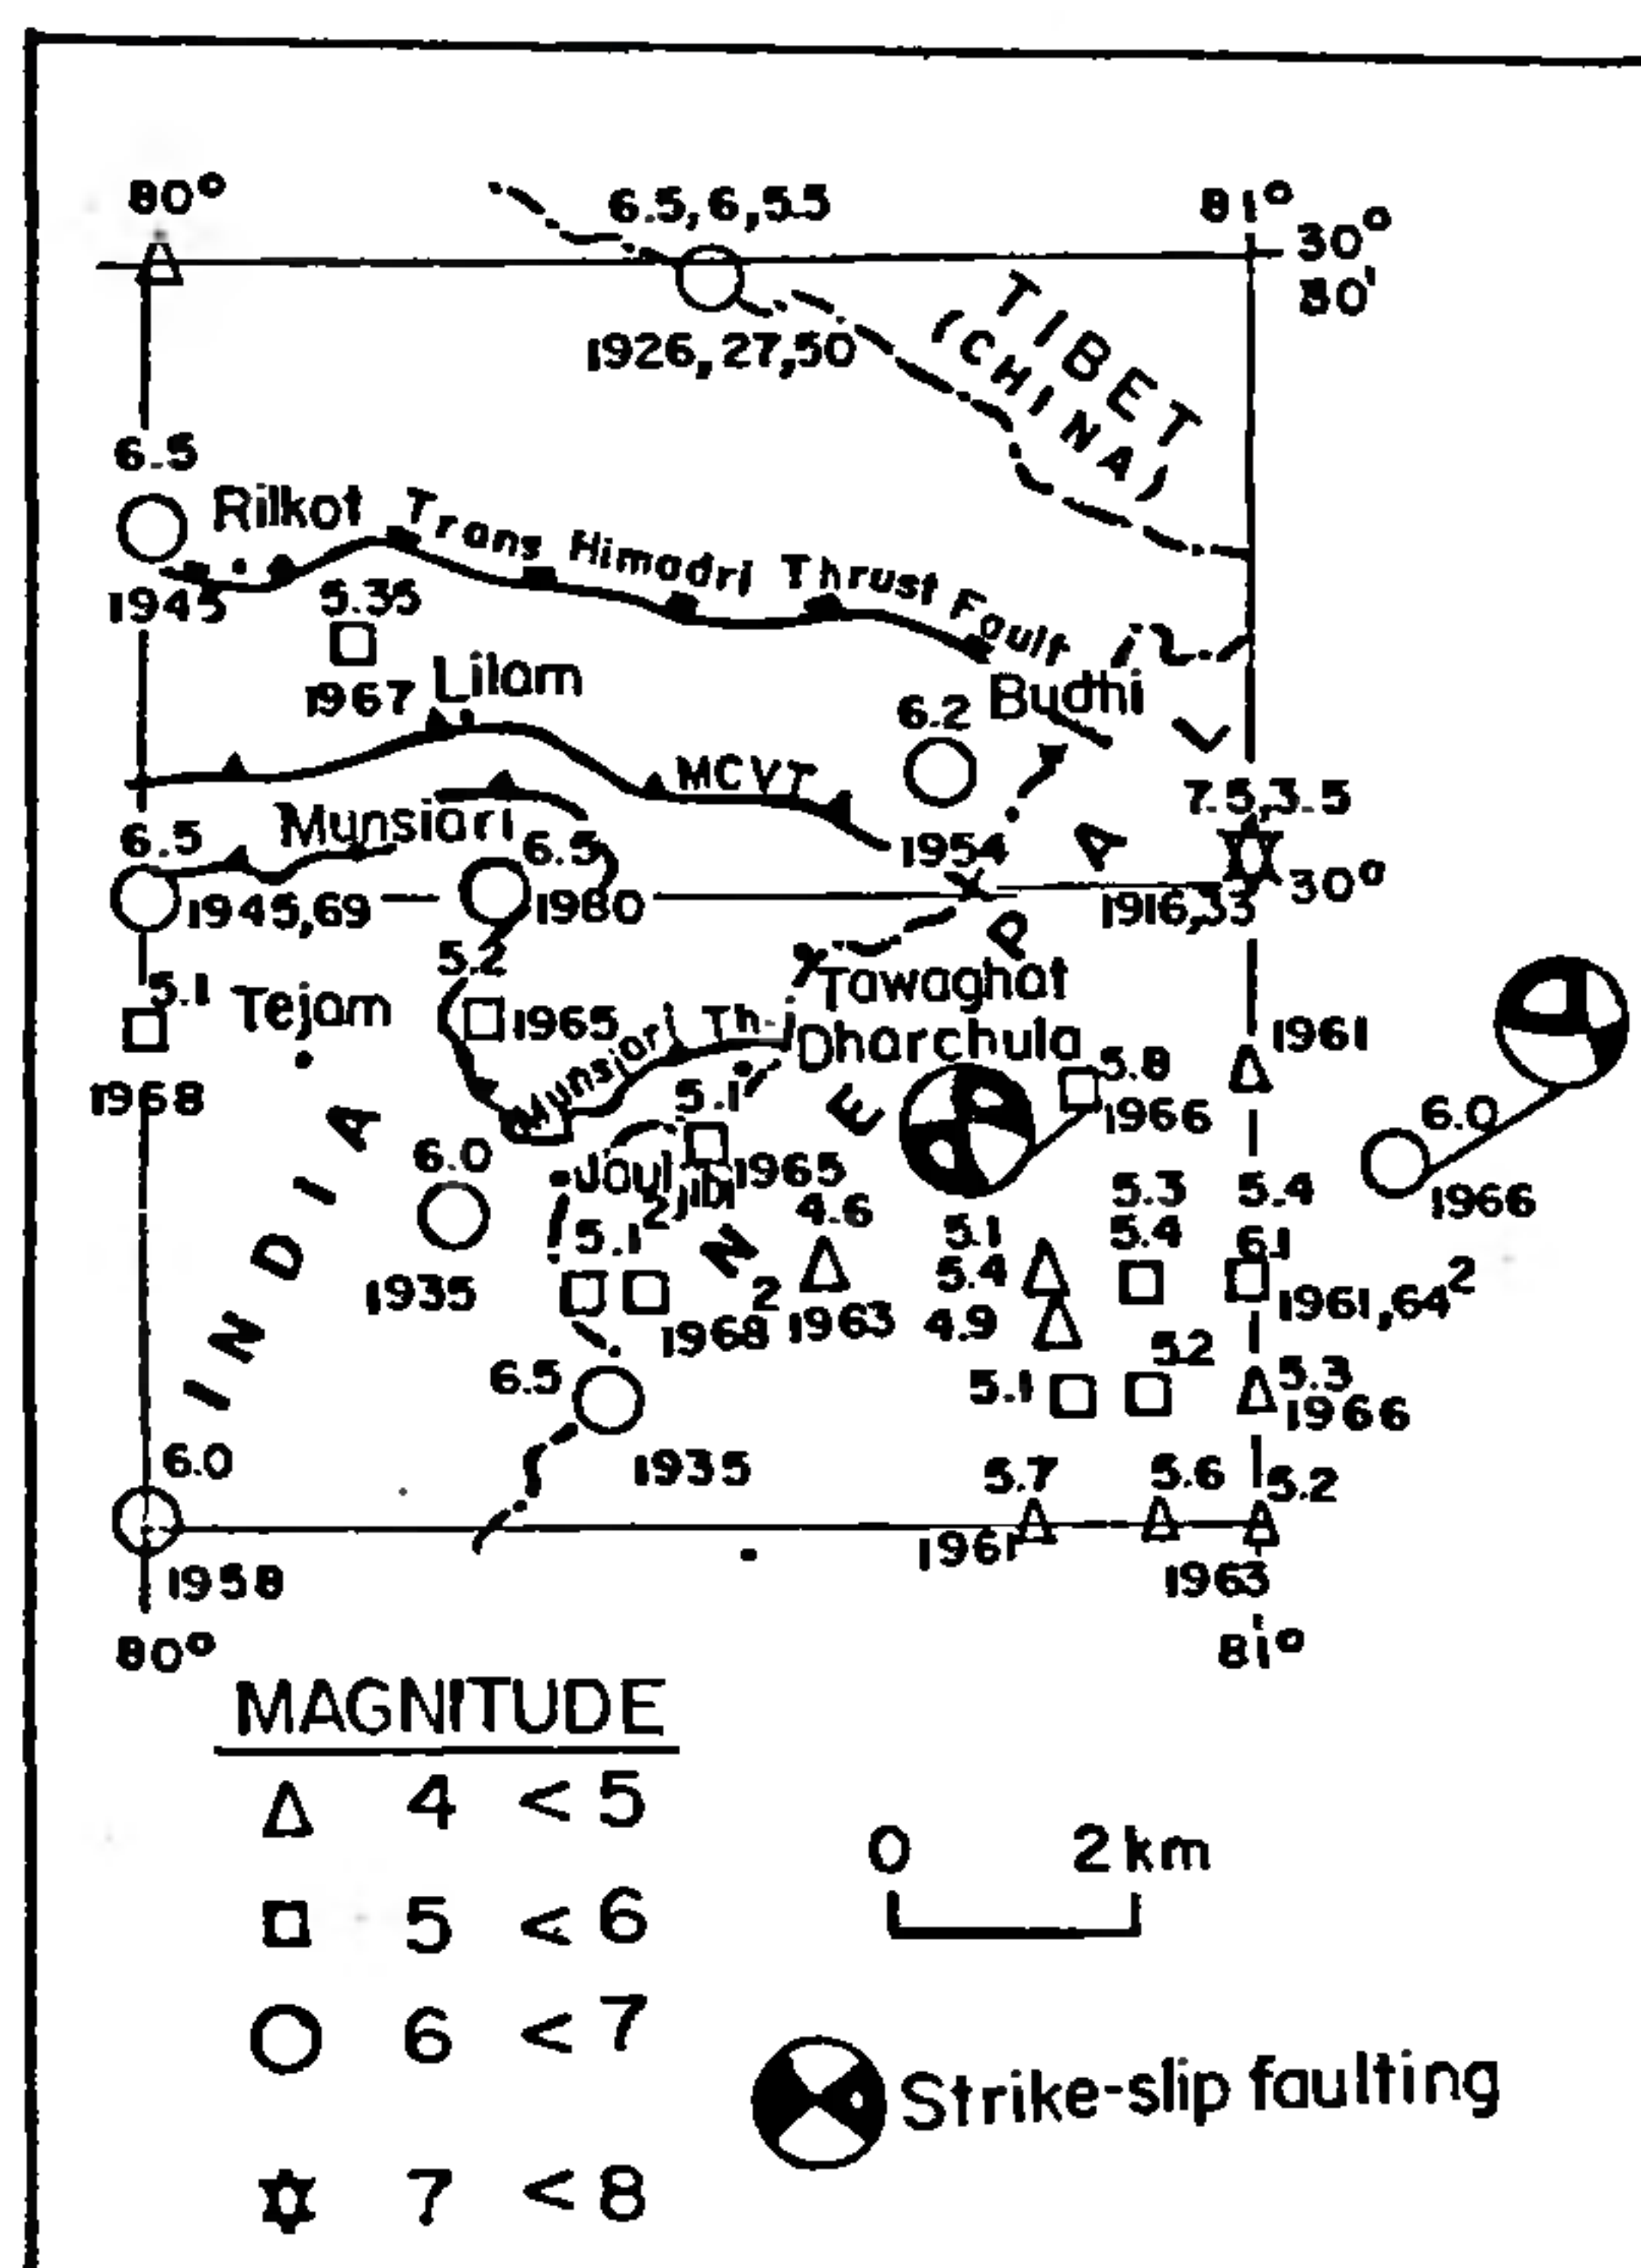
Figure 3. Epicentral map of the northeastern Kumaun Himalaya and adjoining northwestern Nepal.

The northeastern part of the Kumaun Himalaya and the adjoining area in Nepal is seismically active. The area lies in the seismic zone V. Epicentral map of the region reveals that 6.2 magnitude earthquake occurred east of Malpa in 1954 (Figure 3). The strongest earthquake occurred in 1916 of magnitude of $M > 7.0$ in the Dharchula region and ravaged several villages on both sides of the Kali river. The area was jolted by earthquakes again in 1979 and 1980 (ref. 4). There is evidence of movement on the MCT, and the associated thrust planes. The transverse and oblique tear faults have registered vertical as well as lateral movements⁴.

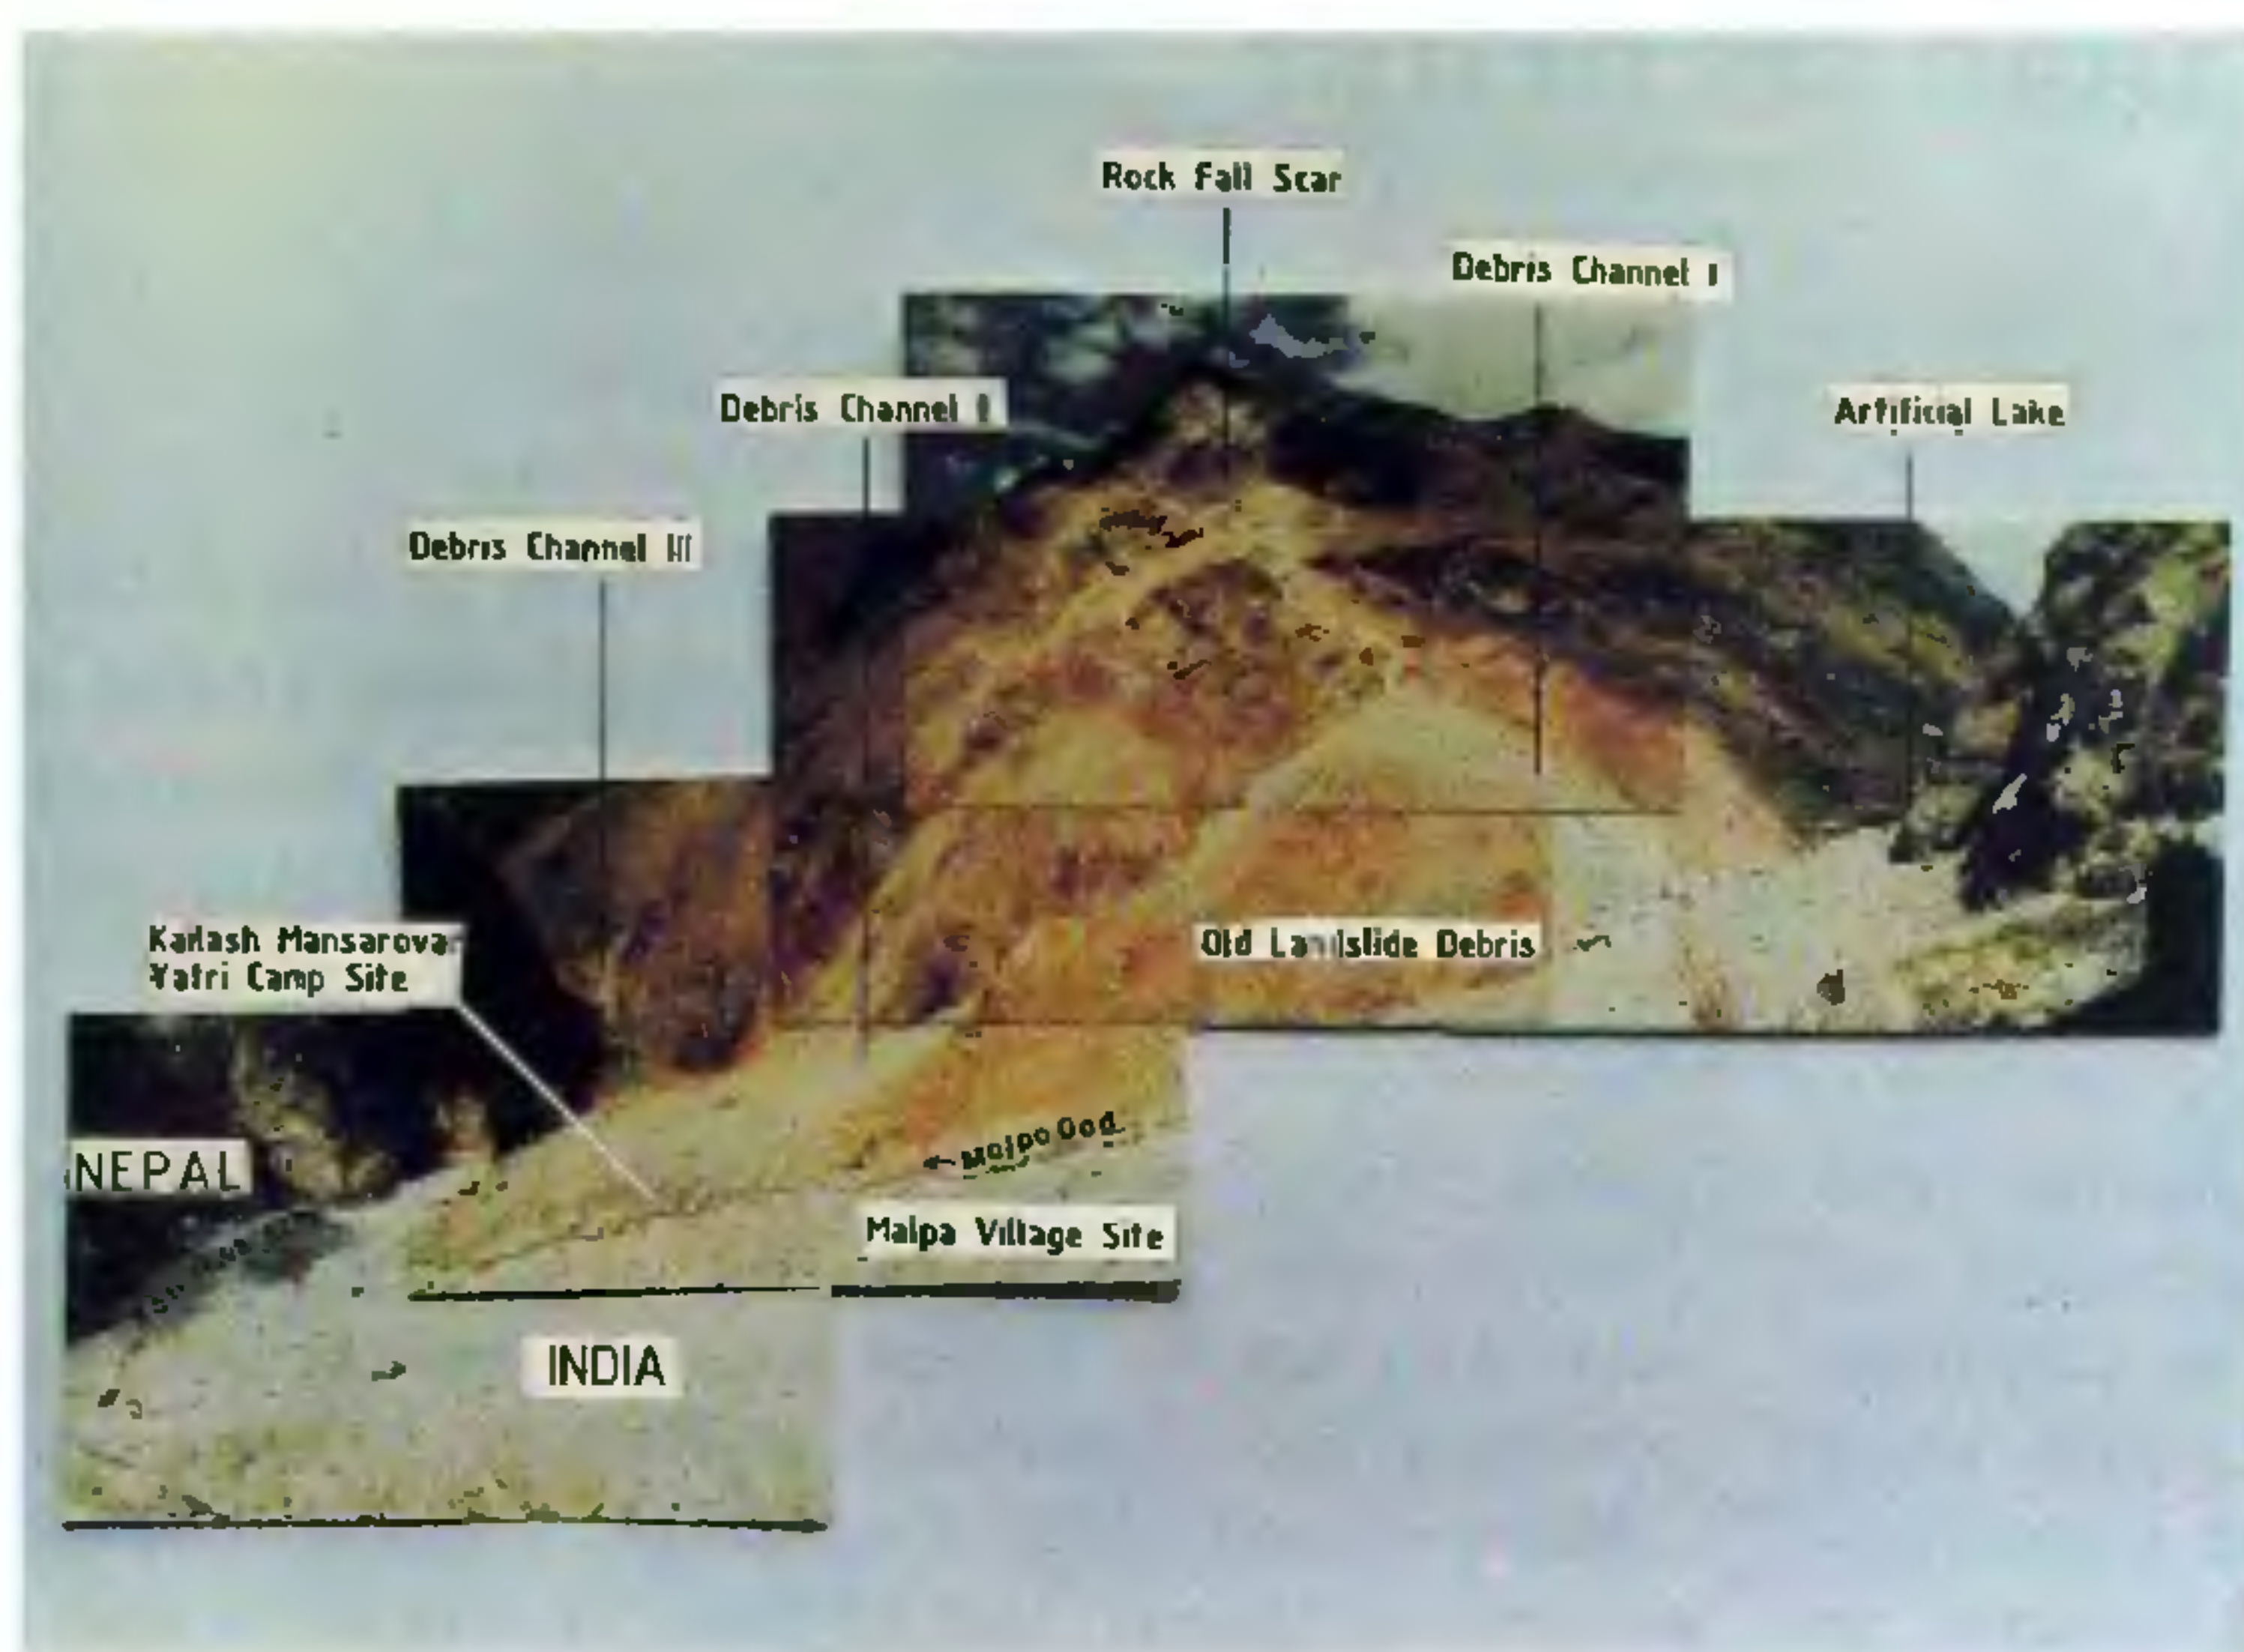
Figure 4. Panoramic photo mosaic of Malpa village and surrounding area, looking southward from ITBP camp site.
