Need for earthquake-resistant design of harbour structures in India in view of their performance during the 2004 Sumatra earthquake

GOUTAM MONDAL
DURGESH C. RAI*

Department of Civil Engineering,
Indian Institute of Technology,
Kanpur 208 016, India
*For correspondence.
e-mail: dcrai@iitk.ac.in

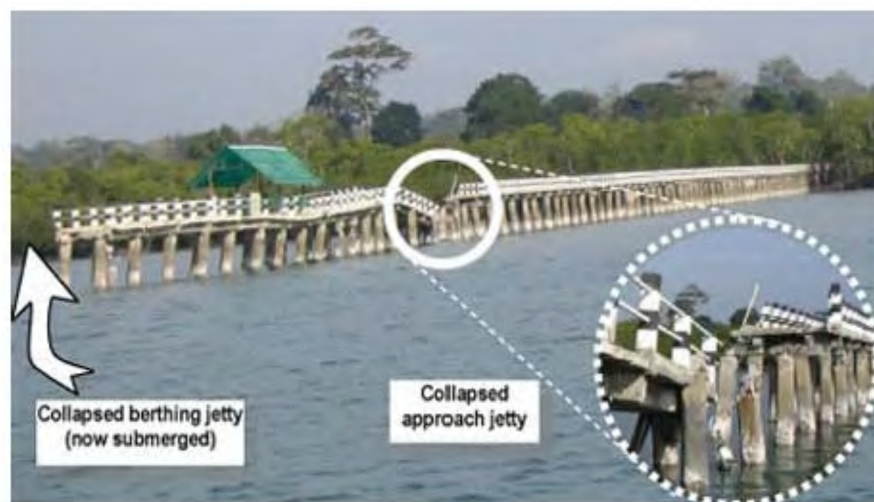
Based on the reconnaissance study conducted by the authors immediately after the earthquake, damages to harbour structures located north of Port Blair are described here along with their possible causes and remedies. Jetties at Rangat Bay and Mayabandar Harbours in the Middle Andaman Islands, and at Diglipur and Gandhinagar in the North Andaman Islands were severely affected, while Kalighat Jetty in North Andaman and Uttara Jetty in Middle Andaman sustained only minor damages (Figure 1). Berthing jetty and a portion of the approach jetty at Sagar Dweep totally collapsed during this earthquake and the jetty was not operational for post-earthquake relief operation (Figure 2).

Figure 2. Gandhinagar Jetty in North Andaman: Total collapse of berthing jetty and partial collapse of approach jetty.

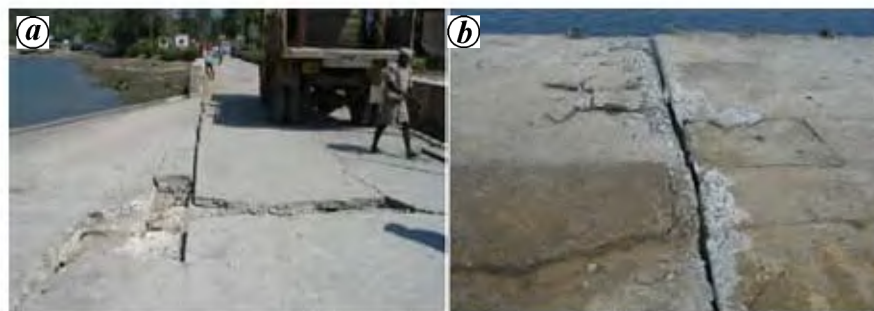
The most common damages of jetties resulted from the pounding at the construction joint of two portions of the jetties supported by piles. Pounding can occur between two adjoining structures due to

out-of-phase horizontal vibrations during earthquake shaking, if sufficient spacing is not provided to accommodate the lateral displacements. Such damages were observed between two portions of berthing jetties of Mayabandar Harbour, Diglipur Harbour and at the junction of the approach jetty and berthing jetty of Mayabandar, Rangat and Diglipur harbours and Sagar Dweep Jetty (Figure 3). Similar pounding damage was noticed at the Diglipur Harbour during the 2002 Diglipur earthquake^{4,5}. Pounding damages could have been prevented or minimized by providing sufficient gap at the location of construction joints of the jetties. It appears that the structures were not designed for earthquake-induced lateral displacement and forces.

Figure 3. Pounding damage to jetties in Middle Andaman (a) at the junction of solid jetty and RC piled approach jetty at Rangat and (b) in the berthing jetty at Mayabandar.

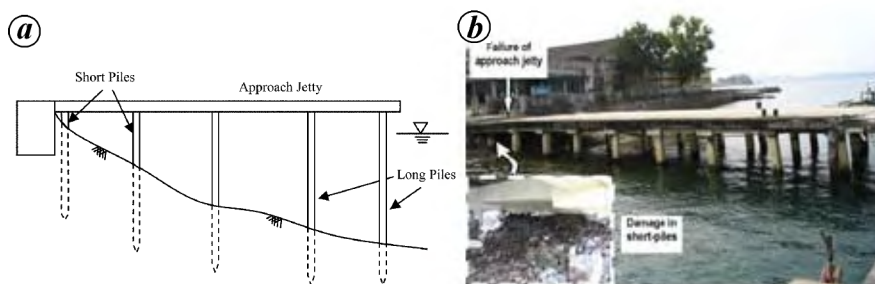
Generally berthing jetties are constructed away from the shoreline inside the sea to get sufficient water depth for anchorage of ships. These are connected to the shore by approach jetties supported by piles, which generally are embedded in the sloping ground and therefore, the unsupported length of the piles varies along the length of the approach jetty (Figure 4 a). The piles mostly affected by this earthquake were those having comparatively shorter unsupported length (short piles) towards the shoreline. These comparatively stiffer, short piles attract more shear forces during earthquakes than those with relatively longer unsupported length and hence more flexible. Such damages were observed in the piles of the approach jetty of Mayabandar where the approach slab fell-off from the ends due to damages to the short piles (Figure 4 b), while little or no damage was found in the relatively longer piles. Therefore, either proper dredging of seabed should be done to increase the unsupported length of the shorter piles or the shorter piles should be designed to withstand large amount of shear forces to prevent short-column failure during an earthquake.

Figure 4. *a*, Pile-supported approach jetty. *b*, Damage in short piles of the approach jetty at Mayabandar Harbour in Middle Andaman Islands.

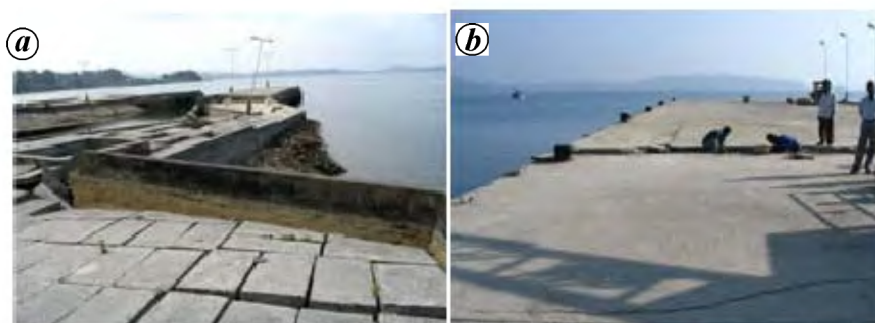
Poor performance of several ports during the past earthquakes throughout the world has been primarily due to liquefaction of the soil⁶. During the Sumatra earthquake, the approach pavement and seawall around the slipway at Mayabandar Harbour were severely damaged due to liquefaction of soil (Figure 5 a). Some soil improvement technique, e.g. vibro-flotation, dynamic compaction can be used to overcome the problem of soil liquefaction. Further, installation of compaction piles also can reduce the possibility of soil liquefaction.

seismic zone map)². This inadequate detailing of transverse reinforcement may lead to shear failure at the top of the piles of the approach jetty at Diglipur Harbour. These piles were also affected during the 2002 Diglipur earthquake^{4,5} and some cosmetic retrofitting was done with 10 to 15 cm thick micro concrete. No assessment was made of the ability of the structure to resist strong earthquake shaking in future. A part of the berthing jetty at Diglipur Harbour sunk due to pile failure underneath (Figure 5 b).

Figure 5. *a*, Damaged side bund of slipway at Mayabandar Harbour in Middle Andaman due to liquefaction of soil. *b*, A portion of the berthing jetty at Diglipur Harbour sunk due to failure of piles. This portion of the jetty cannot be approached by the vehicle for loading/unloading of goods.

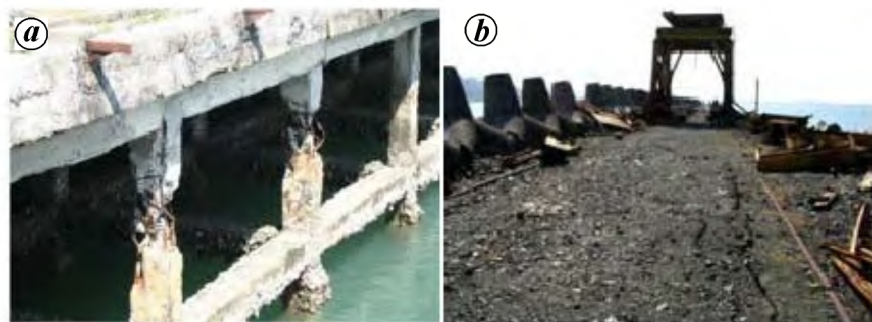
for the severe damages. Jetty structures are continuously in contact with severe and very severe coastal environment (IS 456: 2000)⁷, which led to the deterioration of concrete and steel reinforcement by chemical, electrochemical and mechanical processes. The common deterioration mechanisms are corrosion of steel reinforcement, alkali-aggregate reaction (AAR), carbonation, abrasion, scour and cracking. Steel corrosion is caused by electrochemical processes, AAR and carbonation result from the chemical reaction between the marine environment and concrete, and the rest are mechanical processes. Corrosion of steel reinforcement is prevalent in the splash and tidal zones where alternate wetting and drying takes place. It deteriorates the cover concrete, exposing the reinforcement of piles and deck slabs. Corrosion of the exposed reinforcement in some piles at Rangat Bay Jetty was so severe that the transverse ties were practically missing, which led to the failure of these piles during the earthquake (Figure 6a). Use of galvanized or plastic-coated reinforcing bar along with periodic maintenance of these piles may reduce the risk of such damages. Carbonation and AAR are common in submerge and tidal zones. In the tidal and splash zone, abrasion of concrete piles takes place by the repetitive impact of waves, and the water-borne sands and floating debris which destroy the concrete cover and expose the steel reinforcement. Wave action also increases strain in the piles and thereby causes cracks, which in turn accelerate corrosion of the steel reinforcement by permitting the ingress of chloride, water and oxygen. High performance epoxy-coating materials may be used to protect concrete and steel from such mechanical attack in marine environments.

Apart from jetties, other harbour structures that were affected are breakwater, slipway, passenger hall, etc. The Breakwater at Rangat Bay consists of 100 m long RC-pile trestle followed by rubble mound portion (length 375 m) which was covered with four-legged 'tetrapods' of 4 to 10 tons capacity each, to protect rubble from rough sea waves. Several piles of the reinforced concrete trestle were damaged exposing the steel reinforcement, while the deck slab of the trestle was not damaged. Some tetrapods on the sea side of the breakwater were dislocated due to the tsunami. Longitudinal cracks were developed at the centre at different places

along the length of the rubble mound portion of the breakwater (Figure 6b). Typical failure mode of such breakwaters during earthquakes is 'settlement associated with significant foundation deformation beneath the rubble mound'⁸. Stability against horizontal forces, e.g. sea waves, earthquake loading, etc. is maintained by shear resistance of the rubble, resistance to overturning and bearing-capacity failure.

Figure 6. *a*, Severe corrosion led to damage of columns of approach jetty at Rangat Bay Harbour in Middle Andaman. *b*, Rangat Bay Harbour in Middle Andaman, longitudinal cracks on top of the breakwater.
