On materials science aspects of impact of cannon ball on the stability of the Delhi Iron Pillar

R. Balasubramaniam

Department of Materials and Metallurgical Engineering, Indian Institute of Technology, Kanpur 208 016, India

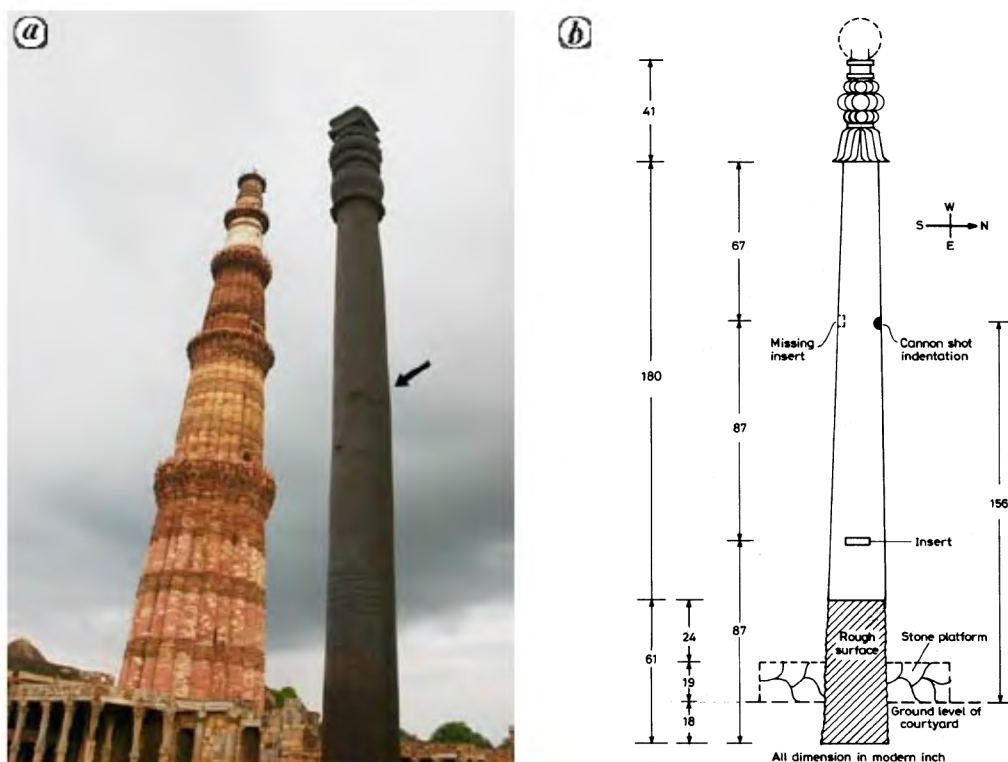
One of the significant marks on the pillar is the indentation of a cannon ball that struck the pillar for a brief moment ($<10^{-6}$ s) in its history (Figure 1a). The indentation

is located at 156 in from the current courtyard ground level (Figure 1b). The diameter of the cannon ball has been estimated to be 5 inches based on plaster of Paris cast of indentation area⁹.

Figure 1. *a*, Delhi Iron Pillar located at the Quwwat-ul-Islam mosque in the Qutub Complex, New Delhi. Arrow shows the cannon ball strike location on the pillar. *b*, Salient dimensions of the pillar showing the relative position of the cannon ball indentation and the inserts. The overall symmetric design of the pillar must be appreciated.

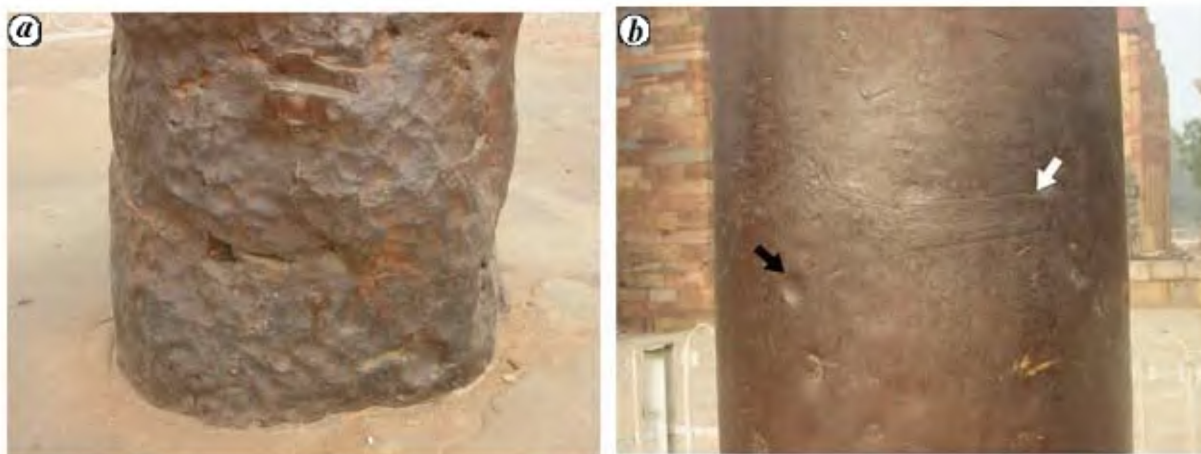
Further, Prasad and Ray¹² noted several smaller diameter indentation marks and concluded that these indicated that sledgehammers were first used to topple the pillar and thereafter the cannon shot was fired. The sledgehammer marks (Figure 3*a*) belong to a time when the pillar was originally forge-welded from individual lumps (of approximate weight 20–30 kg) by horizontal forge-welding method, with the metal lumps added to the main body in a sideways fashion⁶. Some smaller indentation marks located about waist level (black arrowed location, Figure 3*b*) are craters due to shots fired from small arms, and not due to cannon fire.

Figure 3. *a*, Sledgehammer marks on the bottom portion of the pillar due to the original manufacturing technology. *b*, Indentation mark (black arrow) caused by a shot from the fire arm. The outlines of a rectangular insert can be noted at the location indicated by the white arrow.

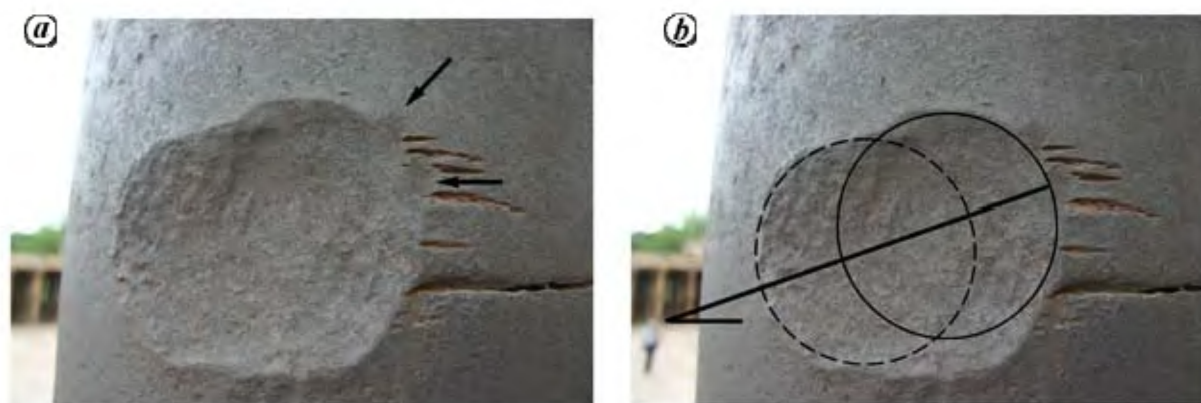
Figure 4. Close-up view of the cannon ball indentation location. *a*, Two shear lips around the cannon ball crater (arrows). *b*, Analysis of the indentation area showing the location where the cannon ball first made an impact (dotted circle) and location where the cannon ball came to a halt (full circle). The trajectory of the ball is indicated by the slanted line.

made. First, the complete impression of the cannon shot is not perfectly circular and the depression is skewed. The depth at the right side (Figure 4 *a*) of the indentation is more than that at the left side (Figure 4 *a*). The left side of the indentation, due to its lower depth⁹, indicates grazing of the ball on its way to the impact. The exact location of the final impact is on the right side of the indentation.

The direction of the cannon shot is deduced to be from the northern direction (Figure 2). The cannon ball first made contact on the left side of the indentation area (dotted circle, Figure 4 *b*) and then came to rest on the right side (full circle, Figure 4 *b*). The trajectory of the cannon ball can also be understood by noting the relative position of the centres of these two circles (slanting line, Figure 4 *b*). The trajectory points from the bottom to the top, thereby confirming that the cannon shot landed on the pillar on its upward motion from the cannon. Another important conclusion is that the angle of the trajectory is 15° , as determined using the slanting and the horizontal lines in Figure 4 *b*.

The plastic strains generated due to the initial grazing motion of the ball and the final impact can also be clearly distinguished on the indentation area (Figure 4 *a*). The surface features on the left of the cannon ball indentation area reveal material removal due to grazing motion of the high-velocity projectile. The features on the right reveal higher degree of deformation caused by the final impact. That the final impact was on the right side of the indentation is further corroborated by a important material evidence, namely the creation of shear lips just at the right of the cannon ball strike location. This is indicated in Figure 4 *a*, where two shear lips are shown (arrows).

The origin of the shear lip is due to material erosion effects at the high velocity projectile impact. When a dense material (like lead cannon ball) impacts the surface with force, it is shattered due to the impact force and the shattered small pieces cause further deformation at the edges of the main impact location¹⁷. The appearance of these shear lips confirms the fracture of the cannon ball into

Generally, fracture occurs at the location of the impact for projectile velocities above 30 m/s in case of metallic materials^{18,19}. The impact of the cannon ball did not fracture the pillar at the location of the impact because the region of impact shows ductile deformation and no fracture in the cannon ball impact area (Figure 4 a). This important observation confirms that the velocity of the cannon ball was not greater than 30 m/s.

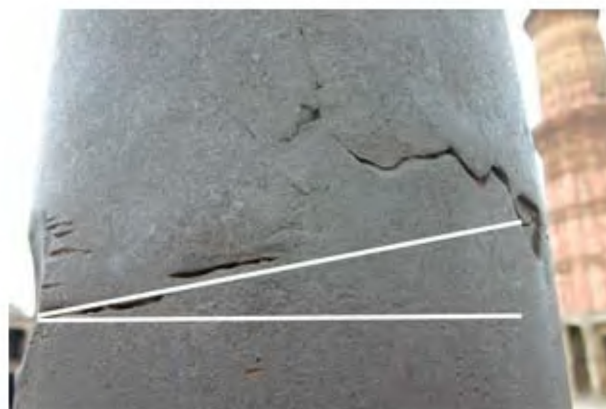
The local fracture adjoining the impact location (to the right of the cannon ball crater) is aligned along a certain direction (Figure 6). Its origin is due to the interaction of the travelling plastic compressive stress shock wave with

the free surface. Its arrest resulted due to the velocity of the moving plastic wave being higher than the crack velocity. Shock waves propagate in solids at the rate of 1–6 km/s, while the velocity of crack propagation¹⁸ is of the order of 2 km/s. Therefore, with impulsive loading, it is generally noticed that cracks form but do not have time to propagate before the stress state changes. This explains the cracking seen on the right side of the cannon ball mark on the pillar (Figure 6).

It is also possible to estimate the trajectory of the cannon ball by relating the crack direction to the direction of the travelling shock wave. Since the cracks adjoining the indentation area are related to the direction of propagation of the wave, it is reasonable to conclude that the trajectory is given by the alignment of the cracks with respect to the horizontal. This has been marked by a slanted line in Figure 6. The angle it makes with the horizontal is 15°. The estimated trajectory matches well with that estimated from features of indentation area (Figure 4b).

Figure 6. Cracks on the right side of the cannon shot indentation area are aligned in the direction of propagation of the shock wave generated due to the impact (slanted line).

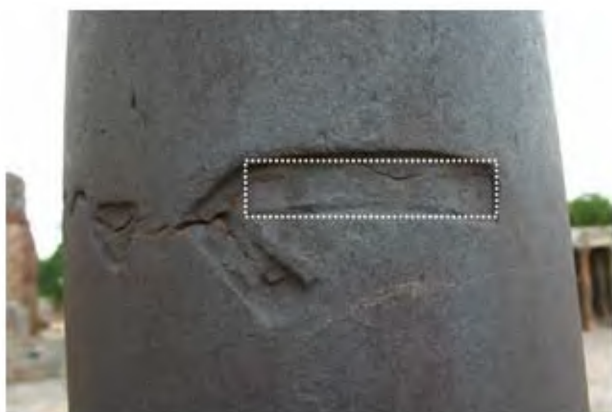
Once the travelling shock wave reached the free surface, it resulted in cracking (Figure 7). In the rear location, one

can see a triangular piece of metal and an almost rectangular lump of metal that fractured and spalled out of the surface (Figure 7). The outline of the missing rectangular material, delineating a missing insert, has been highlighted by dotted lines in Figure 7.

The material from the rectangular-shaped spalled region is not patchwork material. It is a rectangular insert originally present at this location to aid in the manufacture of the pillar⁶. Briefly, the insert is the remnant of the handling clamp used to manipulate the pillar during its manufacture. Later on, once the pillar was fabricated, it was chiselled away, leaving only the rectangular insert

Figure 7. View of the cracked region on the rear, diametrically opposite to the cannon ball strike location. The outline of a previously present horizontal insert is highlighted with dotted line. Note that the material to the left side of the insert was removed by ductile shearing.

The rectangular shape of the spalled insert can be confirmed by well-delineated straight lines on top and right of the region (Figure 7). However, the shape at the left bottom region is not perfectly rectangular and additional material appears to have been sheared with the insert. This can be concluded based on fracture features (plastic tearing) observed on the bottom left portion of the area (see Figure 7 and right side of Figure 8 for higher magnification view). Therefore, it is reasonable to conclude that when the remnant of the clamp was dislodged from the surface, it had fractured some of the material of the surface by plastic tearing.

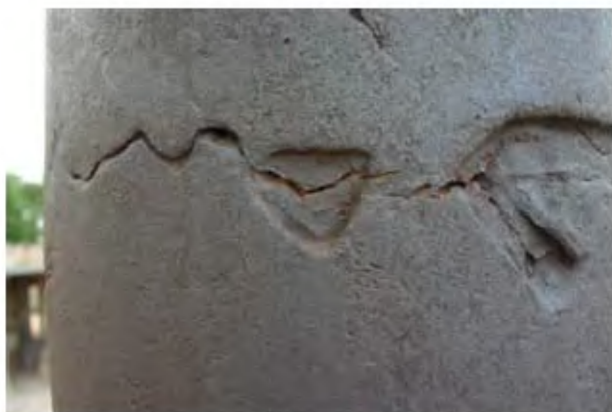
The triangular piece appears to have been a patchwork used to even out the surface. Careful observation revealed that the smooth surface of the pillar was produced by filling all cavities on the surface with smaller bits of iron and later the entire surface was chiseled, burnished and polished⁶. It is confirmed that the triangular piece was a patchwork by noting that the cracking had not progressed from the edges of the triangle. Rather, cracking is evident below the spalled triangular region (Figure 8).

Figure 8. Close-up view of the triangular-shaped spalled region on the rear side.

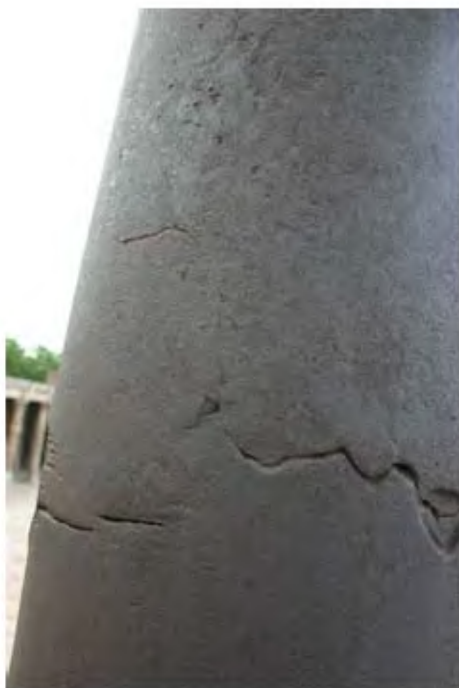
Observation of the cracking pattern noted on the side (Figures 6 and 7) and back side of indentation mark area indicates that the propagating horizontal crack from the rear side has opened out some of the lump–lump interfaces (Figure 9). The nature of cracks (i.e. close relationship between the horizontal crack and the deflected cracks delineating lump–lump interfaces) confirms that lump–lump separation is not due to the onward travelling compressive shock wave, but due to the deflection of the horizontal crack propagating from the rear of the pillar surface.

It further appears that the separation of lump–lump interfaces is also realized within the body of the pillar at this location (Figure 9). In non-destructive studies conducted on the pillar²⁷, evidences for the presence of curved, hollow spaces were obtained near the cannon ball strike location by gamma radiography. The thickness of these hollow spaces is very small. These elongated, curved,

Figure 9. Side view of the pillar at the cannon ball strike location showing deflection of the horizontal crack from the rear (right side of the image) to the axial direction of the pillar by cracking of lump–lump interface.

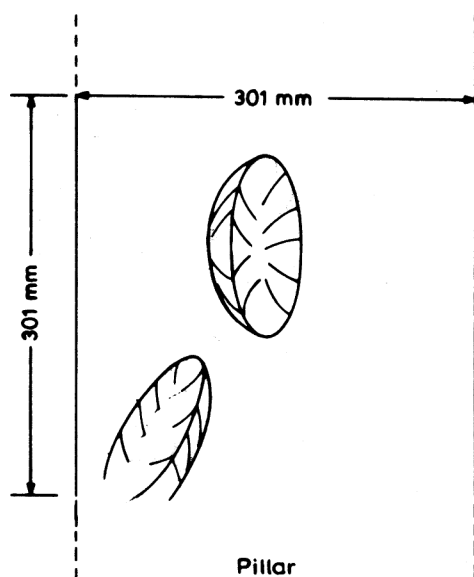
hollow spaces are shown schematically in Figure 10. The imaging of the region around the cannon ball mark by gamma radiography provides valuable proof of fabrication of the main body (using iron lumps forge-welded on the horizontal pillar in a sideways manner). It also offers

Figure 10. Schematic of elongated, curved, hollow spaces in the main body of the pillar near the location of the cannon ball strike. This has been recreated using the gamma radiographs presented in figure 3 of Raj *et al.*²⁷.

convincing proof of deflection of the propagating horizontal crack along lump–lump interfaces.
