Microclimatic condition in relation to conservation of cave no. 2 murals of Ajanta

Archaeological Survey of India, Bibi-Ka-Makbara, Western Zone, Aurangabad 431 004, India

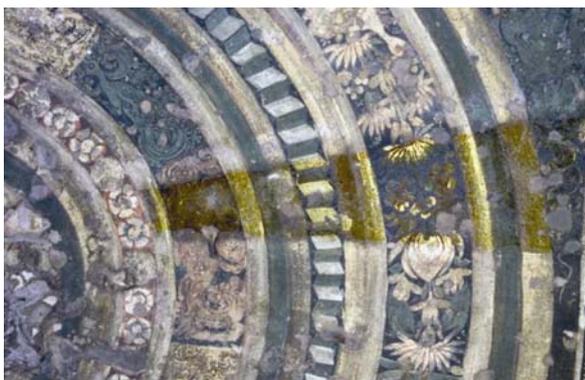
**Figure 8.** Scientific conservation of painted medallion at cave no. 2.

For conservation, the painted plaster was first consolidated by injecting lime-casein mixture wherever there was a gap between the pigments and plaster layer followed by gentle pressing with rubber roller and allowing it to dry for about two months. Bigger gaps and cracks were filled with lime mortar and tinted suitably to match

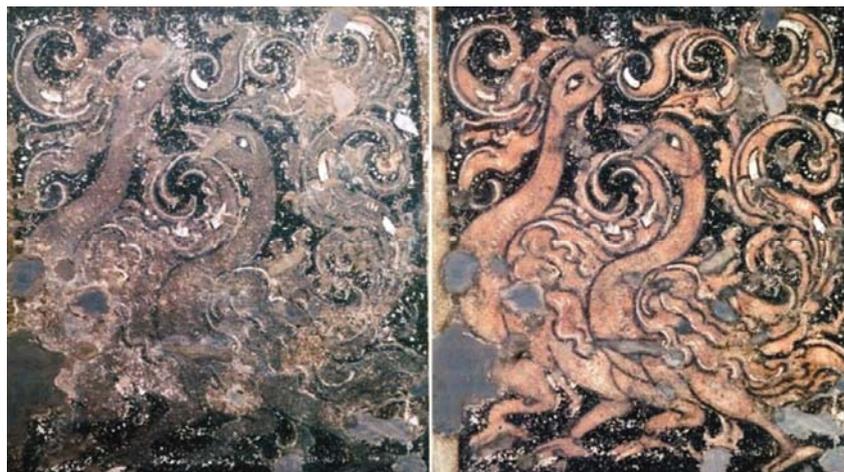
Figure 9. Photographs of ceiling painting at cave no. 2 before (left) and after (right) cleaning.

the surroundings. For the removal of shellac varnish, a mixture of morpholine, *n*-butylamine, butanol, ethanol and dimethylformamide were taken in the ratio of 0.5 : 1 : 1.5 : 2 : 1 and properly mixed. This mixture of chemicals was applied slowly with sable brushes on the shellac portion with utmost care so as to restrict its action only on the outer varnish surface. After softening by wetting the surface for 2–3 min, the varnish was removed carefully with cotton swab so as not to touch the original pigment layer. The main intention of the cleaning is to reduce the thickness of the varnish layer to make the painted plaster breathe naturally. Figure 8 shows the result of scientific conservation of a painted medallion at the central hall of cave no. 2, leaving a small strip to show the actual condition of the painted surface before cleaning.

The falling of white kaolin from the ceiling of cave no. 2 is one of the major problems of conservation here. On careful observation, the ceiling paintings were also found encrusted with soot layer that has to be removed before consolidation of the white pigments. For these, 3–4 grains of EDTA were dissolved in 1–2 drops of distilled water, and 18–20 ml of ethanol, 1–2 drops of ammonia and 2–3 drops of triethanolamine were mixed into it to make 25 ml of solution (pH about 9). After complete mixing, this mixture was applied gently with cotton bud for a short duration with care and precaution. Particular attention has to be paid to restrict its action only to sooty accretions without in any way affecting the black original outlines of the paintings. As the nature of adherence of black soot is different to the original black outlines (it has been applied admixed with glue), an experienced conservator can definitely carry out this delicate operation satisfactorily. Figure 9 shows a part of the ceiling painting recently cleaned using this technique. After complete drying the cleaned part of the painting was applied with two coats of 0.5% polyvinyl acetate solution when the temperature inside the cave was about 27°C and relative humidity 55–60% for better results. After this procedure, no falling of white pigment has been noticed in the 9–10
