August 2012 cloudburst and subsequent flash flood in the Asi Ganga, a tributary of the Bhagirathi river, Garhwal Himalaya, India

Vikram Gupta*, D. P. Dobhal and S. C. Vaideswaran

Wadia Institute of Himalayan Geology, 33, General Mahadeo Singh Road, Dehra Dun 248 001, India

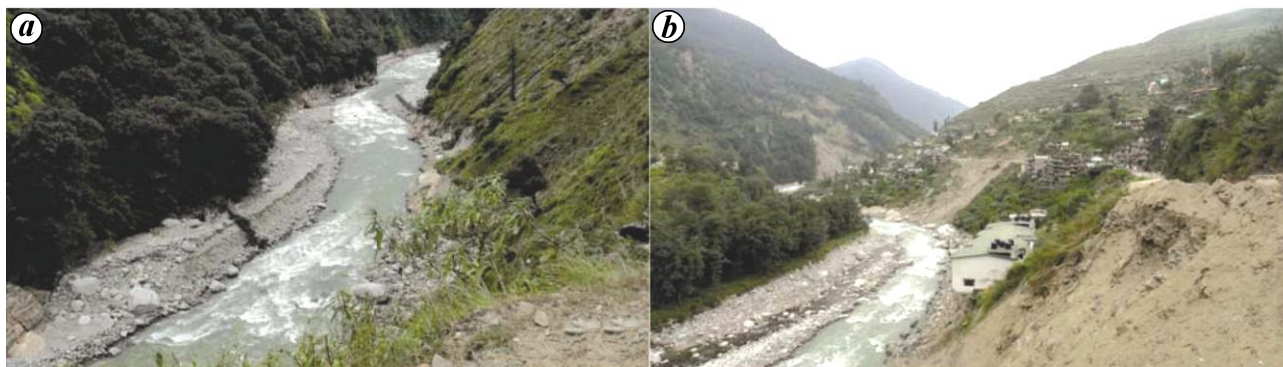
Figure 3. *a*, 2.3 m thick material deposited by 2012 flash flood on both sides of the Bhagirathi river near the downstream of the confluence of Suwari Gad–Bhagirathi river. *b*, Landslides generated by bank erosion in the downstream of the Bhatwari section has made the entire slopes unstable. Note the badly damaged Bhatwari Tourist Rest House.

The confluence of the Suwari Gad–Bhagirathi river is a gorge section and the water level marks have been observed about 3–4 m high above the present level of the Bhagirathi river. The flash flood deposited about 2–3 m thick river borne material of varying sizes on both sides of the Bhagirathi river (Figure 3 *a*). A bridge on the Suwari Gad had been washed away. As there is no habitation and the National Highway (NH-108) is about 60–70 m above the river section, no damage has been reported between Suwari Gad–Bhagirathi river confluence and Bhatwari, though there were number of old subsidence zones in this section. The general angle of valley slopes is about 40° and hard rocks are exposed on both banks of the Bhagirathi river. Thus freshwater marks about 3–4 m above the present level of river could be observed on both sides of the Bhagirathi river.

The bank erosion due to the flash flood is prominent in downstream of Bhatwari section, as loose material is located on both sides of the slopes. Bhatwari tourist rest house was badly damaged and also number of fresh landslides had been generated in this stretch, mainly because of the bank erosion (Figure 3 *b*). Tree logs carried by the flash flood have been observed at many places in this section of the river.

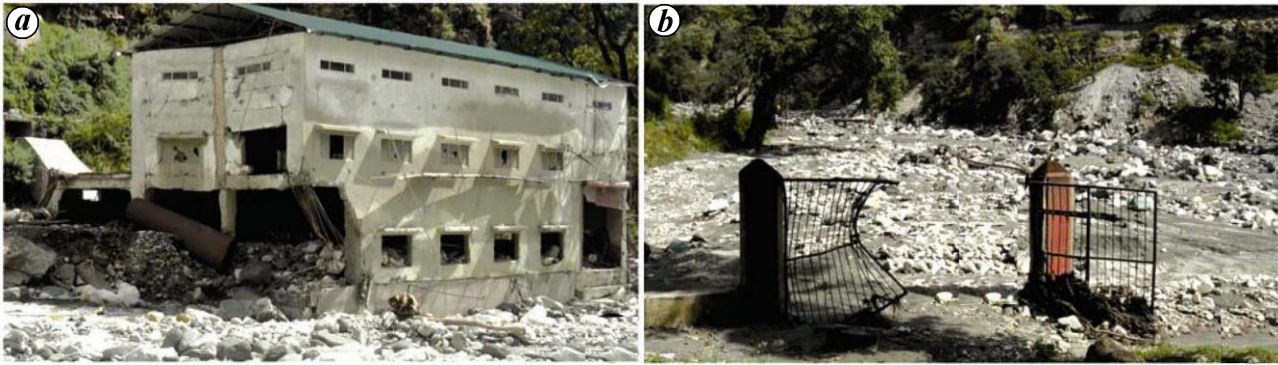
II and one in the Kalidi Gad that were under construction (Figure 4 *a*). Six bridges were either completely destroyed or damaged, including the bridge at Gangori on the confluence of Asi Ganga–Bhagirathi rivers. A high school and Trout Reproduction Centre located at village Kaldya and irrigation and power house canal at Agora on terrace deposits on the right bank of the Asi Ganga has been completely washed away (Figure 4 *b*). The complete road network from Gangori to Dodital was disrupted, with about 10 km of the road completely washed away, besides damage to the flood protection wall on the left side of the Asi Ganga in the Gangori township (Figure 5).

Figure 4. *a*, Highly damaged power house located near Kaldya in the tributary Asi Ganga. *b*, Remains of school entrance at village Kaldya that has been completely washed away.

been completely washed away, as these were located on the active flood plain of the Asi Ganga river, about 3 m above the river channel.

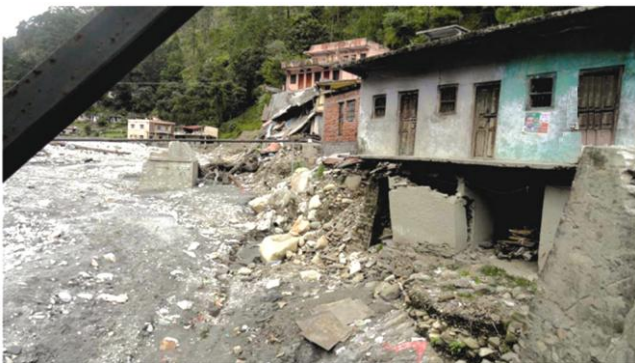
Water level at the confluence of Asi Ganga and the Bhagirathi river rose to about 3–4 m in a river that has a width of about 125 m. A lot of damage has been observed in the Gangori township, in the form of washing away of Gangori bridge, and the flood protection wall (Figure 5). Number of fresh landslides have also been generated in the Uttarkashi township due to bank erosion (Figure 1). The flash flood resulted in damage to shopping complex near Tiloth bridge, national highway, sewerage line and sewerage treatment plant in the Uttarkashi township.

Figure 5. Highly damaged flood protection wall on the left bank of the Asi Ganga near the confluence of the Asi Ganga and Bhagirathi river at Gangori township.
