The Uttarkashi earthquake of 20 October: implications and lessons

K. S. Valdiya

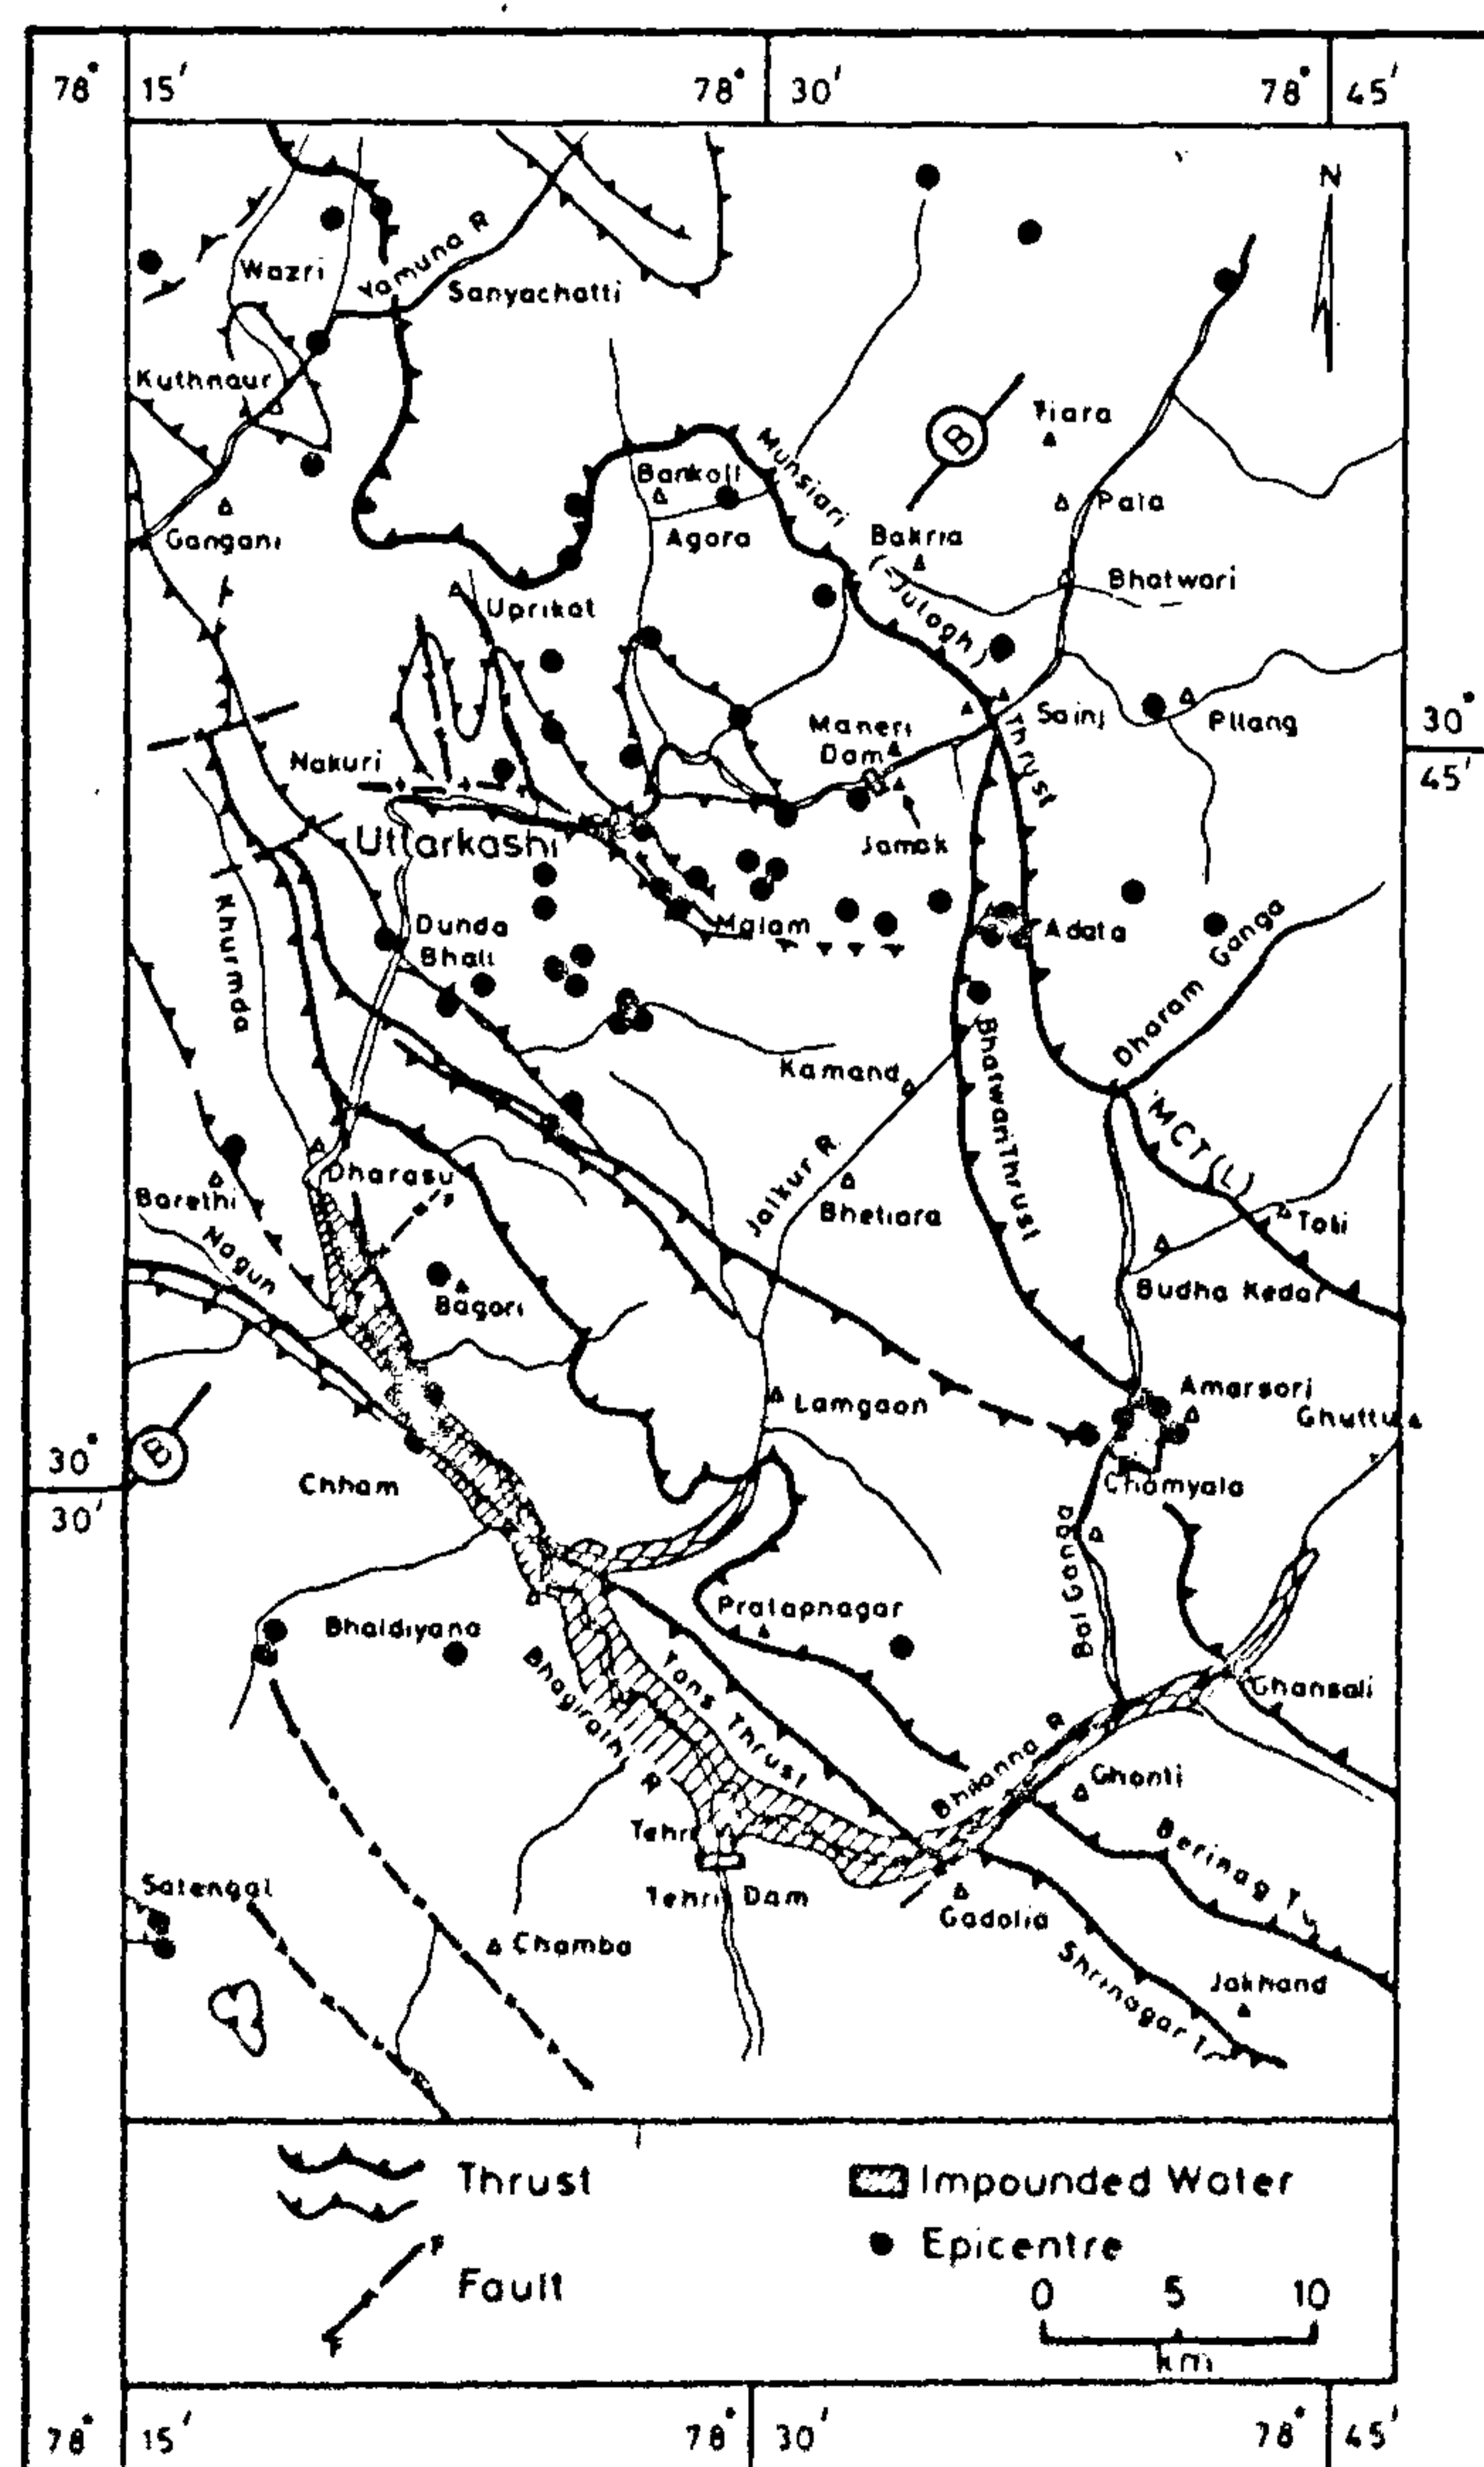
Figure 2. Simplified tectonic map of the northern part of the Garhwal Himalaya. (After Valdiya, ref. 6).

The belt of most severe damage and destruction is related to the Munsiri Thrust defining the lower boundary of the MCT zone (Figure 2). It extends southeast from Bankoli-Agora through Sainj, Lata, Saur in the Bhagirathi Valley, the Belak Khal-Adata saddle (3400-3424 m), the Koti-Budhakedar-Thatikathur group of villages in the Balganga Valley, the Ghuttu group of settlements in the Bhilangana Valley to

The fourth belt, of moderate damage, follows the Berinag Thrust (Figure 2) traceable from Gamri, through Pratapnagar to near Ghonti in the Bhilangana Valley. The zone of Shrinagar (Tons) Thrust has registered but very mild damages, as witnessed at Dharasu, Chinyalisaur, Bhalidiana, Tehri and Gadolia.

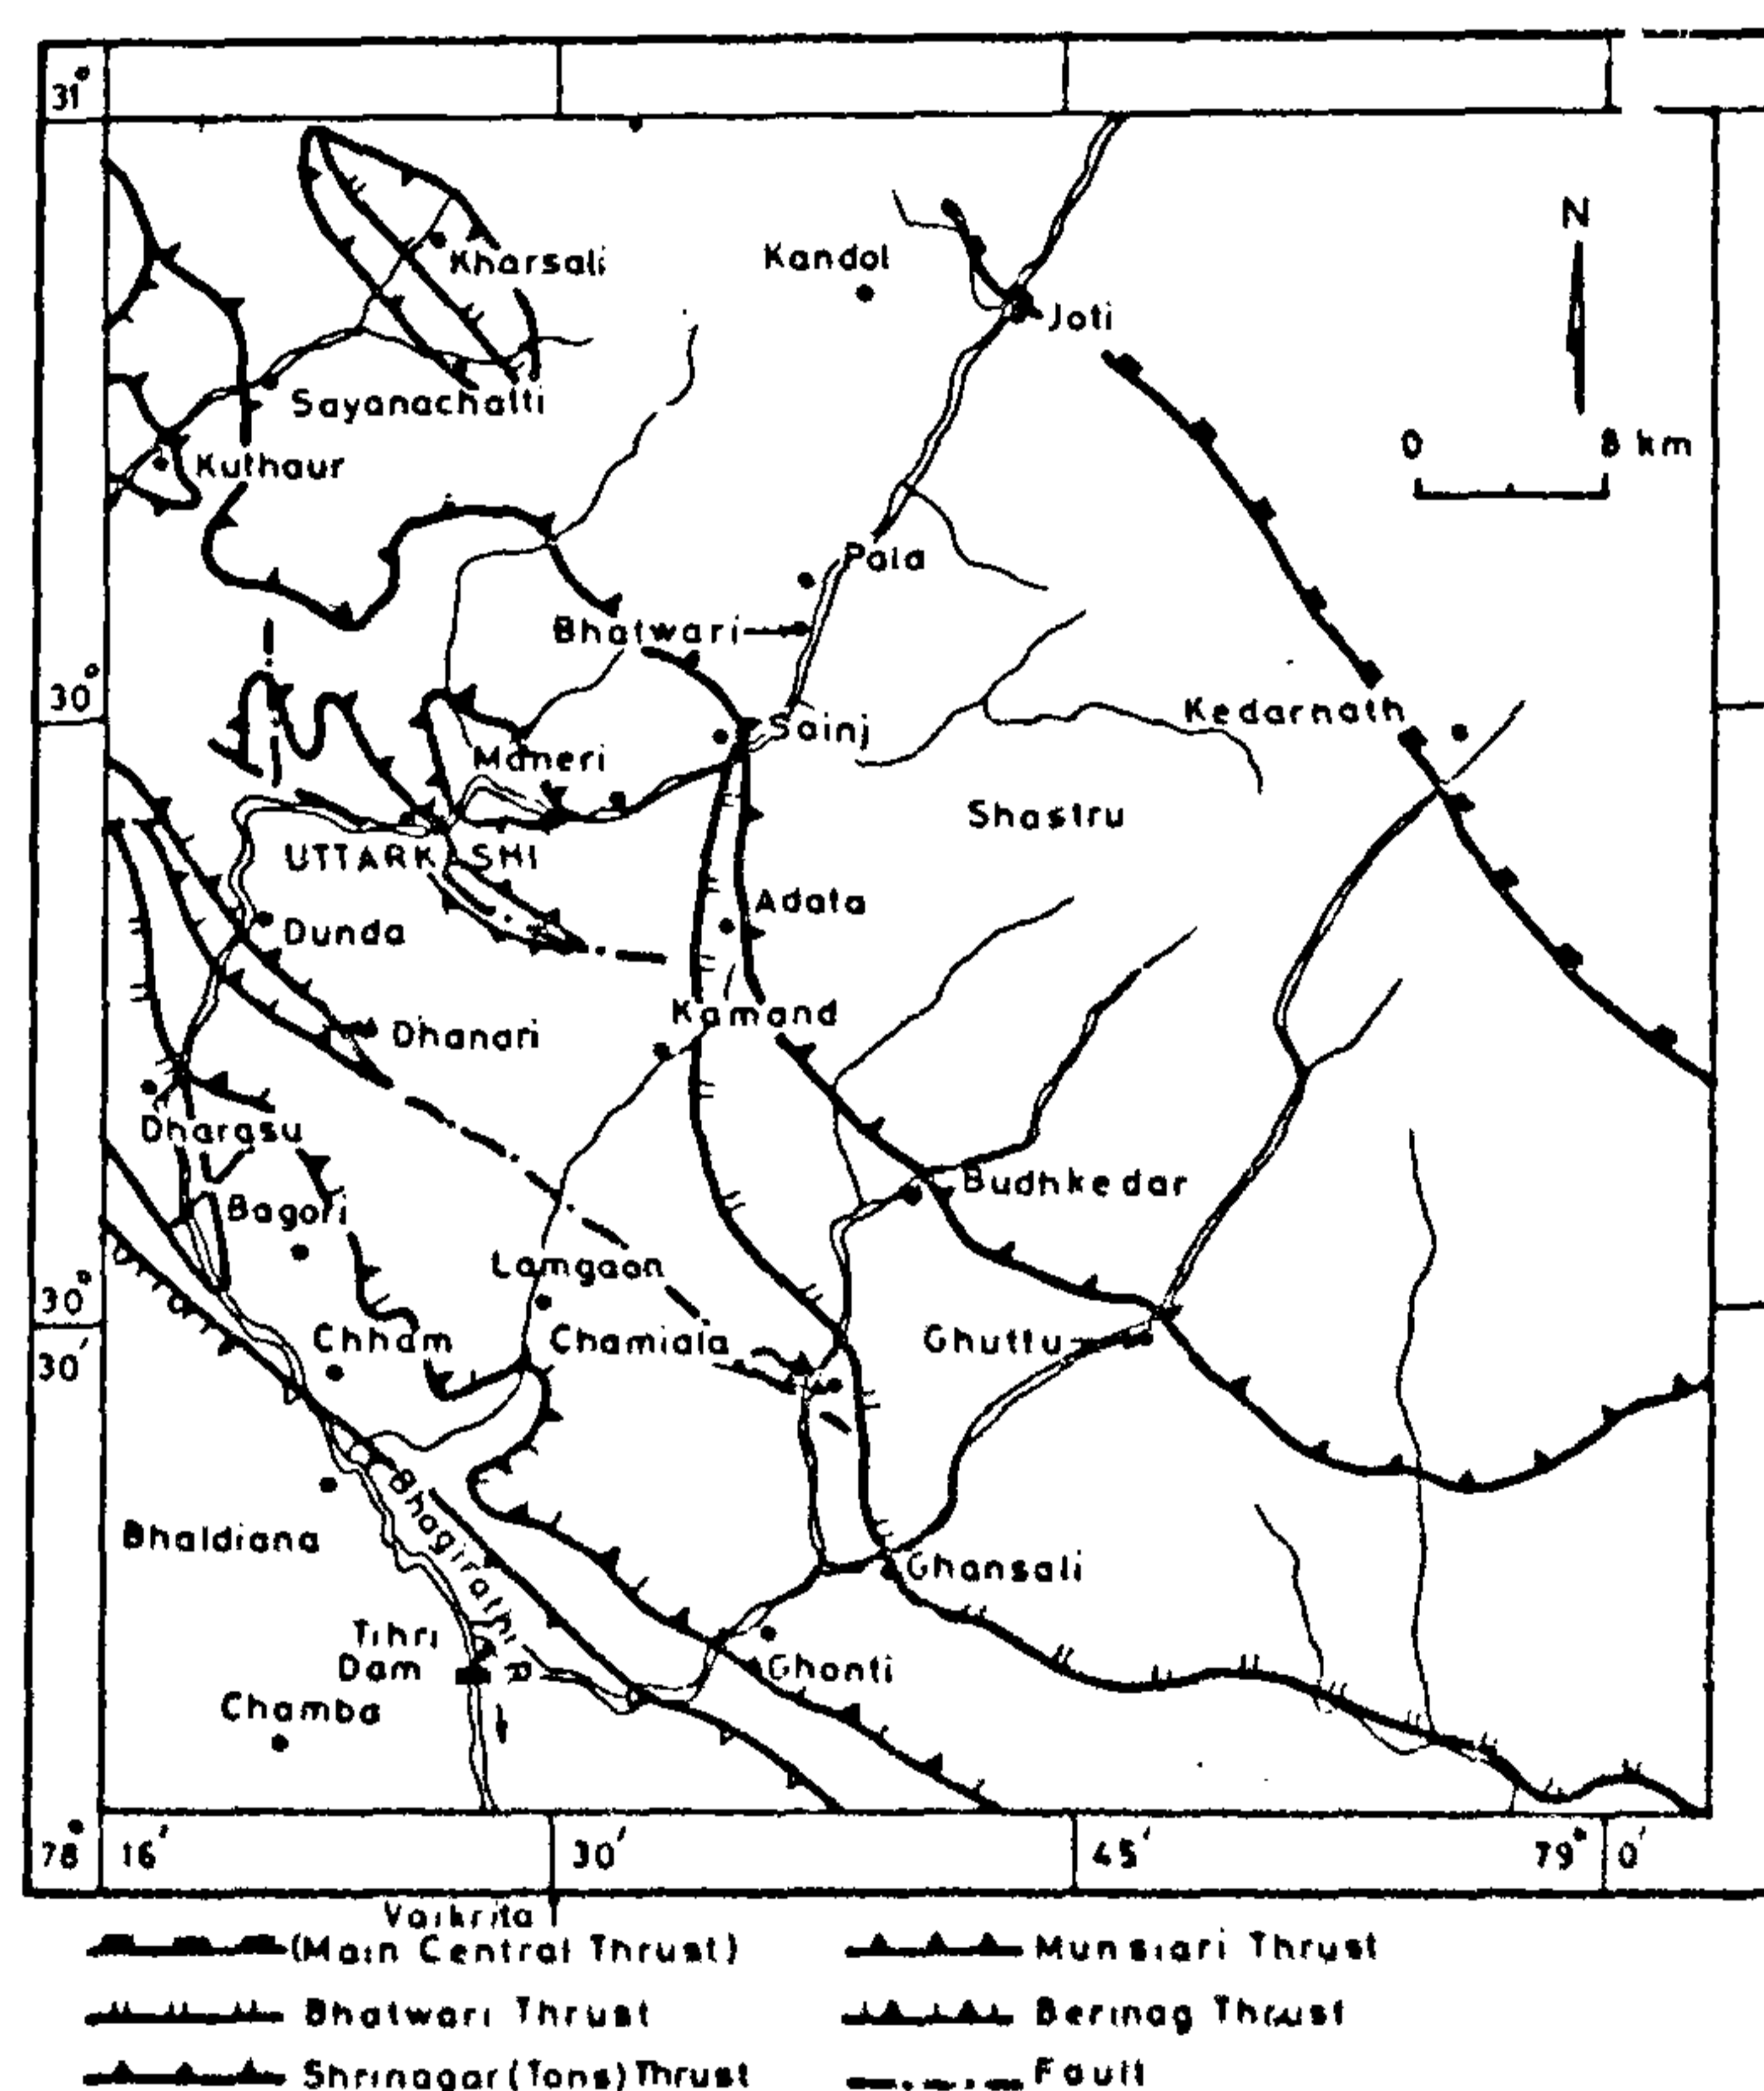
Figure 1. The Uttarkashi region, ridden with faults and thrusts, exhibits persistent microseismicity, ($M \leq 3$), indicating internal tectonic tumult. (After Valdiya, ref. 4).

The belts of maximum damage are clearly identifiable with the faults and boundary thrusts (Figures 1 and 2). Between the northern and southern boundaries of the MCT zone in the Himadri domain and within the Bhatwari Thrust sheet, the surface waves travelled in a roughly N-S direction, implying overthrusting of the Himadri or underthrusting of the Lesser Himalaya beneath the Himadri pile. The passage of these N-S surface waves caused extensive slumping of the fan-shaped colluvial deposits resting on steep slopes. These fans consist of loose aggregates of debris deposited by mountain torrents and shattering damages (Figure 3), such as those seen on the slopes of the Kaldi Gad (e.g. Bankoli, Agora), Bhagirathi River (e.g. Gorsali, Saur, Bhatwari, Pala-Morara, Rainthal, Tiara), Bhilangana Valley (e.g. Gangi), Mandakini Valley (e.g. Gaurikund), and Helaun Gad (e.g. Gorti, Bajra).

Immediately to the south, the second belt, of equally severe destruction, is related to the Uttarkashi Fault (Figures 1 and 2) traceable from NW of Nakuri, through Uttarkashi eastward to the Adata peak, where it seems to branch off from the Munsiri Thrust. It is linked with the NNW-SSE-trending, very active tear faults of the Rano and Shyalam streams. The fluvial terraces lining the Bhagirathi Valley at Nakuri, Uttarkashi, Gangori, Gawana, Netala, Maneri, Jamak, Dedsari, Lunthru, Bina—among many others—were subjected to rapid heaving by the E-W passage of strong surface waves. The differential settling of the soft, unconsolidated fluvial sediments is responsible for the collapse and cracking of structures (Figure 4). The E-W travel direction of the surface waves is significant, for this fact tends to show that there was a very strong component of strike-slip movements of the Uttarkashi Fault, and, as a matter of

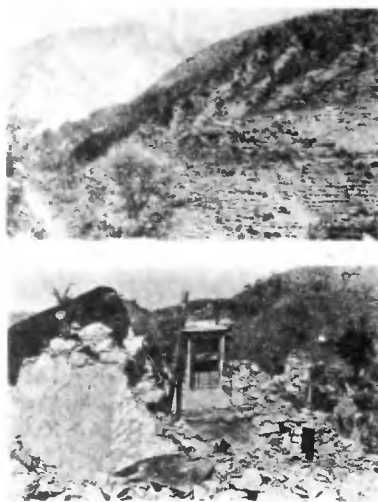
Figure 3. Collapse of or damage to buildings constructed on fan-shaped deposits of ancient landslides and mountain torrents. Slumping of the loose aggregate of debris caused the havoc.

2. In these identified hazard zones, future buildings and structures on soft, unconsolidated or loose aggregates of sediments/debris of the riverine terraces and colluvial fans on mountain slopes should invariably have reinforced masonry or concrete foundations or pillars or both, the walls should be braced mutually or with the pillars, and the roof and floor securely tied to the walls. Furthermore, irrespective of design and orientation, houses should have at least two exits, on walls at right angles to each other. This will ensure easy exit in the event of one of the doors getting stuck or jammed owing to distortion of its frame.

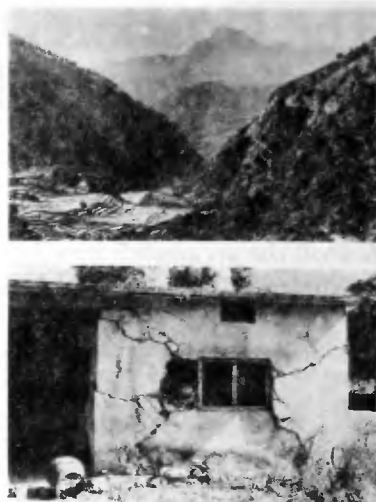
Figure 4. Differential settling of soft, unconsolidated sediments of riverine terraces was responsible for house destruction and damage

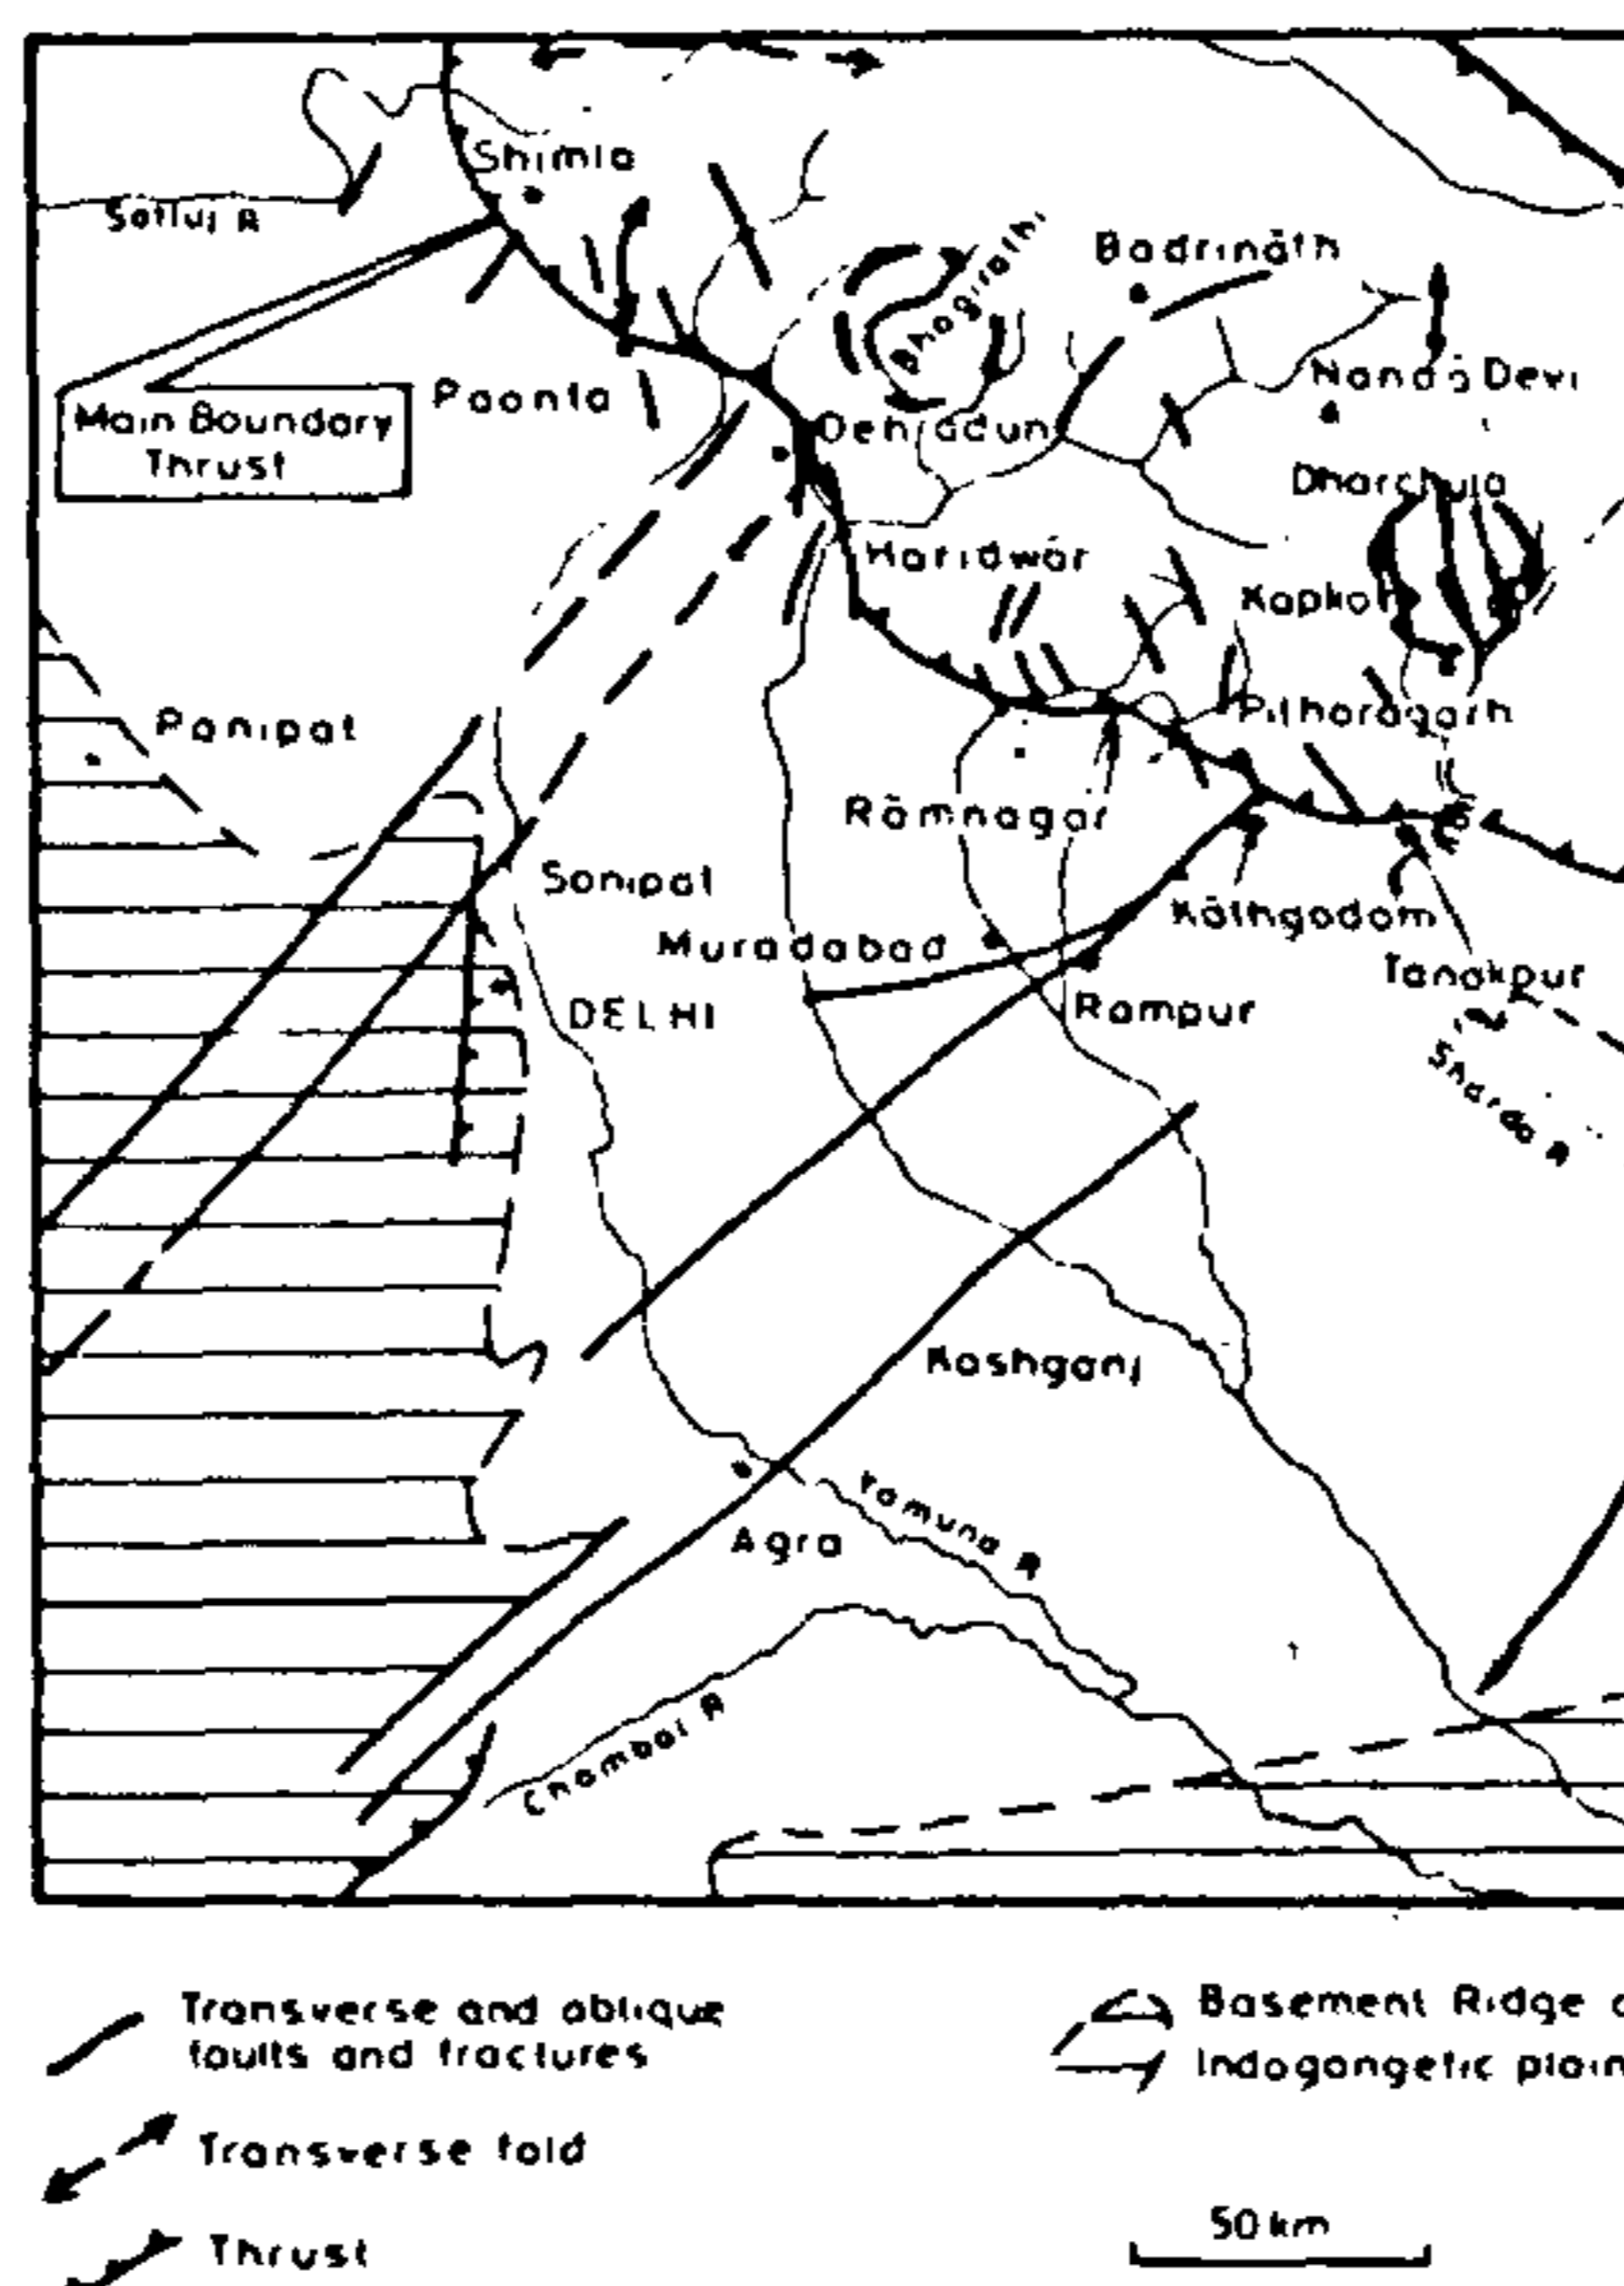
Figure 5. The fault-lined Aravali Ridge is prodding the Himalaya like a battering ram. The Uttarkashi area happens to be in the line of this ridge. Likewise in the line of the hidden Muradabad Fault of the Ganga Basin lies the Kapkot-Dharchula-Bajang region in northeastern Kumaun, which is frequently and severely rocked by earthquakes and ravaged by mass movements. (After Valdiya, ref. 7).

is persistently pressing the Himalaya^{2,7,8} like a colossal battering ram (Figure 5), considerable stresses are accumulating in the body frame of the orogen in front of the promontory. The last major earthquake (M 7.5) in the region occurred 164 years ago in 1828, and not all the accumulated stress was released by the 20 October earthquake of M 6.1. It is clear that a significant amount of the residual stress is waiting to be released by a future earthquake, whose magnitude must be M 8 or higher⁹. The severity would be much greater, and the extent of destruction and damage would stretch far beyond the Shrinagar Thrust.
