# Conservation of mural paintings

S. Subbaraman

**The role of different branches of science such as physics, chemistry and biology in the conservation of antiquities and art objects through in-depth studies for a proper understanding of the deterioration process as well as the evolving of effective conservation techniques, is being increasingly recognized in the past few decades. This article deals with the application of scientific techniques in the conservation of mural paintings.**

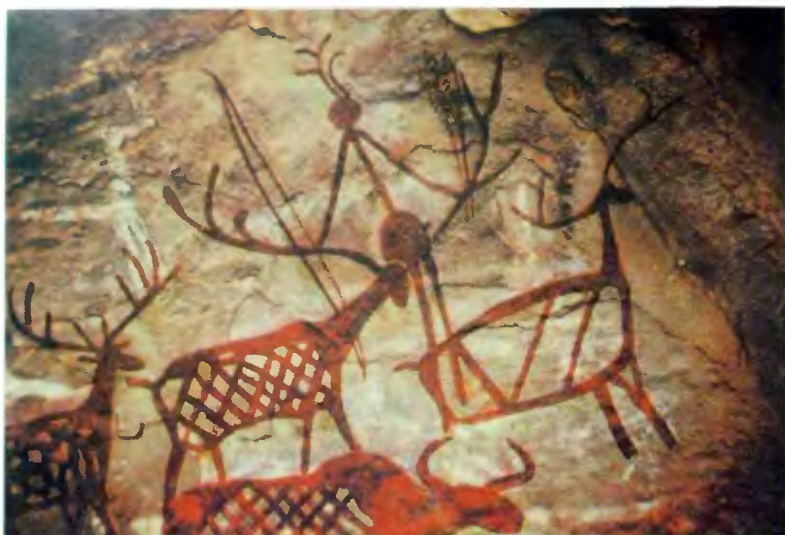
Figure 2. Prehistoric rock painting. Bhimbetka; Late Mesolithic. [Courtesy: M/s D. B. Taraporevala & Sons Pvt. Ltd, Bombay]

directly on the rock, making use of the roughness of the natural rock surface to bind the colours. Even the contours of the uneven rock surface were sometimes deliberately made use of to give a three-dimensional effect to the figures. The pigments most commonly used were the naturally occurring oxides of iron, haematite and limonite to produce shades of red, yellow, orange and brown. For white, kaolin or lime-stone was used. Charcoal or manganese dioxide provided the black colour. In Bhimbetka, instances of copper compounds being used for producing a bright green colour are found<sup>1</sup>.

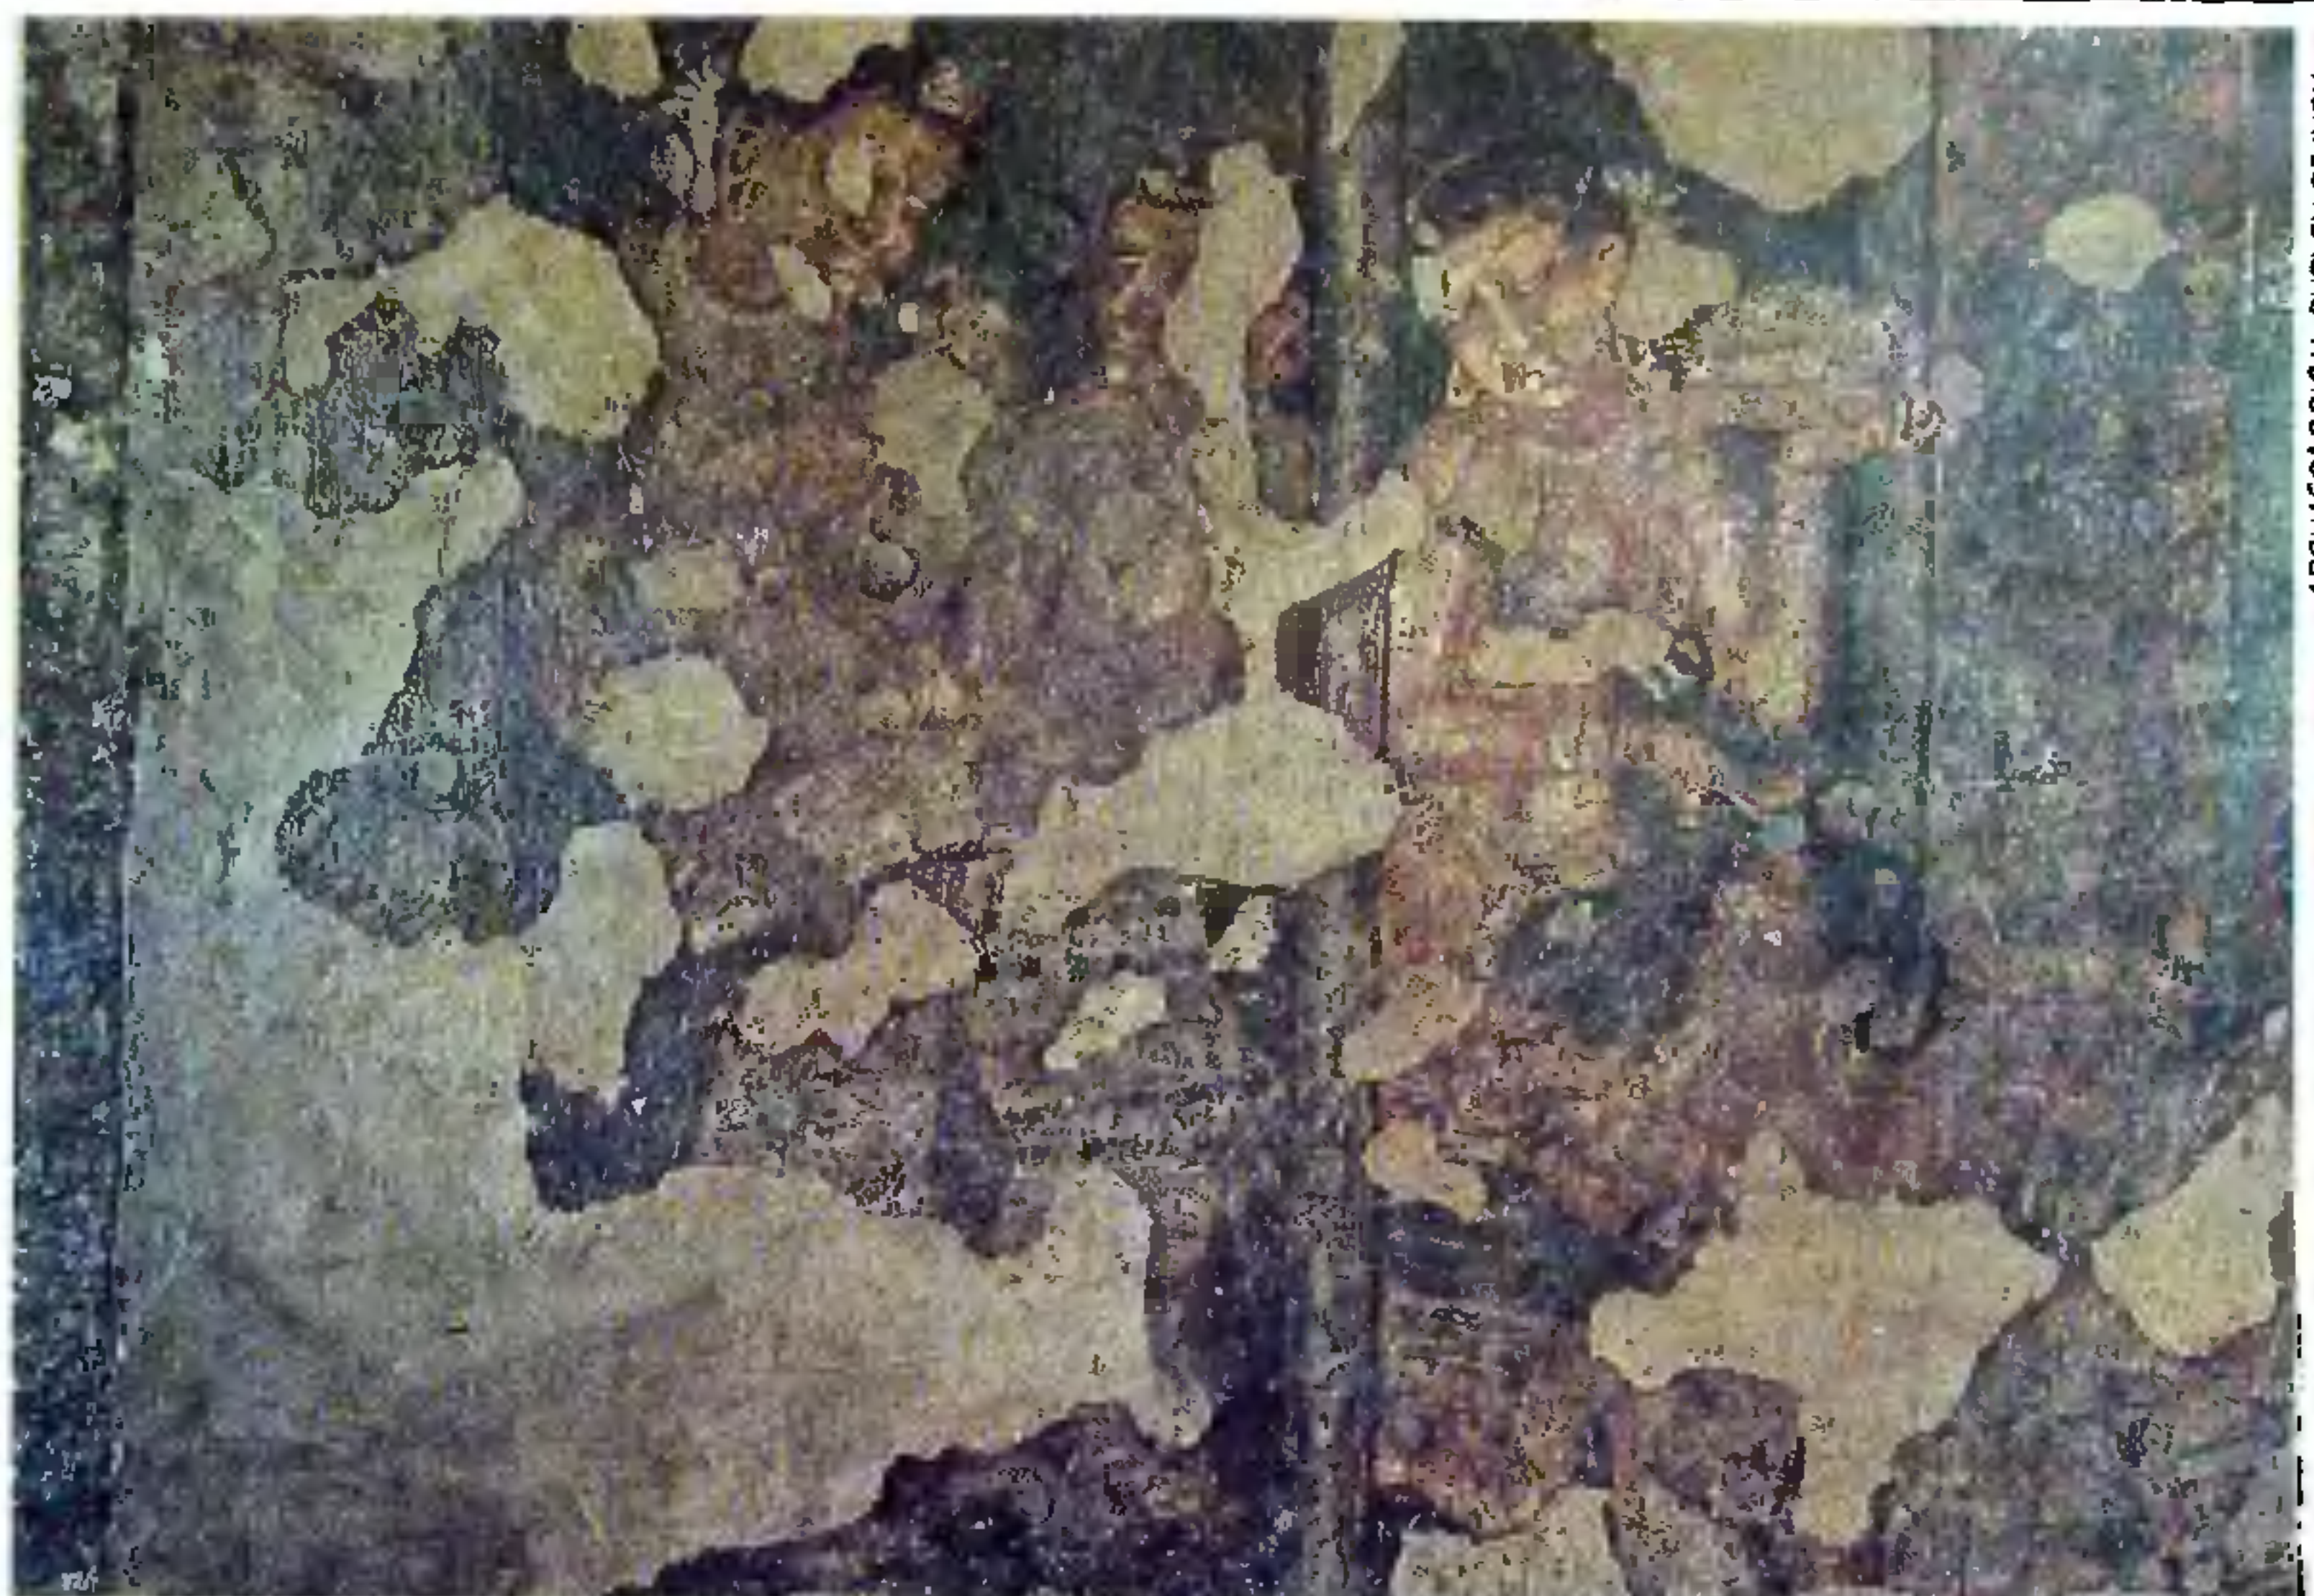
Figure 5. Ajanta painting (5th century AD)—Lacunae in the paint surface filled with plaster and tinted with neutral colour

Sometimes there may be lacunae, small or large, within the body of the painting, which have a jarring effect on the viewer. Reconstruction of the missing portions of the painting is not permitted, according to the conservation principles strictly adhered to in this country, because such reconstruction has to depend on guess-work and interferes with the authenticity of the painting as a whole. To remove such jarring visual effect, the lacunae are covered with plaster-of-paris and tinted with water-colours (which are similar to the pigments used in paintings) so as to merge with the surrounding areas of the painting (See Figure 5).

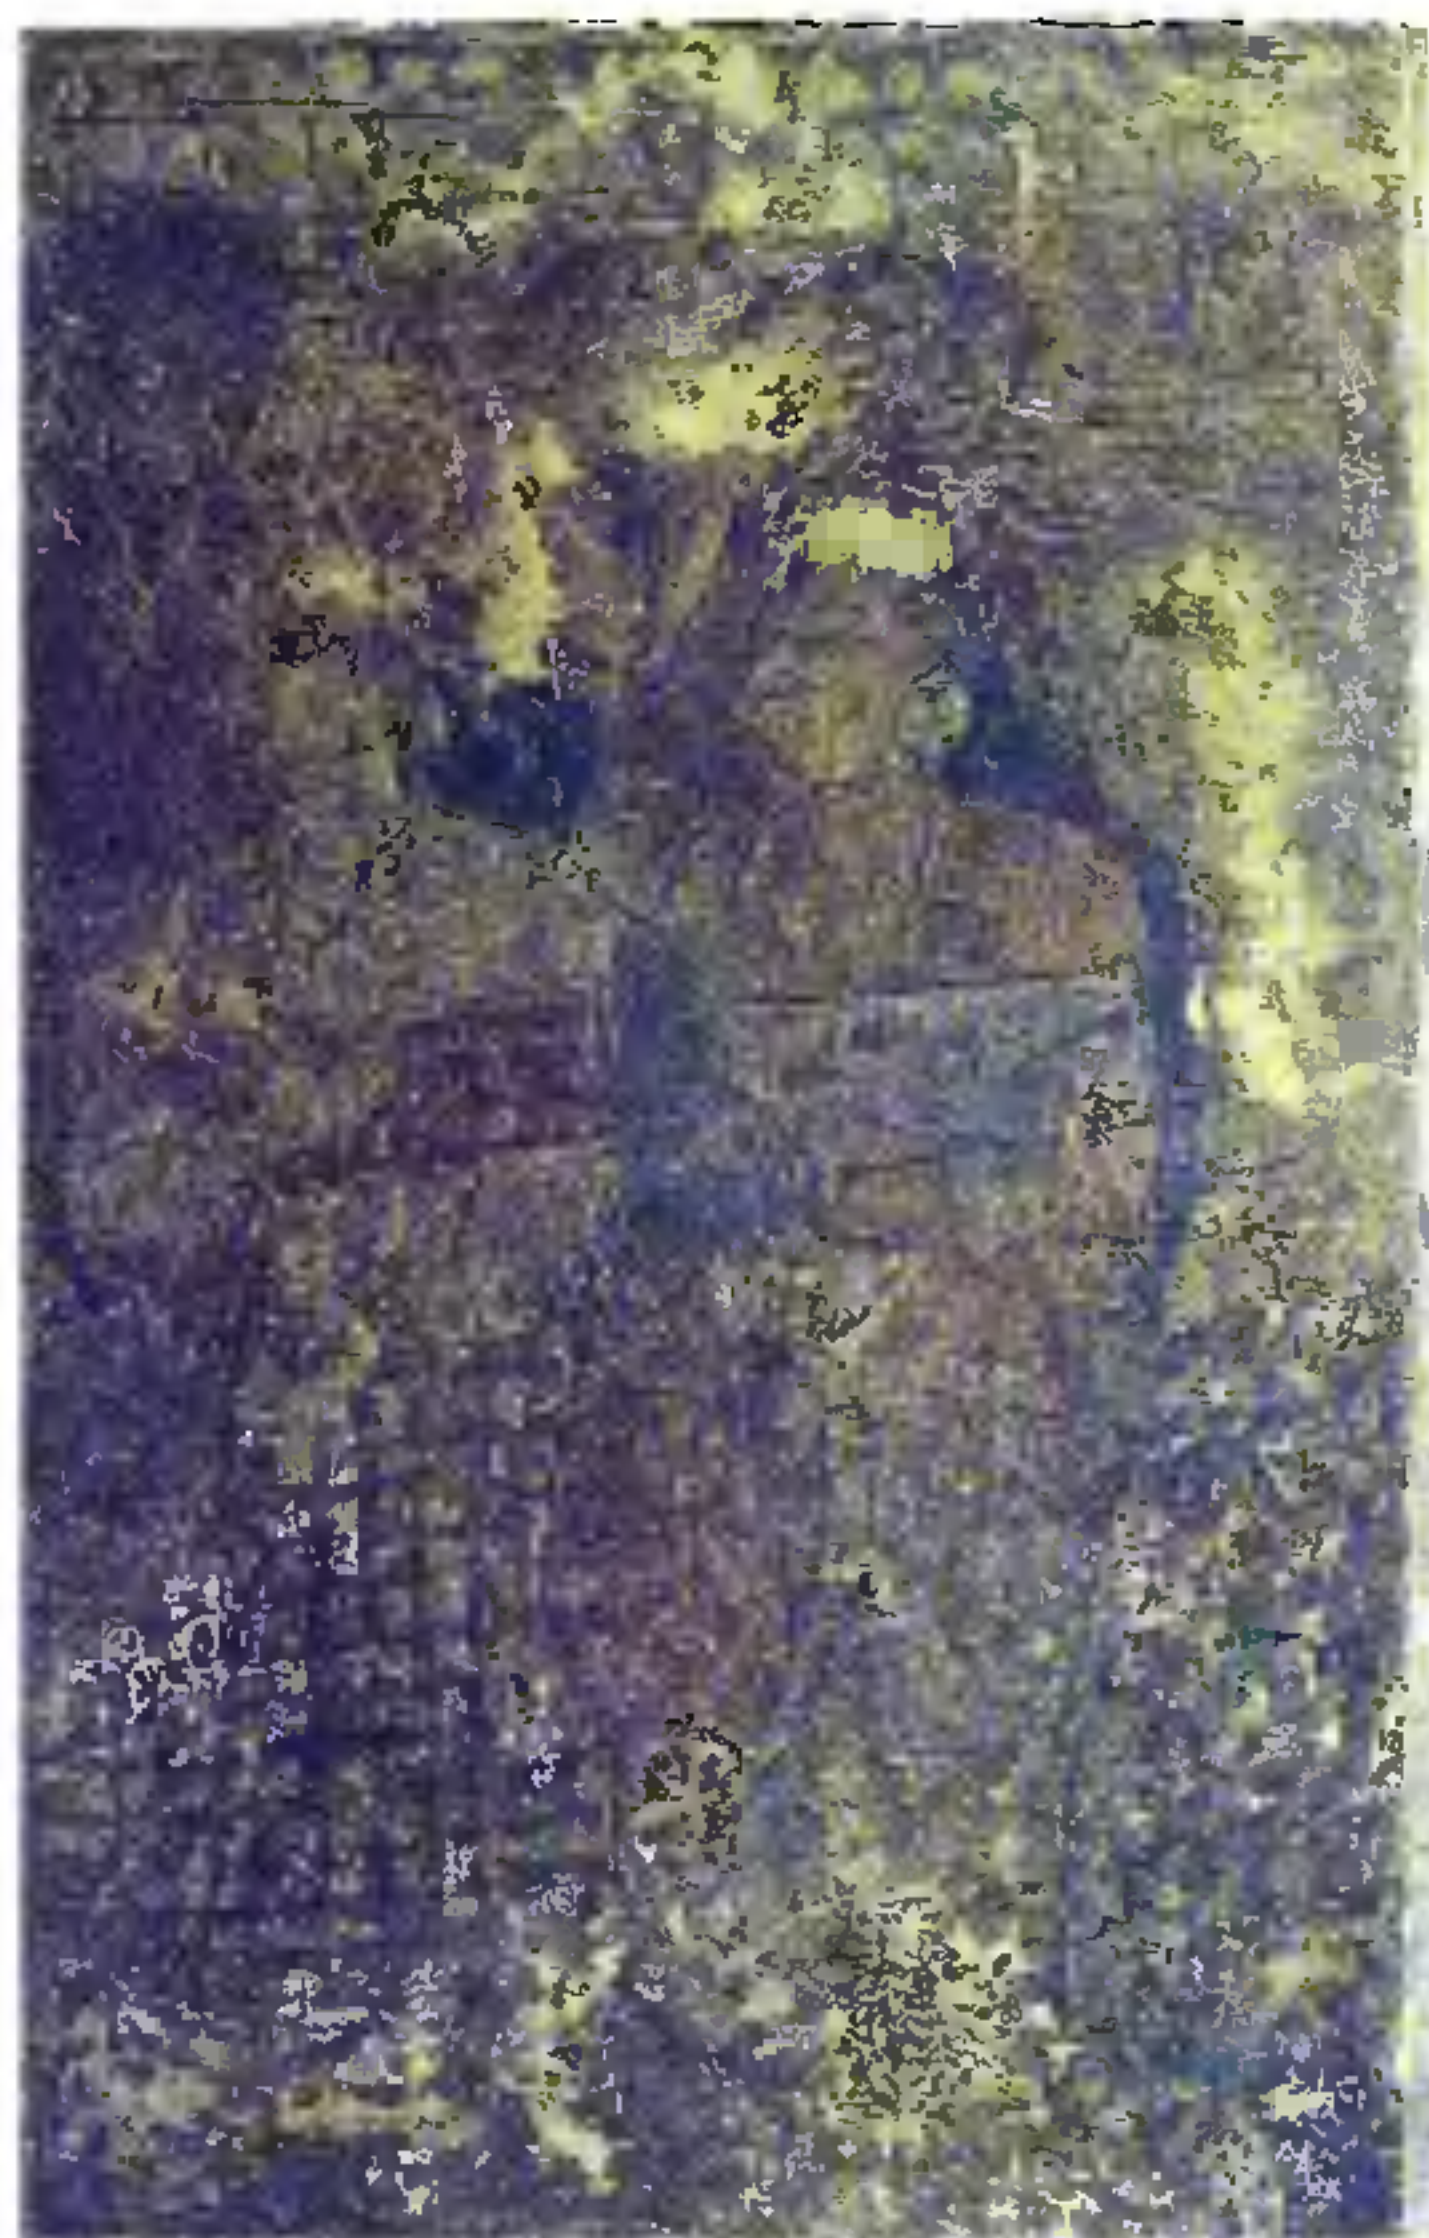
Figure 7. Detached Nayaka painting mounted on fibre-glass support.
