The devastating landslide of August 1998 in Ukhimath area, Rudraprayag district, Garhwal Himalaya

It was a week of disaster from 11 to 19 August, 1998 in the Ukhimath area in Garhwal Himalaya. The landslides affecting 20 km² area occurred in two phases along the lower catchments of the Madhmaheswar and Kaliganga rivers. The study area lies between 79°03' to 79°09'E longitudes and 30°35' to 30°35'N latitudes, in the Great Himalaya. The northern extent of the landslides is seen from the confluence with the Mandakini River up to Lenkh in the Madhmaheswar valley, and up to Khunnu (Kotma) in Kaliganga valley.

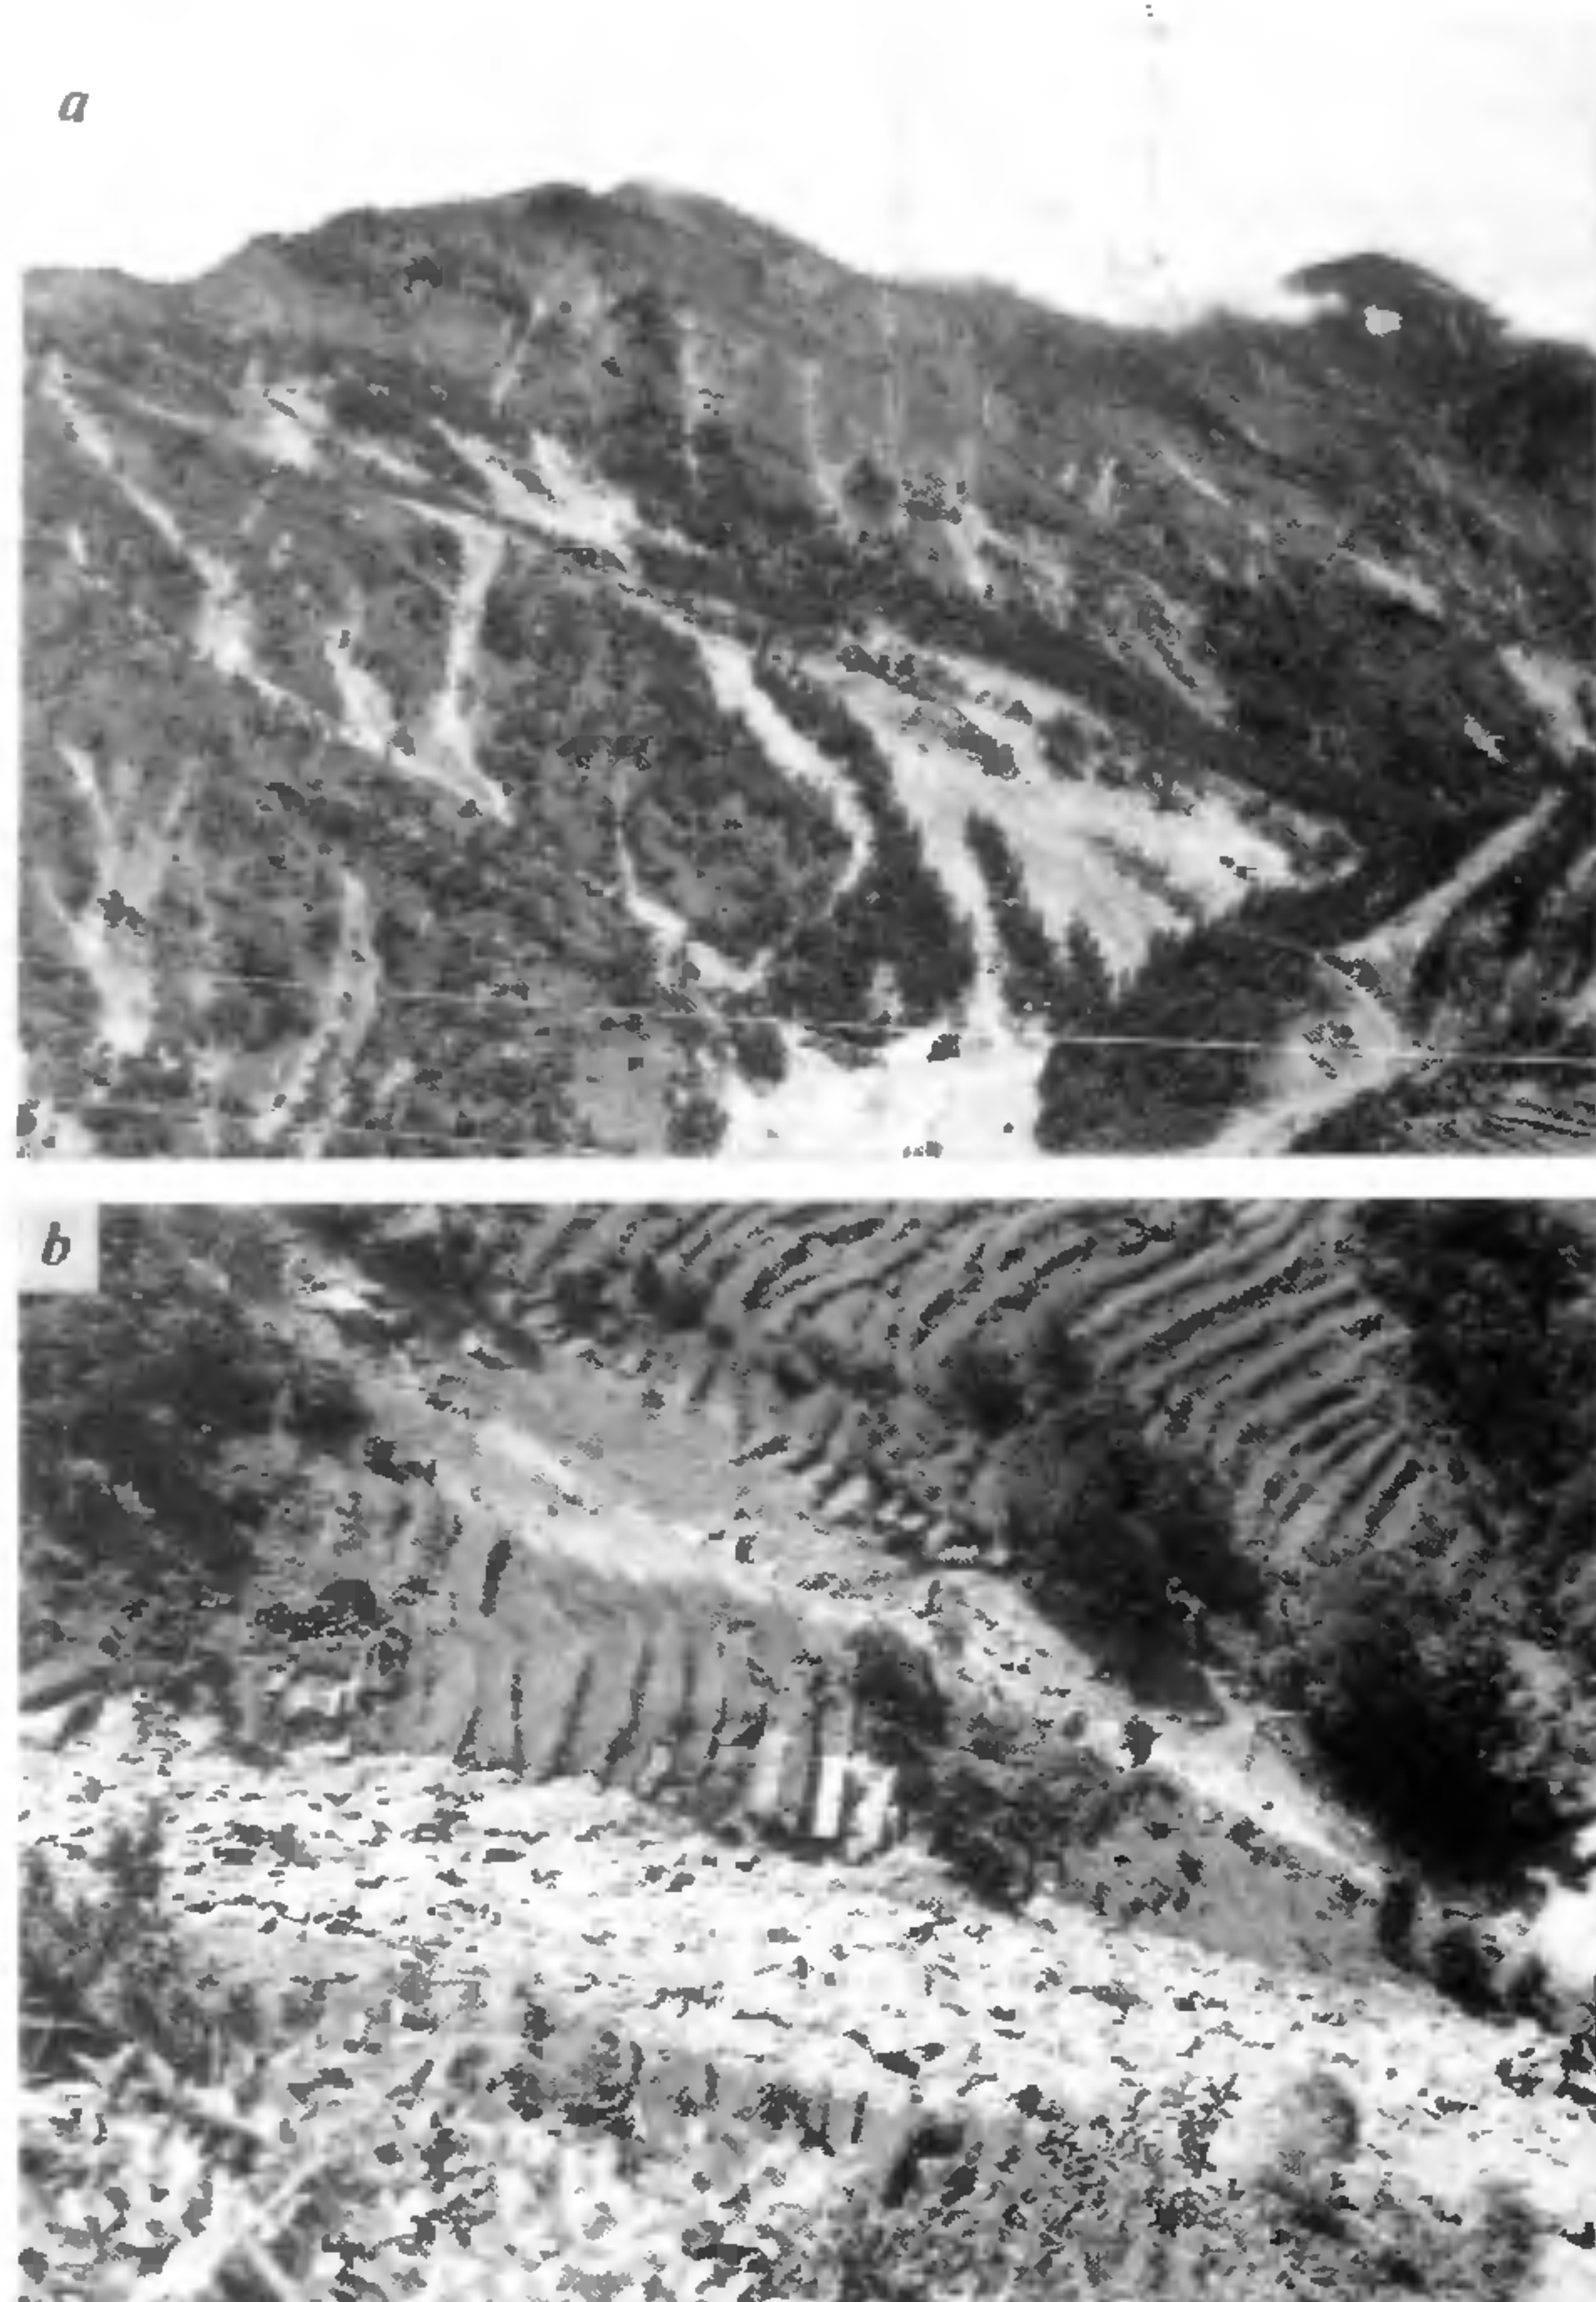
Figure 2. *a*, Translational slides along steep slopes in the lower reaches of the Kalsila Ridge; *b*, Massive debris flow which damaged agricultural fields and houses along a small tributary at Phapanj near Ukhimath.

The Kalsila ridge in Madmaheswar and Kaliganga valleys at the altitudes of 1800–2000 m was ravaged due to rotational slips and debris flow, while translational slides and wedge failure occurred on the right bank of the

Madmahewar river (Figure 2a). Along the Guptkashi–Kedarnath road, lunar cracks developed at many places near Guptkashi, causing 2–3 m subsidence. In the Madmaheswar valley, the Ukhimath–Mansuna road sank 10–40 cm and developed 10–150 m long lunar cracks.

west, caused the slope-failures leading to extensive mass movements. The interaction of two or more joint planes is marked with a wedge failure and translational slide. Slopes having small agricultural terraces (Figure 2b) with thin soil cover and characterized by two or more sets of joints were ravaged by translational slides. Debris flows were common along high-gradient tributary streams, the valleys of which are confined. In the case of most of debris-flows, minor rotational slips and translational slips blocked the channels and created minor blockades which later gave way, leading to draining out of the pools. It was evident that the zone which is mainly under human occupation on steep slopes was severely affected.

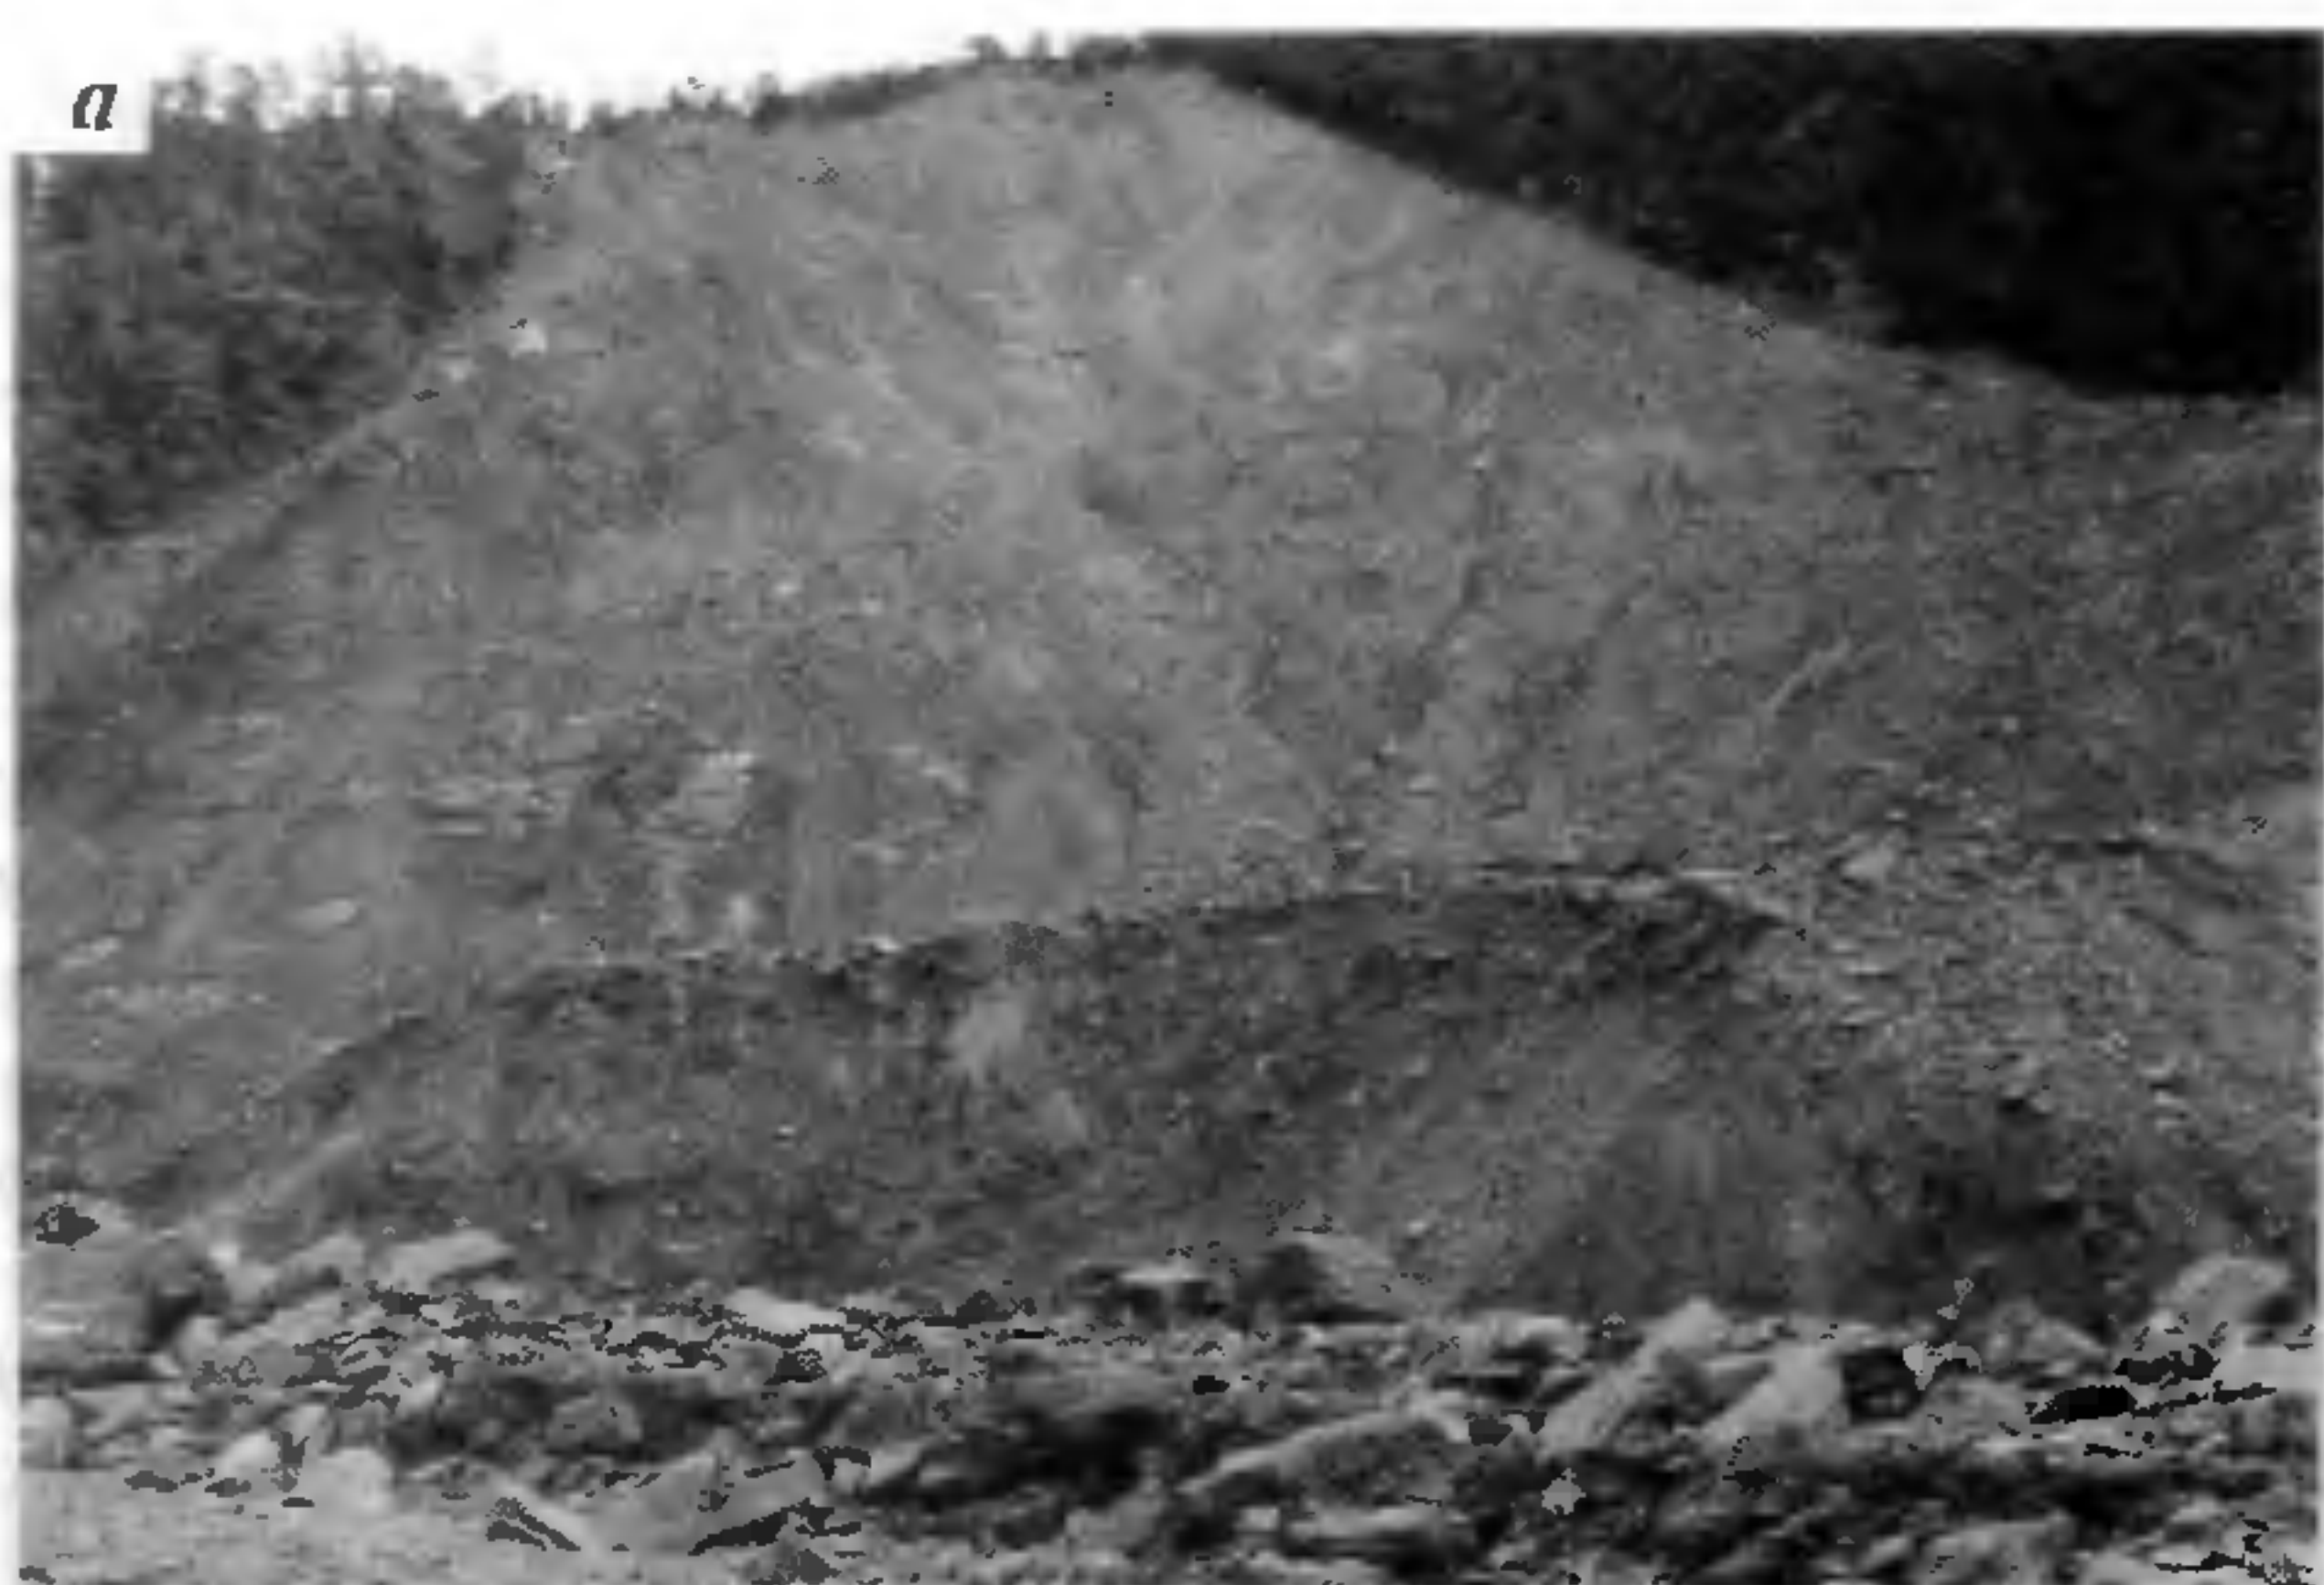
Figure 3 *a*. Panoramic view of the devastating Bhenti landslide near Burwa.

The rotational slips, generally triggered by high porewater pressure, are developed along deeper slip surfaces where thickness of the Quaternary regolith is 5–50 m or more⁶. At Bhenti (Figure 3a), north of Burwa, the depth of slide at its thickest and distal portion is 80–90 m, the average depth at basal rotation plane being 50–60 m. The slide moved at least 1100–1200 m along the left valley slope and rode up 150–200 m on the right bank slope of the river, covering the lower slope of Raun-Lenkh where Pundar (now buried under rubble) was situated⁷. The length and width of unconsolidated slid mass across the river is 160–200 m wide and 200 m long. The debris mass totally blocked the flow of the Madhmaheswar river from 2 a.m. to 2 p.m. on 19 August, thus creating 1000–1250 m long, 50–70 m wide and 25–30 m deep lake in the valley. This blockade was subsequently breached.

At Bhenti, the slide is about 660–680 m high and 550–600 m wide, covering a width of 700–800 m and the length of 665–700 m.

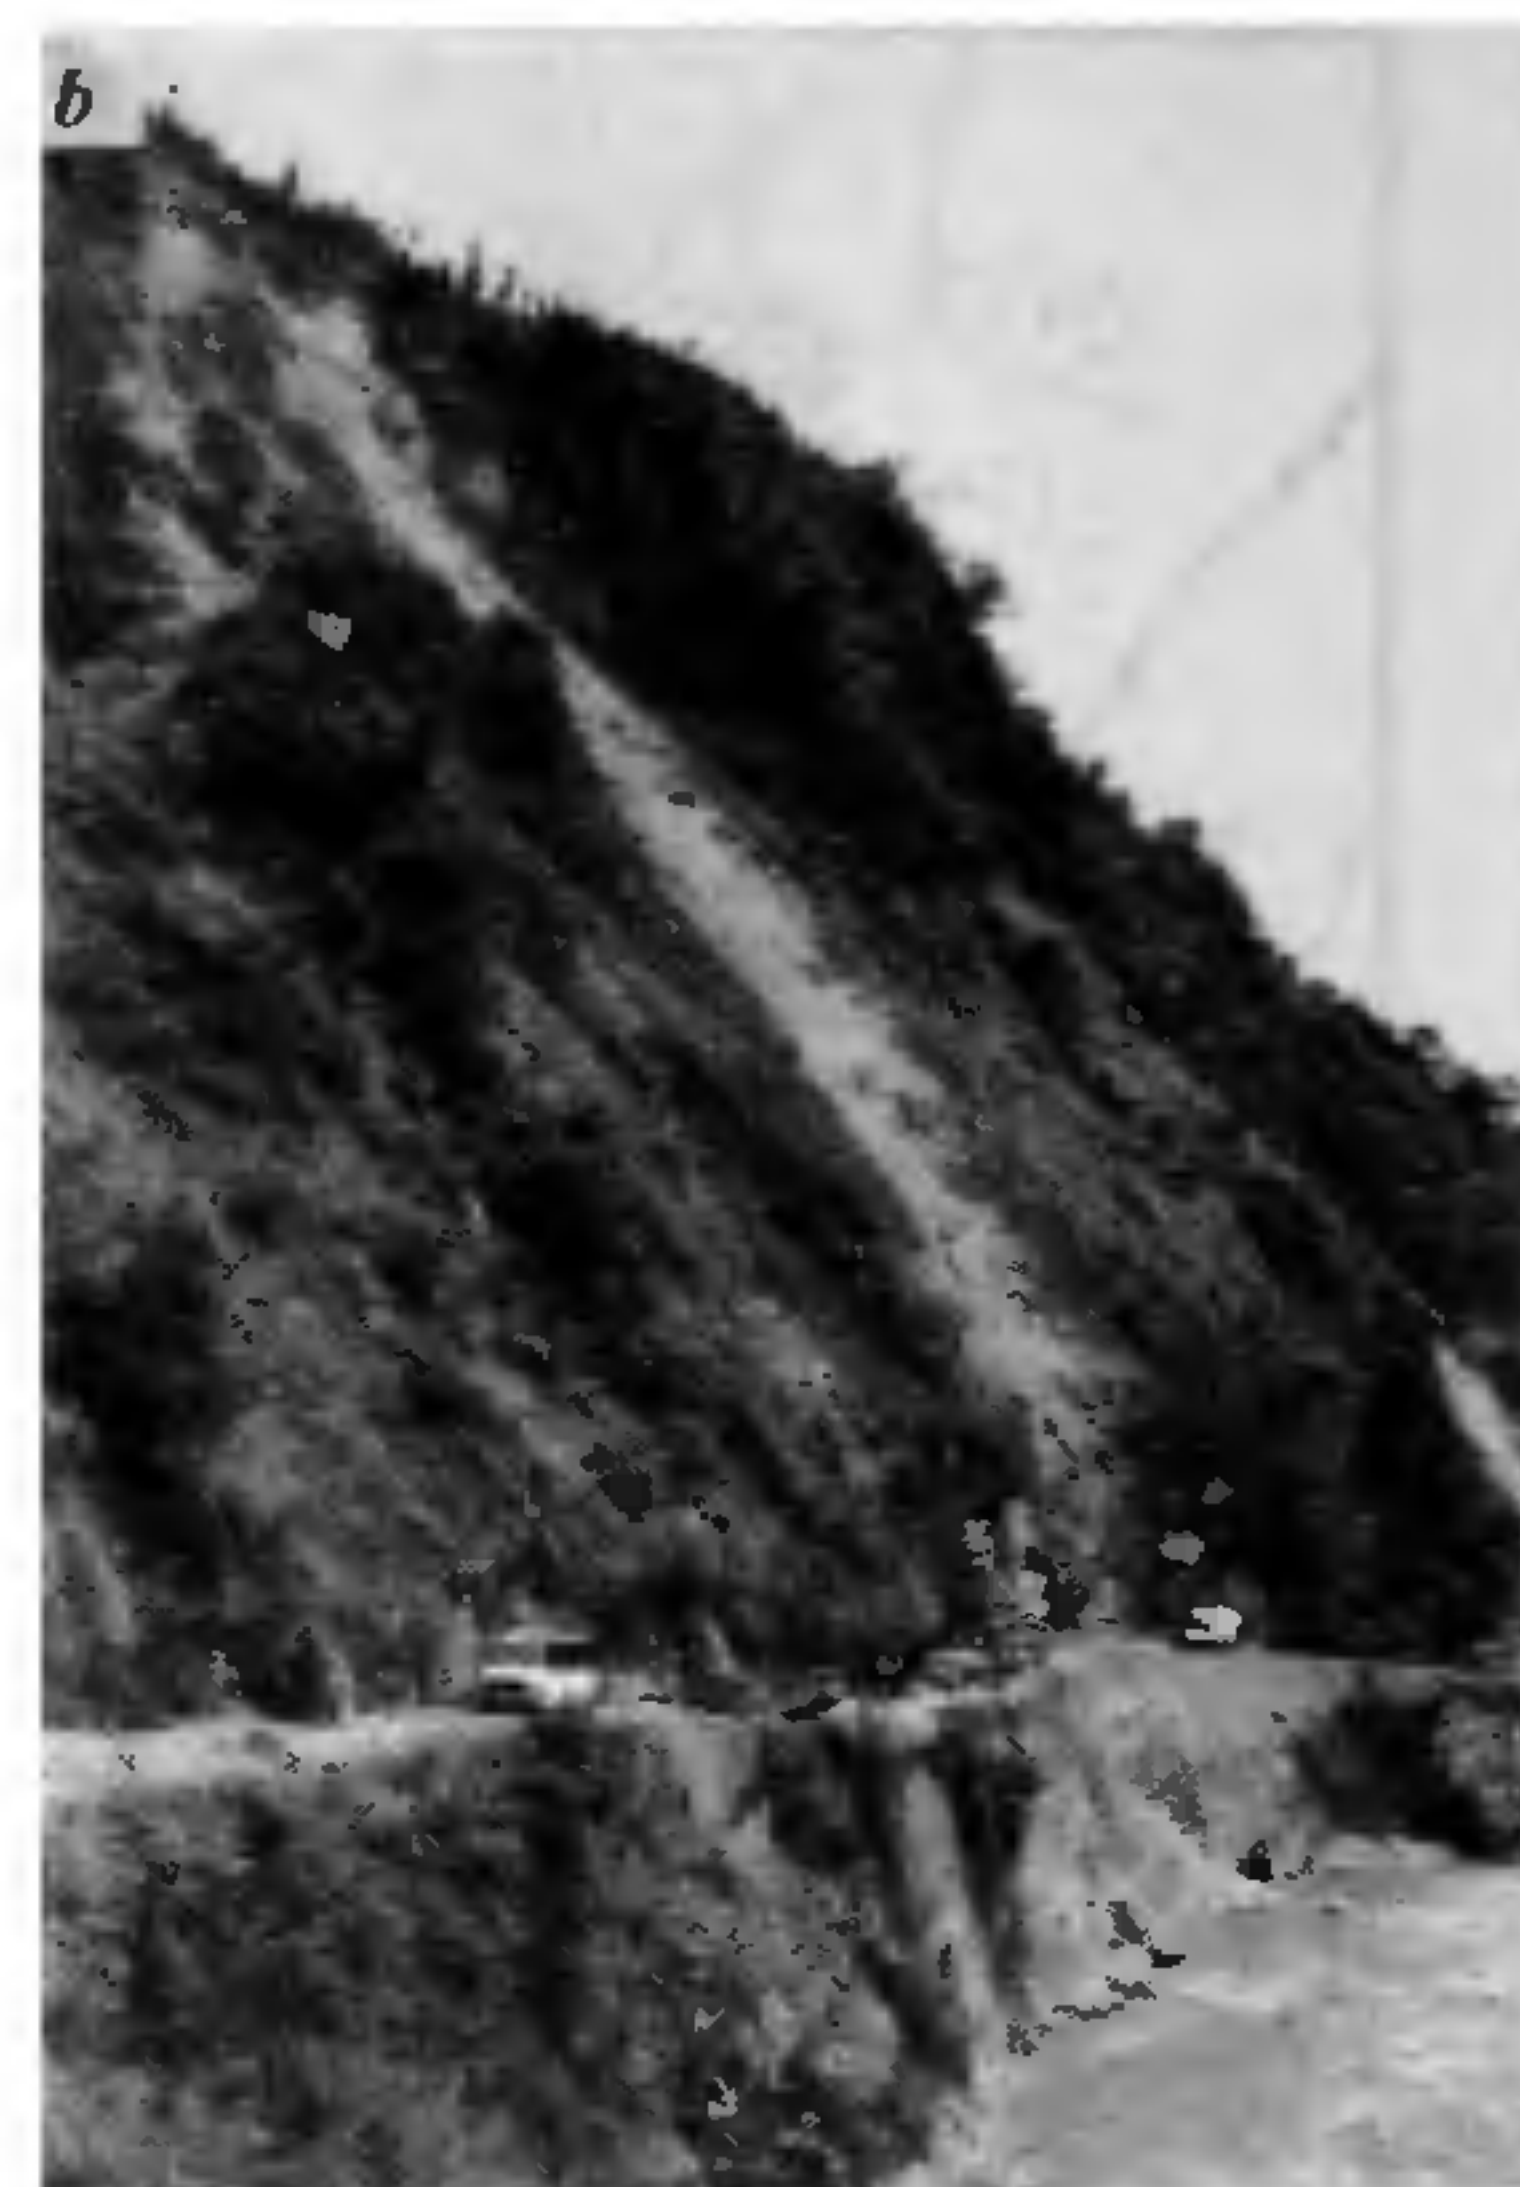
Figure 3 *b*. Rockfall and wedge failure due to deep weathering and opening up of joints at Banswara, south of Ukhimath.

The fractured and highly jointed nature of the bed rock (granite gneiss) in the MCT zone – especially the steeply-dipping southwesterly joints – and uncontrolled blasting for a new road are mainly responsible for rockfall and wedge-failure at Banswara (Figure 3b), south of Ukhimath. At Bhenti, uncontrolled blasting for construction of the Burwa–Jugasu–Raunlenkh road with its hair-pin bend near Burwa in the Vaikrita Thrust zone greatly weakened the stability of the hill slope. The infiltration of water from two seepage zones
