The 2001 Kutch (Bhuj) earthquake: Coseismic surface features and their significance

Kusala Rajendran^{*,#}, C. P. Rajendran^{*}, Mahesh Thakkar[†] and Martitia P. Tuttle[‡]

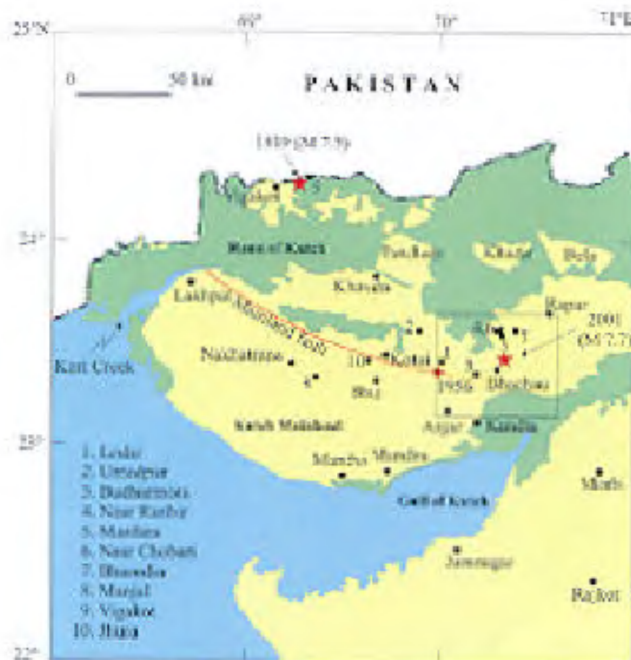
Figure 1. Map of the Kutch area showing the epicentre (USGS) of 2001 Bhuj earthquake. Locations of 1819 and 1956 earthquakes are also shown. Observations at sites 1 to 10 are discussed in the text. Square indicates the approximate extent of the aftershock zone based on the MAE center data.

Although the main fault rupture did not reach the surface, the epicentral area showed secondary structures characteristic of compressional tectonics. The earthquake also generated a variety of liquefaction-related features, including lateral spreading, sandblows and waterspouts. Most of the surface effects discussed in this paper are from within 50 km around Bhachau, but we also recorded several types of liquefaction features around Khavda, Allah Bund and further north, near the international border. Some of the sites of liquefaction are located in the marshy Rann and/or in the border zone, which are not easily accessible. Documentation of distant liquefaction features is incomplete at this stage. Liquefaction features and waterspouts (along ancient river channels) have also been reported from regions on the other side of the border and from Hyderabad in Pakistan. Thus, our report is by no means a complete documentation of what might have been generated during this earthquake. In the following part of this paper, we discuss some of the features we mapped, with their locations keyed to Figure 1.

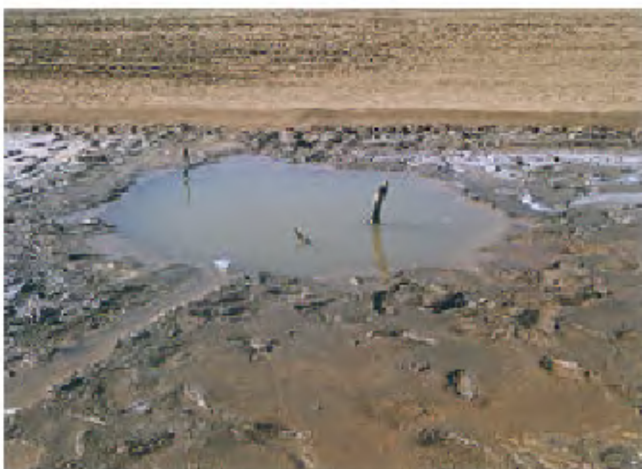
Figure 2. Wet crater (3 m wide) near Lodai, which continued to spout water for three weeks after the earthquake.

reconnaissance survey, we relied on the accounts of local residents and post-earthquake SPOT images to select specific sites for detailed observations. Some of the largest sandblows we observed occur near the village of Chobari and also at Lodai and Umedpur (Figure 1 for locations). Several craters at Lodai (site 1) and Umedpur (site 2) were spouting saline water at the time of inspection, three weeks after the earthquake. One of them is a 3-m wide crater at Lodai (Figure 2). The largest crater (10 m \times 5 m) that we mapped is at Umedpur, located about 50 km north-west of the epicentre. An apron of

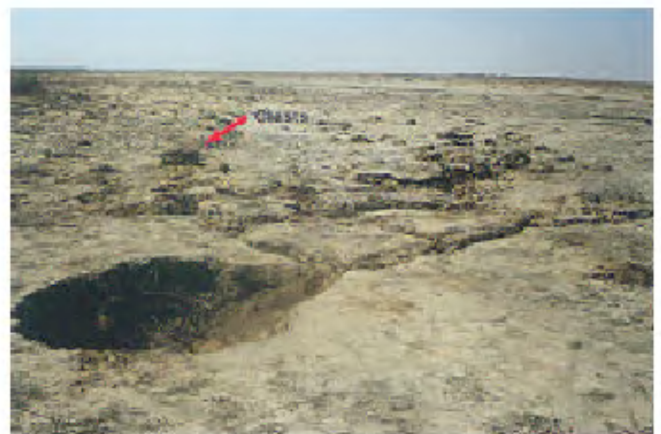
Figure 3. Dry hole at Umedpur formed by the release of gas. Note ground cracking and the presence of clasts ejected from the crater.

vented greyish sand, 33 m \times 32 m, is associated with this crater. We excavated a trench through the apron and found that the vented sand has a maximum thickness of 26 cm adjacent to the crater. Two dry craters, the largest of which was about 2 m across, also occur at this site (Figure 3). Large clasts ejected out of one of these craters are strewn over a zone extending about 30 m in a westerly direction. At the base of the eastern wall of this crater we found a deep hole and since it was dry we attribute its origin to release of gas. Cracking and localized subsidence of ground observed near the edges of this crater (Figure 3) are probably related to the release of gas. Although we found several 'dry blows' aligned along many of the fissures and cracks, none of them was as spectacular as the one at Umedpur.

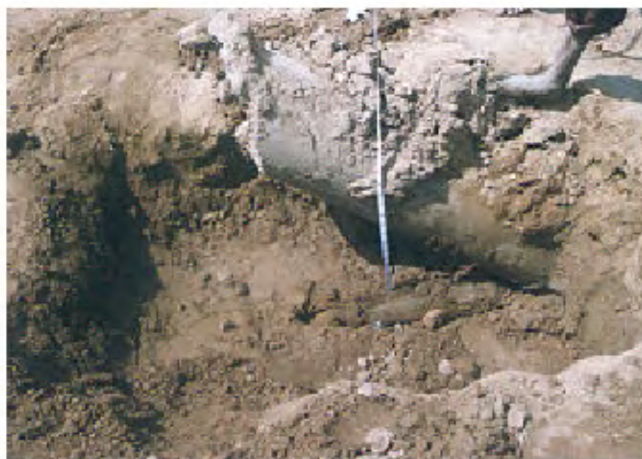
Figure 5. Horizontal shortening and vertical displacement (0.8 m each) of the irrigation pipe due to compression and bulging. Photograph taken from the toe bulge formed by the lateral spread shown in Figure 4 *b*.

irrigation pipe shows extensional movement of 1.3-m at the head of this deformation. The same pipe is displaced at the toe, causing vertical displacement and horizontal shortening of 0.8 m each (Figure 5).

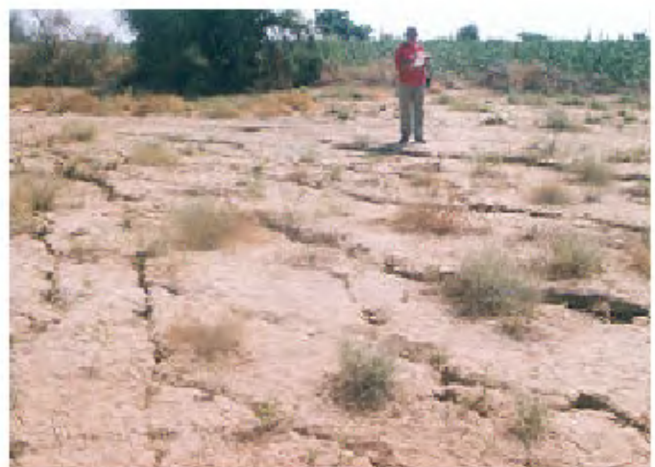
Figure 8. Parallel ground cracks near Manfara village forming a small graben with a maximum vertical offset of 15 cm (view from south). Note that the cracks within the down-thrown block show little or no vertical displacement.

At a location south of Manfara village (site 5), we observed a series of ground cracks oriented N 60° to 90°E, a few of them crossing the road to Manfara, forming a bulge in the tarmac. Some of the larger cracks extend to a distance of about 1 km and show vertical offsets

of 10–15 cm, the northern and southern sets showing motions in the opposite sense. On the largest and the most prominent ground crack that extends through the road, the south side is up by 10 cm, whereas a parallel crack located 100 m to the north in the same field, shows movement of about 15 cm on the northern block. The block within these two cracks is cut by several parallel fractures with little or no vertical displacement (Figure 8). Formed parallel to the trend of the main thrust, these cracks may be part of a graben-type extensional feature formed on the crest of the folded surface, as exemplified by some large earthquakes resulting from reverse-faulting¹⁹.

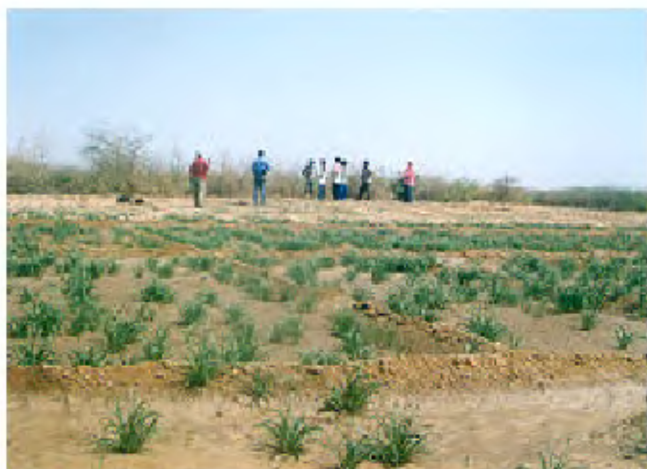
Figure 9. Arched portion of a field near Bharodia village showing an uplift of 80 cm. Note the drying of crops where people are standing.

A zone, about 80 m long and 10 m wide, in an agricultural field near Bharodia is elevated by about 80 cm and shows a gentle north-easterly dip. Crops in the arched portion of the field have dried due to the sudden change in the moisture content. Several ground cracks oriented in a NW direction have developed on the upwarped portion. We suspect this structure to be a monoclinial fold formed as a result of compression and deformation of the surface layers, but this suggestion needs to be substantiated with more field evidence.

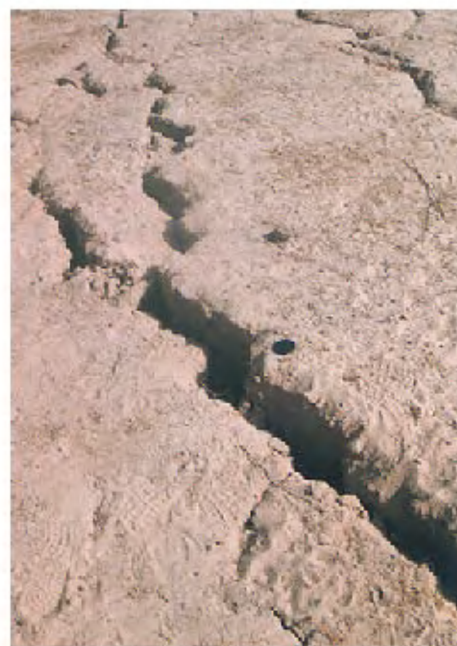
Figure 10. Right-lateral strike-slip fault with an oblique component observed near Manfara village. Several right-stepping en échelon cracks are noted to the right of the fault.

Seeber *et al.*²⁰ have reported a north-west striking fault at a location close to 23.46°N 70.38°E which they refer to as the Manfara fault. According to their preliminary report, this fault displays a right-lateral strike-slip motion with a maximum lateral displacement of 32 cm. They have described this as a ‘tear fault’ in the hanging wall block above the fault plane. We examined parts of this fault oriented N 10°E to N 20°W near Manfara village (close to site 5). The fault exhibits a horizontal offset of 16 cm, with a small oblique component and is characterized by a series of right-stepping en échelon fractures showing right-lateral movement (Figure 10). We noted several ‘dry blows’ (a few centimetres in diameter), but there were no signs of ejection of sand or water within the disturbed region. A similar fault, about 1 km long and striking

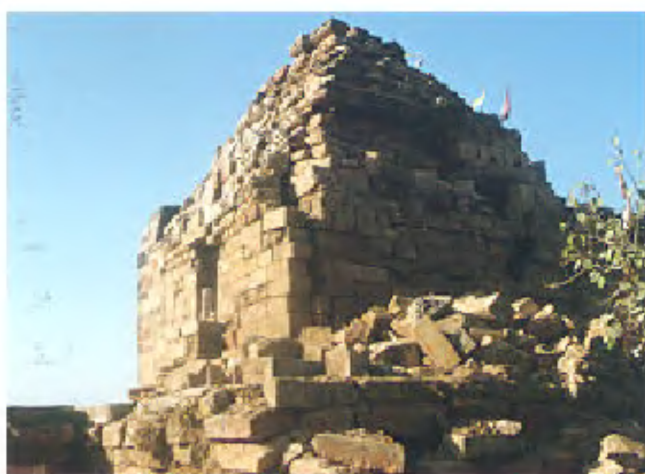
Figure 11. Damage at the Punvareshwar Temple at Manjal, built in 9th century AD.

The Bhuj earthquake destroyed several historical monuments in the region, dating back 9th century A.D. Among them are the Aina Mahal Palace (~200 years old), *Lakhpatri's Chhatardi* (A.D. 1752–1761) in the city of Bhuj and some of the old temples in its vicinity. The Sun Temple at Kotai (11th century A.D.) and the Punvareshwar Temple at Manjal (9th century A.D.) are among the oldest temples that were destroyed. While the *Chhatardi* collapsed completely, Aina Mahal Palace is still standing, with extensive damage. These structures seem to have survived the 1819 and 1956 earthquakes, but the ground shaking was apparently too severe during the recent earthquake. The damage to the two temples mentioned here is not severe; their main structures are intact. A view of the Punvareshwar Temple at Manjal is shown in Figure 11 (site 8). Although the damage is not severe, it is conceivable that the 2001 earthquake was the largest to have

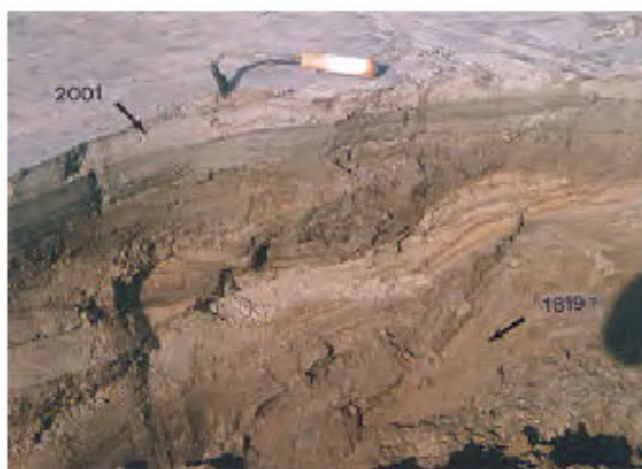
Figure 12. Two generations of sandblows exposed on the walls of a crater located northeast of Vigakot. The grayish sand forming the top layer is due to the recent earthquake and the yellowish sand below is due to an earlier earthquake, probably 1819. Note the vent of the yellowish, lower layer.

Figure 12 shows exposure from one of the cleaned crater walls near site 9. Freshly-ejected greyish sand layer (~ 10 cm) exposed on the ground is interpreted as a 2001 sandblow deposit. Below this fresh layer of sediment and separated by a thin layer of clay occurs a layer of yellowish sand that we interpret as an older sandblow. We could trace its feeder dike to the base of the crater (Figure 12). Similar features, possibly related to three episodes of liquefaction occur in a few other trenches in the area. We have not dated any samples or made detailed trench logs, nor have we examined the sedimentary characteristics of various sand layers. More systematic study of these features will be required to further constrain the ages of these events. However, based on the historic documentation of the liquefaction events in the area and the nature of exposures from numerous trenches excavated near Vigakot⁵, we attribute the second layer to the liquefaction related to the 1819 earthquake.

Maximum thickness of the recently-ejected sand near site 9 is about 15 cm, whereas the thickness of earlier sand ejection is more than 30 cm. It appears that liquefaction was more severe at this site during the 1819 event, which was located closer to this site than the Bhuj earthquake. Whether the thickness of the sandblows can be correlated with the distance to the source (of similar size earthquakes) is something that needs to be assessed. Extensive search and systematic studies will be required to characterize these features.

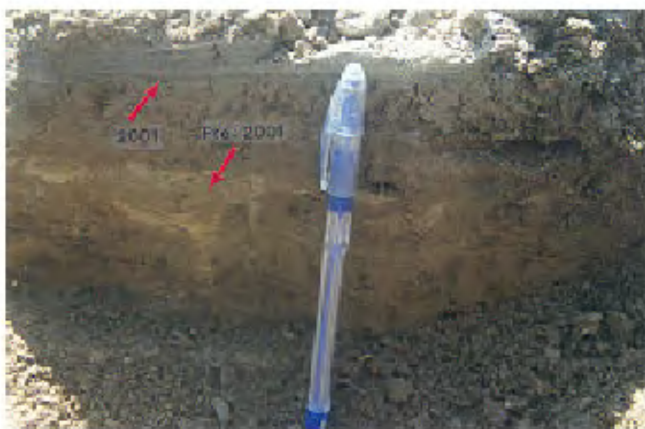
Figure 13. Two generations of sandblows exposed in a shallow trench near Umedpur. The laminated top layer of greyish sand was ejected during the recent earthquake. The features below, including a sand vent represent an earlier event.

In an excavation of the 2001 sand blow at the Umedpur site mentioned above, we found a thin older layer of sand and possible feeder dikes that may be related to an earlier earthquake (Figure 13). Additional study is needed to determine whether or not these features are related to earthquake-induced liquefaction and if so, whether they were formed in response to the 1956 Anjar or 1819 Kutch, or any other historic earthquake in the region.

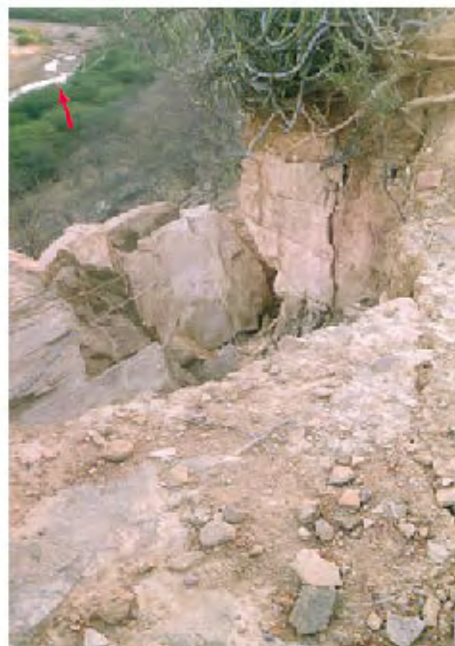
Figure 14. Slumping of the hillside along the southern face of the Jhura Hills. Part of the fracture can be seen on the right-hand side. Liquefaction of the riverbed (spouting of saline water) can be seen in the left-hand top corner, indicated by an arrow.

mainland fault, the recent earthquake is unlikely to be related to this structure for various reasons. One, there are no indications of any visible movement on this fault which is well exposed. The best illustration for the lack of movement along this fault comes from an exposure in the Jhura Hills; a domal structure presumably formed due to the magmatic upwelling in the early Cretaceous and is considered as an expression of the mainland fault²⁵. We observed a linear fracture running parallel to the southern edge of the Jhura Hills (site 10). Slumping has taken place along the down-slope side of the cliff (Figure 14), where no apparent displacement on the fault has taken place. Two, the earthquake originated at a focal depth of 22 km (USGS) on a fault dipping 40–50°S (Arch Johnston, pers. commun.), with its epicentre located north of the mainland fault. Based on the above observations we infer that the Kutch mainland fault could not be the source of the earthquake. From the severity of damage and pattern of deformation it appears that the blind thrust that generated this earthquake occurs north of Bhachau, probably closer to Bharodia. Imbricate faults within a rift may have the potential to be reactivated and one such hidden fault located north of the Kutch mainland fault appears to have produced the recent earthquake. Seismic threat from blind thrusts has been recognized for a while and mapping hidden faults is part of the agenda for better seismic hazard assessment²⁶. Mapping of such faults in the Kutch–Saurashtra region and assessing their seismic potential may remain one of our long-term goals, but efforts towards that direction must start now.
