Application of lichenometry to slided materials in the Higher Himalayan landslide zone

The lichen-based study involving the measurement of per cent cover of lichens on slided materials in the Pawari landslide zone located in the Higher Himalaya is described. This has been correlated with the indicators showing movement of deposits and activity of the slide. It is well documented that in a slided mass, boulders containing more lichen cover are stable in the present climatic scenario or have moved least compared to the ones showing lesser lichen cover. Slopes covered with more or less fresh rock boulders and pebbles in the slide zone indicate an active part within the slided mass. This study can be used as an indirect method to assess the differential movement of slope within the slide mass.

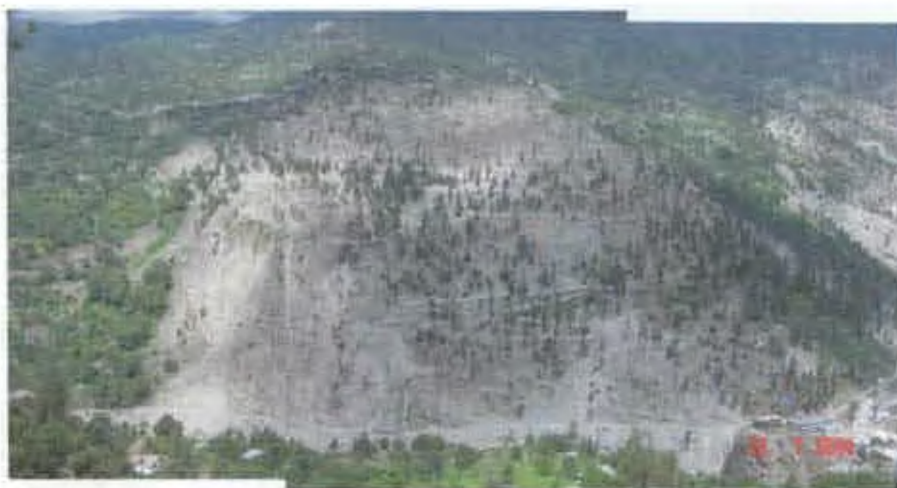
Figure 2. Panoramic view of Pawari landslide. Six road cuts were made on a single slope to connect the National Highway-22 passing through the bottom of the slope with the village Pio situated at an altitude of 2700 m amsl (crown of the slide).

The Pawari landslide measures about 1200 m in length and 700 m in width, affecting about 1600 m of National Highway-22 (NH-22) passing through the toe portion of the slide (Figure 2). Six boreholes through the slide mass dug by the Central Road Research Institute (CRRI)¹³ New Delhi,

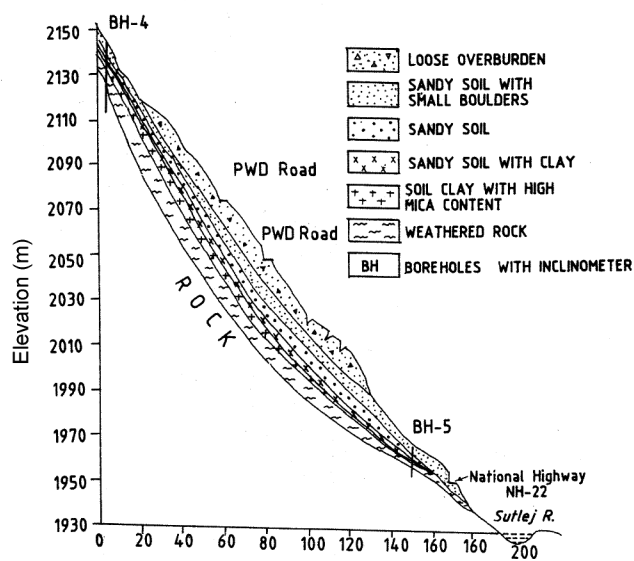
Figure 4. Cross-section across the Pawari landslide based on field observations and borehole details (adapted from O. P. Yadav¹³).

confirmed that the maximum depth of this slide is about 25 m (Figures 3 and 4). It is one of the largest landslides located in the Satluj valley. It is a typical example of a complex slide, which represents a combination of debris slide in the upper part, subsidence in the middle slope and debris slide at the toe. Six hairpin bend road cuts were made on a single slope to connect the NH-22 passing through the toe region of the slope with the village Pio, district headquarters of Kinnaur, located at an altitude of 2700 m amsl, in the middle portion of slope. Activity in the slide zone has increased due to road-cutting in 1975. The slide has been studied for its causative factors by many workers (V. Gupta, unpublished)^{13,14}. It has also been monitored by CRRI¹³ for 489 days during 1992–94. Two inclinometers were installed at two different locations, one at the bottom of the slide near NH-22 and other in the middle of the slope (Figure 4). The average rate of movement for uphill and downhill slopes recorded during 1992–94 was 0.23 and 0.56 m/yr, respectively. Each year several cubic metres of materials find their way into the river, thus creating a nickpoint in the river Satluj¹⁵ which flows at the base of the hill.

The exact date of the initiation of this slide is not known. However, the slide gets activated every year immediately during or after the rains or snow melt. The inclination of the failure plane of the slide varies between 60 and 70° due east (Figure 4).

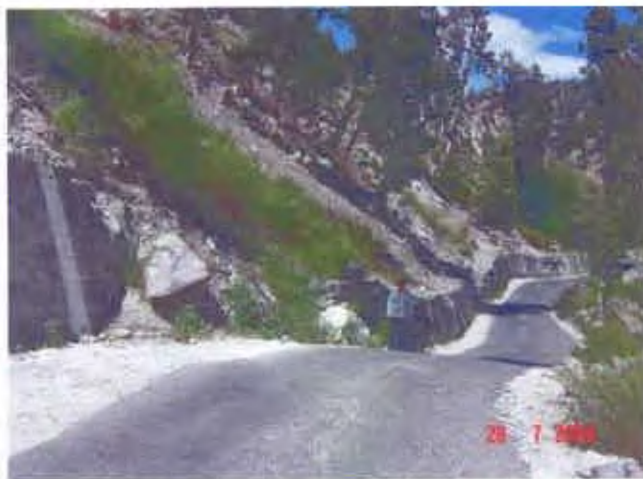
Figure 6. An offset of about 3 m in the retaining wall in zone I. Widespread damage to the wall and subsidence in the road indicate movement in zone I of the Pawari landslide.

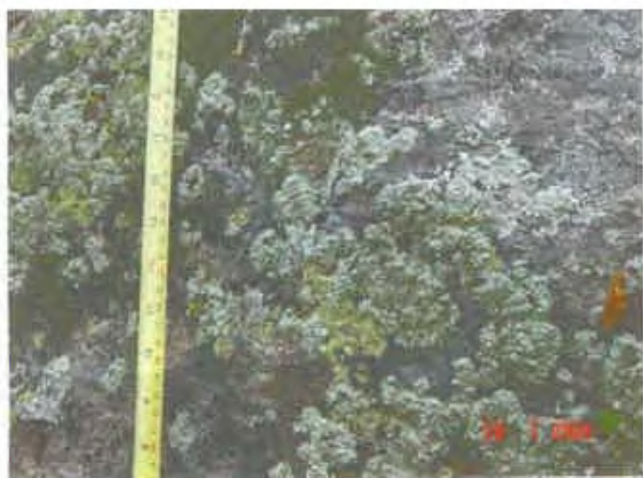
Figure 7. A boulder lying loose on slopes in zone II of the Pawari landslide containing lichen coverage of about 70%. These slopes are stable in the present-day climatic scenario, as no movement indicator has been noticed.

with lichens. The dominant lichen coverage on the easterly facing rocks and boulders is about 70% (Figure 5). On most of the surfaces of the boulders, lichens coalesce to a diameter as much as 50 cm (Figure 7). This is the most stable part of the slide in the present climatic regime. No distress and slumping or subsidence of roads in this zone has been noticed. Also from the documented unpublished reports and eyewitness accounts, this zone appears to be stabilized and no activity has been reported here during the last 10 years.
