Soil and plant nutrient loss during the recent floods in North Karnataka: Implications and ameliorative measures

A. Natarajan*, Rajendra Hegde, L. G. K. Naidu, A. Raizada, R. N. Adhikari, S. L. Patil, K. Rajan and Dipak Sarkar

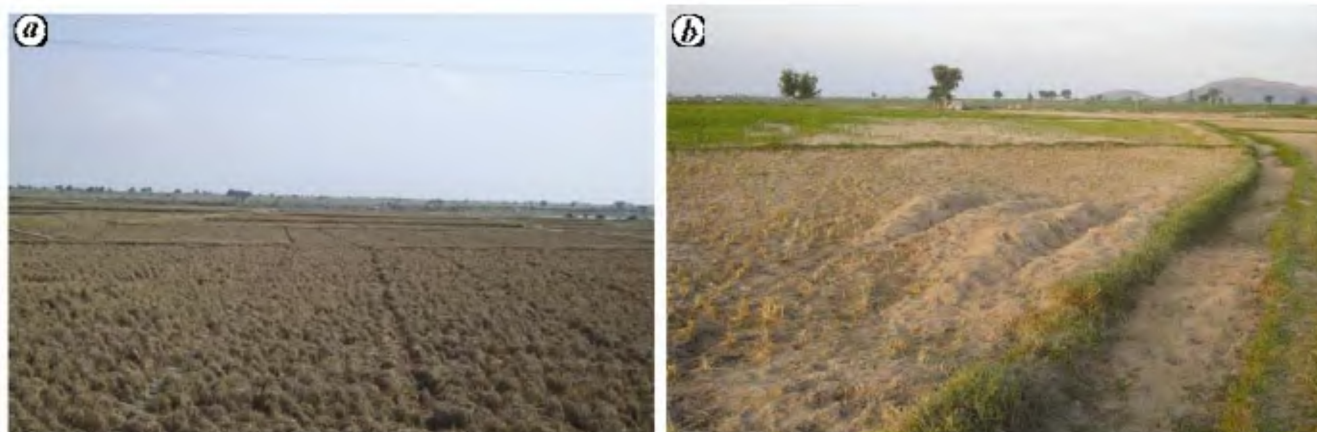
the standing crops and siltation of fields along their water courses (Figure 2). Standing crops in nearly 22 lakh ha of area were affected by the heavy downpour and floods. Crop damage was mainly due to waterlogging, lodging and high incidence of disease. But, more than the damage caused by the floods in the downstream areas, maximum damage in the form of severe loss of soil (Figure 3 a–d), soil organic matter and soil nutrients was caused by the heavy downpour in the catchment areas of all the 13 districts in the state.

Figure 2. *a*, Damaged paddy crop due to waterlogging near Albanur village, Sindhanur taluk, Raichur District. *b*, Sand deposition in cultivated fields after the breach of bunds along the Hagari river, Bellary District.

Sand (fine and coarse) has been deposited in agricultural fields adjoining the river banks only in a few locations, particularly along the Hagari River, Garchi Vanka stream in Bellary District, Sindhnur Nadi and Maski Nadi in Raichur district, Dhoni River in Bijapur District and Malaprapha River in Bagalkot District (Figure 3 *b* and *c*). The depth of sand deposition varied from place to place. In many places, deposition was limited to a depth of 10–15 cm. Only in a few places the deposition was up to more than 1–2 m high. The distance of siltation varied from 50 to 200 m from the river course. Only in a few locations, like in Dhoni River near Belvad village, was siltation spread over more area along the river course. Sedimentation was observed mostly in those locations where the river course is meandering and has breached the banks.

The deposition, comprising mostly of sand and some amount of silt, has caused damage to the standing crops like paddy. In the long run it is beneficial to crop growth. This is because of the heavy clayey texture of the soil present in the area, particularly along the river course. Actually mixing of some amount of sand in this type of clayey-textured soil improves permeability, aeration, aggregation and nutrient availability¹¹. These soils already suffer from severe salinity, particularly in the Tungabhadra command areas. Addition of sand to a

1. Construction of field bunds wherever it has been breached with adequate provision for free drainage.
2. Repair of breached field bunds.
3. Removal of excess sand (if > 10 cm depth) and spreading it out in the field evenly.
4. Deep ploughing to mix the sand and silt with the clayey soil.

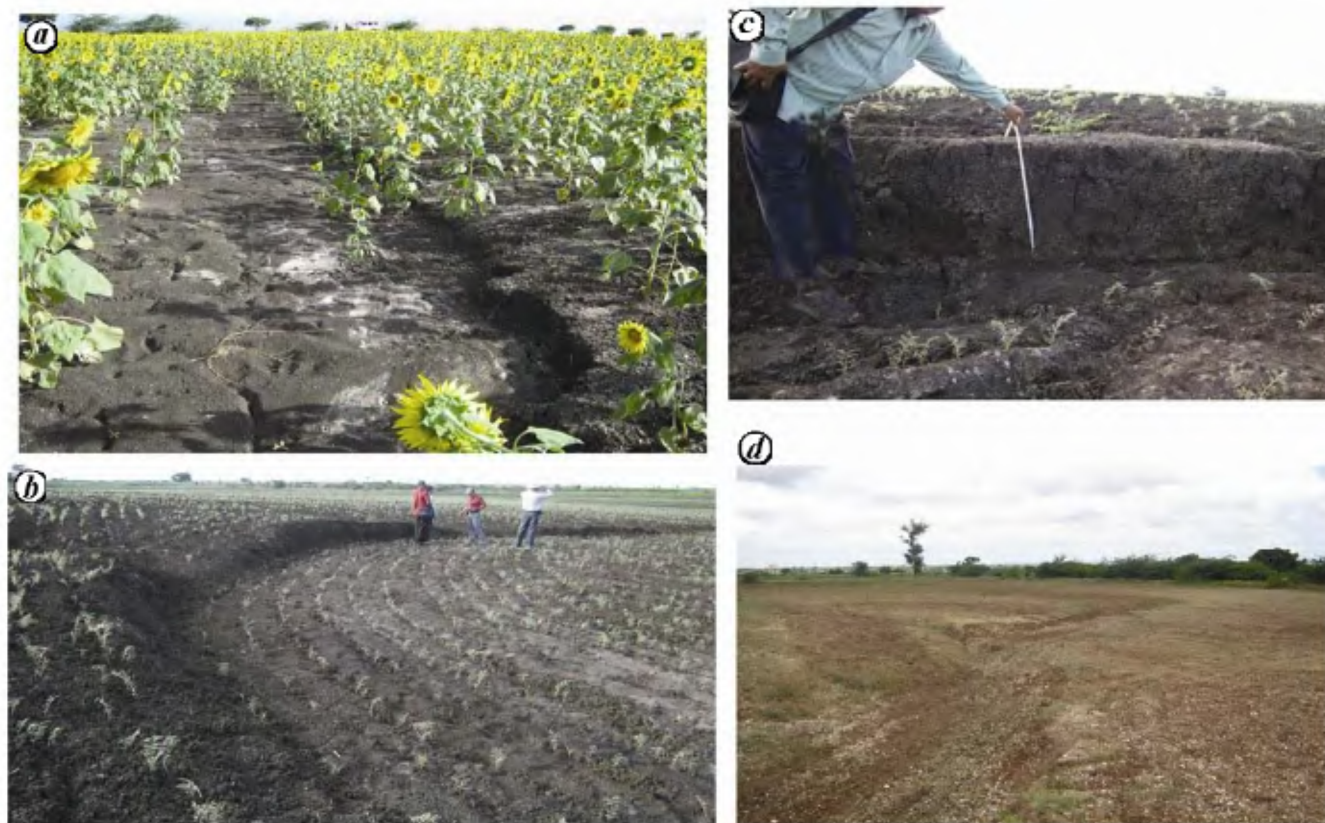
Figure 3. *a*, Sunflower plot affected with rill erosion in black soils near Kalmali village, Raichur District. *b*, Deep gullies in black soils in Kalmali village. *c*, Depth of severe gully (60 cm) in cultivated fields in Kalmali village. *d*, Erosion in red soils near Somnal village, Talikotta taluk, Bijapur District.

During the flood period nearly Rs 1625 crores worth of total soil nutrients were lost (Tables 2 and 3, and Figure 3 a–c). The losses were maximum in Gulbarga, Belgaum and Bijapur districts. Nearly Rs 888 crores worth of phosphorus, Rs 464 crores of micronutrients, Rs 161 crores of nitrogen and Rs 110 crores of potassium were lost during the flood period. The extent of loss of phosphorus was high as these soils are very rich in this nutrient element. Totally 8.17 lakh tonnes of soil nutrients were washed away. For restoring reasonable levels of crop yields, additional application of plant nutrients than the normal recommendation is now required. The essential role of these nutrients in maintaining crop productivity, particularly in rainfed areas needs no emphasis. In a short period of five days, the amount of nutrients equivalent to that normally applied over a period of one and half

districts only indicates the inadequacy or lack of proper soil and water conservation measures adopted in this region in the past. The deep and wide gullies seen in many fields, caused by the recent floods need to be plugged and whatever soil is left needs to be conserved before the start of the next kharif season. If this is not done, then cultivating the fields will become difficult in the subsequent season. Further, this will expose the ploughed soil to more severe erosion during summer and monsoon rains.
