1 Use of poulticing in desalination of masonry units – implications on salt 2 deteriorated structures

7 8 **Abstract**

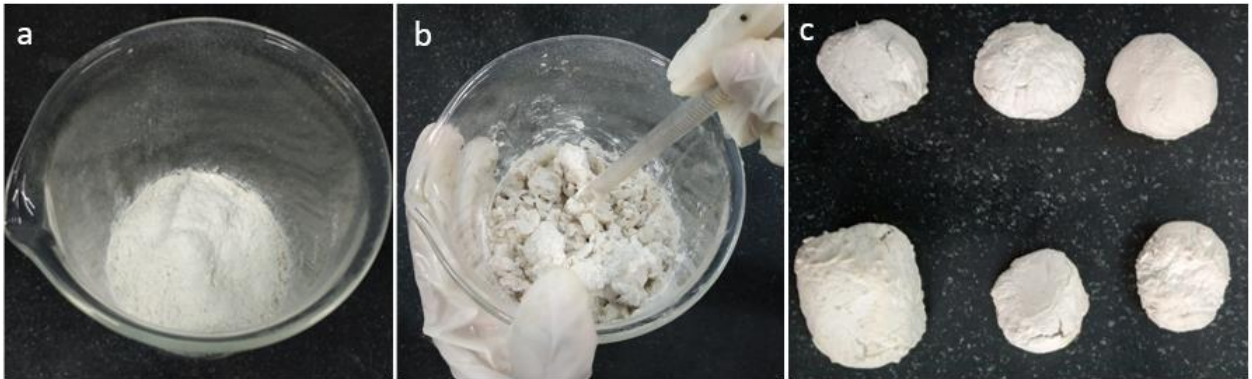
494 Figure 1. Steps followed in the process of poulting (a) cellulose powder in the dry form (b)
495 mixing of cellulose powder with water to prepare the poultrice (c) samples covered with the
496 cellulose poultrice left for drying

148 determined at 24 hours on a separate set of specimens with application of poultice on a single
149 face and was found to vary from 3 to 4 cm. The specimens were conditioned by drying at 40 C
150 until reaching constant mass and then cooling to room temperature before applying the
151 poultice. The moisture penetration was measured using a vernier callipers from the wet depth
152 from surface at mid-length on breaking each sample into two. The maximum drying shrinkage
153 of the poultice was measured as 5%. The poultice was removed on complete drying. The
154 specimens were then washed in water and dried to get desalinated specimens which were later
155 analyzed with microstructural characterization techniques. The process of preparation and
156 application of cellulose poultice on specimens was as shown in Figure 1. The cellulose powder
157 as such is shown, followed by the mixing of cellulose powder with water to form the pulp

158 (poultice) and then the samples covered by the prepared poultice.

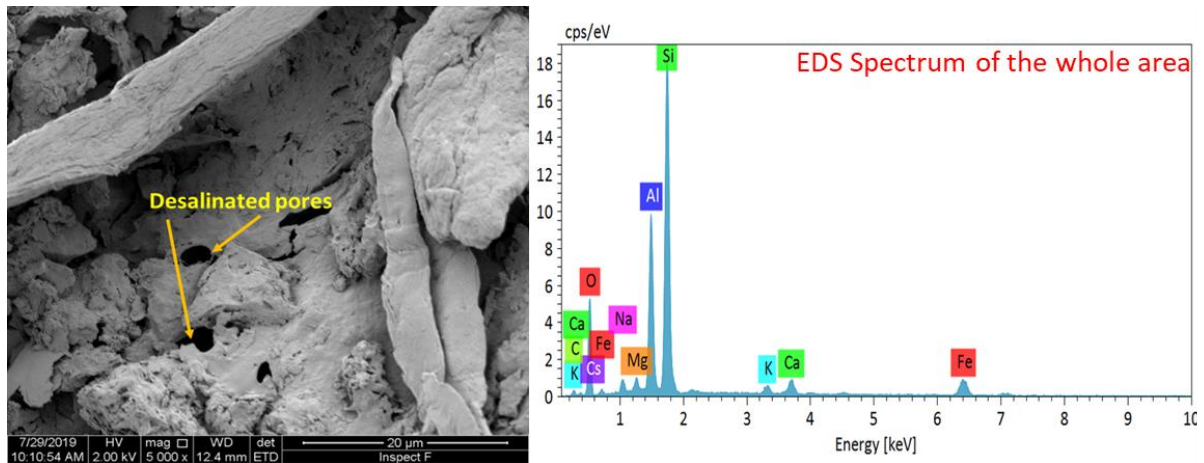
(a) Surface of a weathered uncoated HP sample showing NaCl crystals

(b) Surface of the sample after desalination showing pores opened-up, with the EDS spectrum

501 Figure 3. Surface of weathered (with NaCl) uncoated HP sample before and after desalination
 502

196 efficiency of cellulose poulticing in removing the sodium sulphate salts from the bricks. EDS
197 spectrum was collected at the open pore observed in the SEM image in Figure 2 and is shown
198 adjacently. It is seen that sulphur was not shown in the spectrum, which is indicative of the
199 absence of sodium sulphate in the pores. The poulticing was also applied in samples subjected
200 to NaCl weathering. Figure 3 shows the surface of a weathered sample (HP) with NaCl
201 exposure, before and after desalination. EDS spectrum of the whole area of the SEM image in
202 Figure 3b also shows the absence of NaCl in the surface from the mineral composition. The
203 weathered surface before desalination (Figure 3 a) clearly exhibited larger NaCl crystals,
204 almost completely covering the exposed area. The image of the sample surface after
205 desalination showed that the NaCl crystals were completely removed from the surface, and in

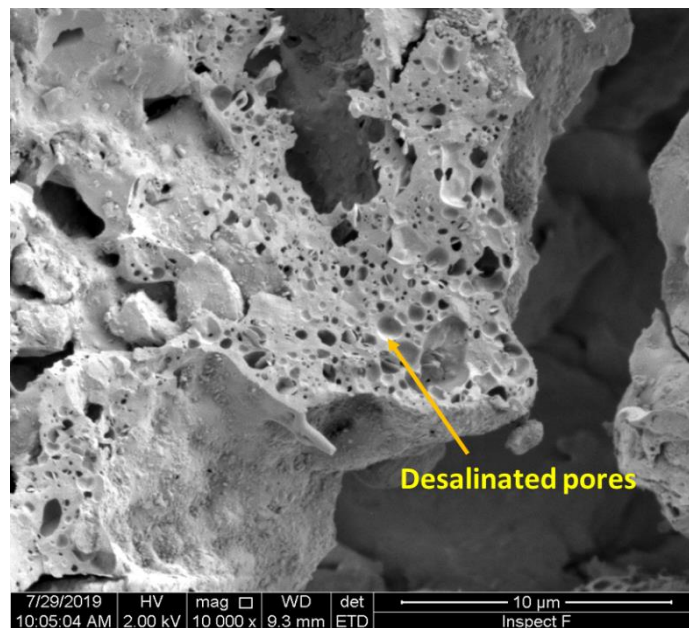
(a) Interior of the desalinated sample showing micropores

(b) Magnified view of 'A' marked in the previous figure

Figure 4. Interior of weathered (with NaCl) uncoated LP sample after desalination

206 addition, new small pores were opened up from which salts would have possibly been removed.
207 Figure 4 shows SEM images taken on desalinated samples collected 3-5 mm deep from the
208 surface of a weathered uncoated LP sample (with NaCl). The large group of micropores
209 observed shows that NaCl could deposit in pores of such small sizes, and poulticing could
210 remove NaCl salts even from these small pores. However, SEM images are insufficient to
211 quantify the efficiency of salt removal fully.

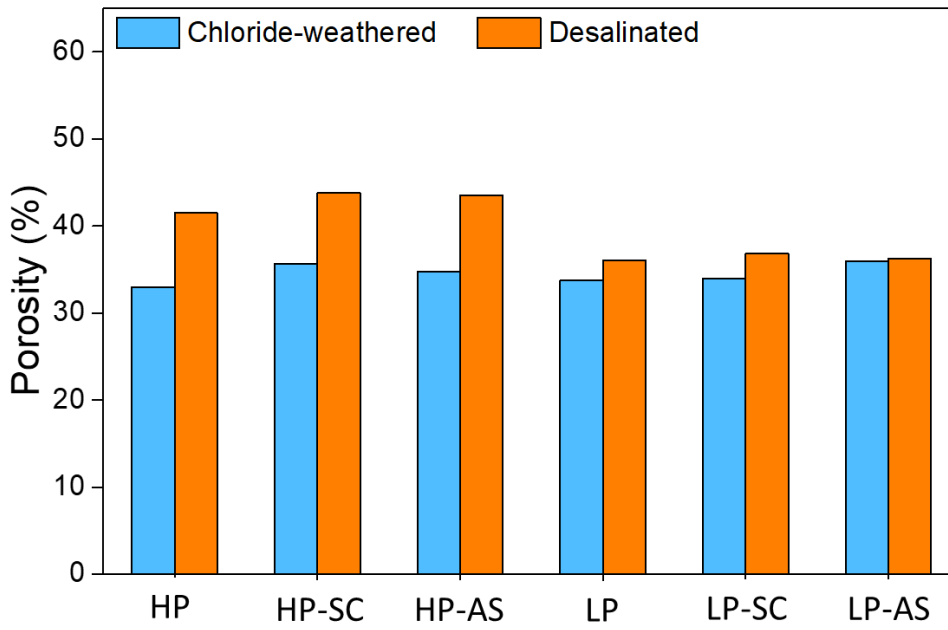
506 Figure 6. Comparison of total porosity values before and after desalination on (a) Samples
507 weathered with sodium sulphate (b) Samples weathered with sodium chloride

245 after desalination in HP, HP-SC and HP-AS samples as seen from Figure 5 (a). LP, with its
246 inherent micropores and newly formed micro-fissures on weathering, facilitated easy
247 crystallization and precipitation of sodium sulphate salts, which were then removed on
248 desalination. Whereas, the difference between total porosities before and after desalination in
249 case of chloride affected samples are much higher (Figure 5 b). This is because NaCl salt does
250 not face phase transitions, but gets precipitated and deposited on evaporation. Hence, a
251 remarkable number of macropores in HP would get filled with NaCl salts. The accumulated
252 NaCl salts from HP were then removed on desalination resulting in an increase of up to 13%
253 total porosity.

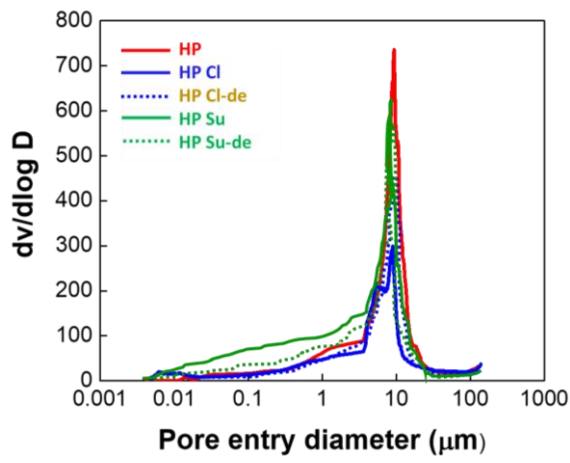
514 Figure 7. Differential Intrusion Curves of samples at different conditions (a) For the high

515 porosity brick sample HP (b) For the low porosity brick sample LP

261 Figure 7 shows the differential intrusion curves for the samples at different conditions
262 using the corresponding data derived from MIP test. The peak of each differential intrusion
263 curve represents the critical pore size of the sample, which is the pore diameter corresponding
264 to the maximum mercury intrusion, or it is similar to the most common pore size in the material.
265 Figure 7 a shows the differential intrusion curves for the high porosity brick HP, where the
266 nomenclature for reading the plots is as follows: HP is the curve corresponding to unweathered
267 form of the HP sample, HP Cl is that for HP weathered with chloride salt, HP Cl-de is the
268 desalinated form of HP Cl. This follows similarly for the low porosity brick LP also, in Figure

269 7 b. The upward shift of curves in the pre-peak region denotes the salt deposition in the pores
270 of that regime. The reversal of this upward shift denotes the removal of salts from those pores.
271 It can be seen from Figure 7 a that the critical pore size does not significantly change in the
272 highly porous brick HP, before and after weathering or desalination. This is because of the
273 inherent high salt weathering resistance of the HP brick due to larger pores in which salt
274 damage is minimum. The salt deposition in the case of HP is evident with chloride and sulphate
275 salts inside the pores, along with the effective removal of those salts (dotted lines), because of
276 the ease of removal from the large pores. In the case of LP, the salt deposition is higher for
277 sodium chloride (which can be seen from the larger area under the curve prior to peak);
278 however, the corresponding salt removal is not very significant, because of the failure of
