On materials science aspects of impact of cannon ball on the stability of the Delhi Iron Pillar

R. Balasubramaniam

Department of Materials and Metallurgical Engineering, Indian Institute of Technology, Kanpur 208 016, India

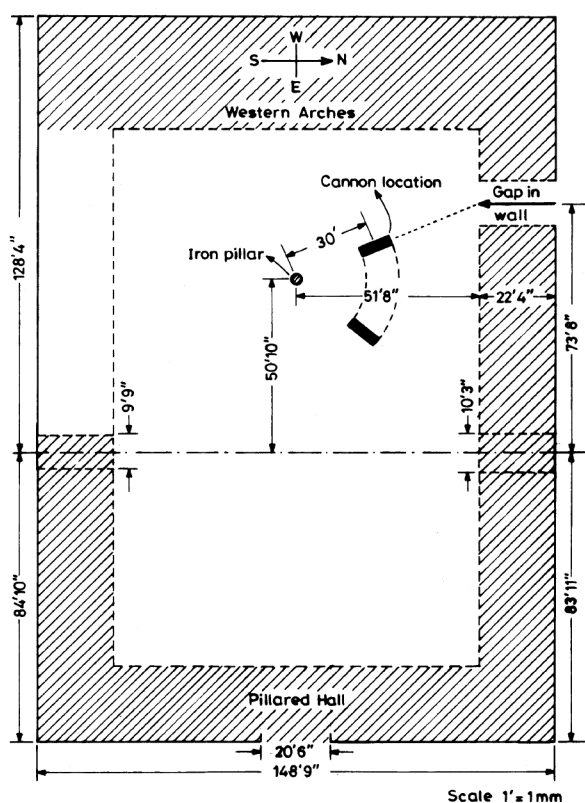
Some aspects of the cannon ball strike have been earlier addressed briefly by Prasad and Ray¹². They concluded that the strike was intentional and that an expert artillery directed the cannon fire. They proposed that the well-placed cannon did not try a second shot because the deflected cannon ball damaged something else in the vicinity. The possible damage caused to the structures has been analysed in greater detail elsewhere¹⁶. The location of the cannon that fired the shot can be determined from the trajectory of the cannon ball and location of the indentation. The trajectory has been determined to be 15° based on two approaches as described below. Utilizing the location of the indentation (156 inches from the ground level) and that the cannon must have positioned at a height of 5 ft (or 60 inches) from the mosque courtyard level (i.e. resting on carriage), it is estimated that the cannon was located at a distance of approximately 30 ft (namely 358 inches = $156 - 60 / \tan 15$) from the pillar when it was fired. This cannon location has been marked in Figure 2 and is well within the courtyard. This discounts the possibility that

Figure 2. Plan of the Quwwat-ul-Islam mosque showing the salient dimensions of its premises and the possible location of the cannon that fired the shot.

the cannon ball may have reached the pillar's surface after having been lobbed over the mosque boundary.

The direction of the cannon shot is deduced to be from the northern direction (Figure 2). The cannon ball first made contact on the left side of the indentation area (dotted circle, Figure 4 *b*) and then came to rest on the right side (full circle, Figure 4 *b*). The trajectory of the cannon ball can also be understood by noting the relative position of the centres of these two circles (slanting line, Figure 4 *b*). The trajectory points from the bottom to the top, thereby confirming that the cannon shot landed on the pillar on its upward motion from the cannon. Another important conclusion is that the angle of the trajectory is 15° , as determined using the slanting and the horizontal lines in Figure 4 *b*.

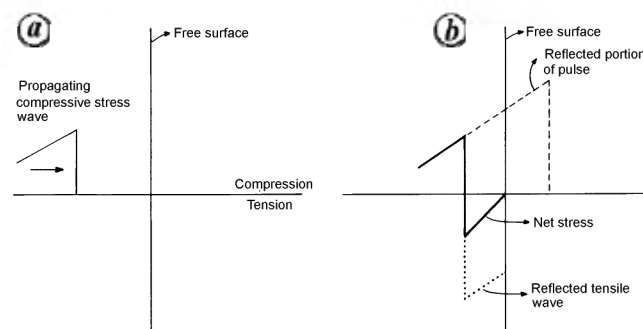
In particular, it is important to consider the reflection of shock waves due to the free surface, to understand the nature of cracking seen on the side and rear side of the cannon ball indentation area. Reflection of stress waves generally occurs at the free surface and fixed ends, at changes in the cross-section and at discontinuities within the solid¹⁸. The effect of shock waves on material fracture can be understood¹⁸ by considering Figure 5. A compressive shock wave propagates through the solid and approaches the surface from left to right (Figure 5a). At the free surface, the wave is reflected back as a tensile wave from right to left (Figure 5b). Therefore, the net stress is obtained at this location by summing up the incident compressive stress and the reflected tensile stress. It is noted that there is rapid build-up of tensile stress as the wave is reflected back from the free surface (Figure 5b). When this tensile stress reaches a high enough value, fracture occurs.

Figure 5. (a) Propagation of compressive stress wave and (b) reflection as a wave from the free surface resulting in net tensile stress near the free surface.
