Thickness estimation of Deccan Flood Basalt of the Koyna area, Maharashtra (India) and implications for recurring seismic activity

CORRESPONDENCE

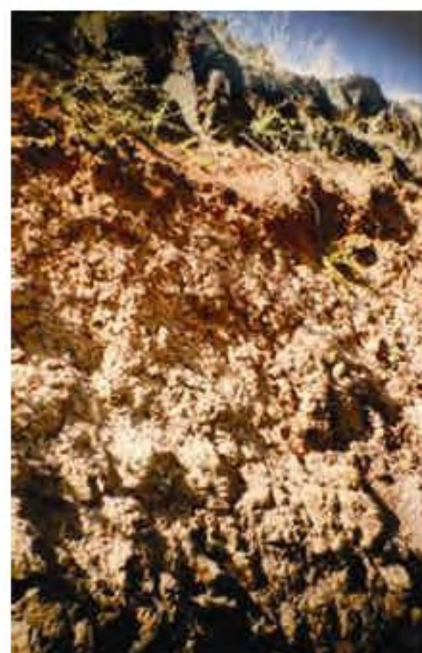
Figure 1. Disposition of basaltic flow layers and their contacts.

The entire thickness of the Deccan Flood Basalt consists of several basaltic flows, each consisting of two main trap units: (i) a lower massive unit and (ii) an upper vesicular/amygdaloidal unit. The massive unit constitutes the main trap unit and forms 60–85% of the flows. The vesicular/amygdaloidal unit forms the upper horizon of each basaltic flow and constitutes 15–40% of the flows. The density of vesicles increases toward the top of each flow. Generally, the consecutive lava flows are separated by a red layer, varying in thickness from 0.15 to 1 m, termed as 'redbole'. A field disposition of these layers is shown in Figure 1.
